Portland Public Schools Roosevelt High School Modernization

Board Report
1970 Auto Shop Due Diligence
October 2015

1970 AUTO SHOP DUE DILIGENCE REPORT TABLE OF CONTENTS

Roosevelt High School
1970 Auto Shop Due Diligence Report

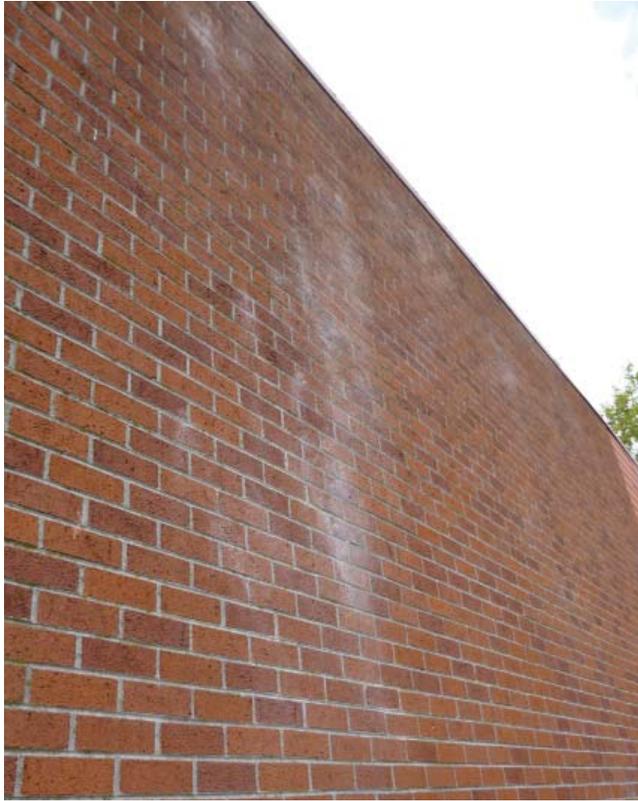
- 1) The exterior walls vary in condition depending on material. The brick veneer walls appear to be in good shape with no sign of cracking at the exterior although cracking was visible at the interior side of the walls. Cracking was localized and occurs mid-span of structural bays; refer to structural recommendations for additional information. Some limited damage to CMU block occurred at corners of the building. Efflorescence was witnessed along the brick portion of the south wall indicating water infiltration has occurred.

Efflorescence at brick veneer wall, typ.

- 1) Clean and seal brick veneer and CMU block to prevent water infiltration and further degradation.
- 2) Replace degrading wood siding. Further investigation is needed to determine extent of water damage within wall cavity along the south side of building. Per PPS Guidelines, acceptable siding would be painted fiber cement (Hardie or Certainteed), monolithic factory colored fiber cement.

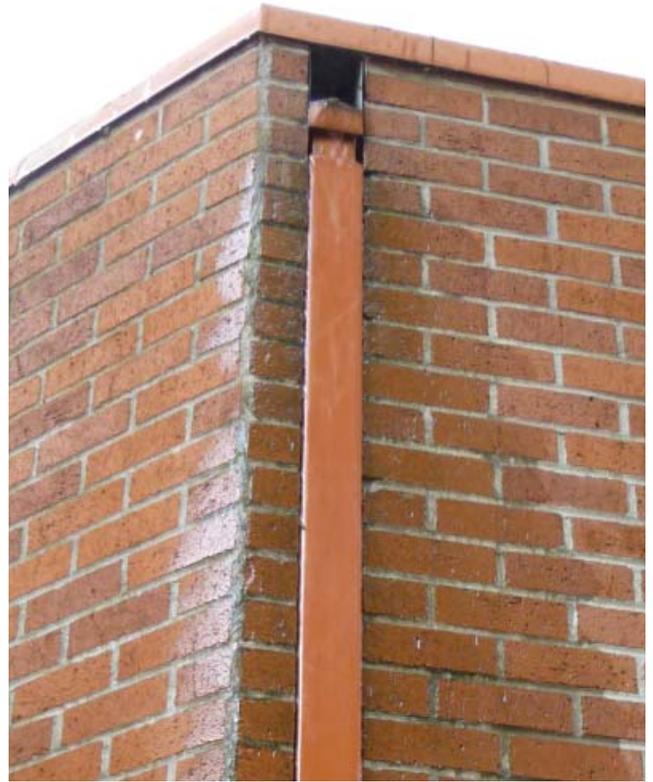
- 5) An exposed tube steel rain leader, located on the northeast corner of the building, does not function as intended. Water was observed leaking from the conductor head and at the top and bottom connections of the downspout during a rain storm.

The scupper is not sealed at wall penetration. Water infiltration is extensive. Further investigation is required to determine extent of water damage.

Unsealed wall penetration and water overflow at conductor head

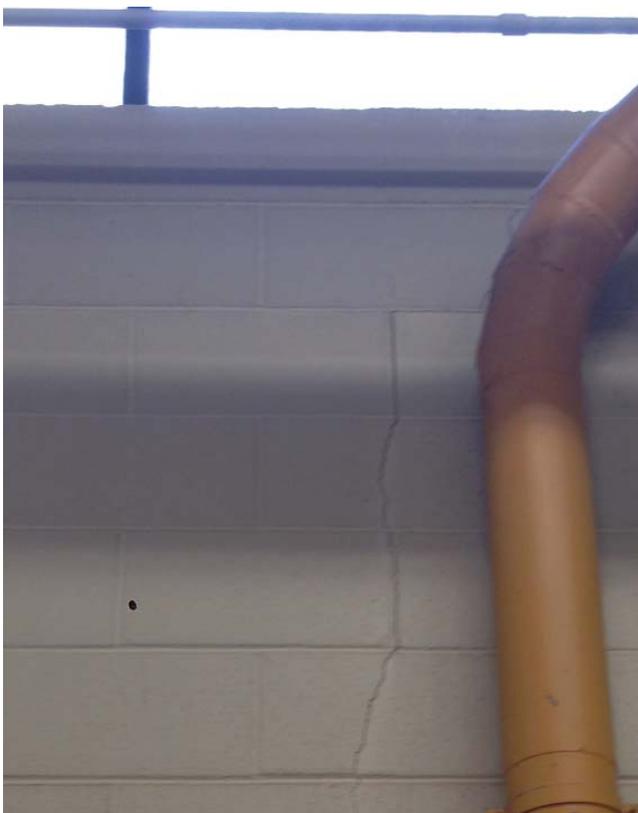
Cracking at interior side of exterior wall,typ.

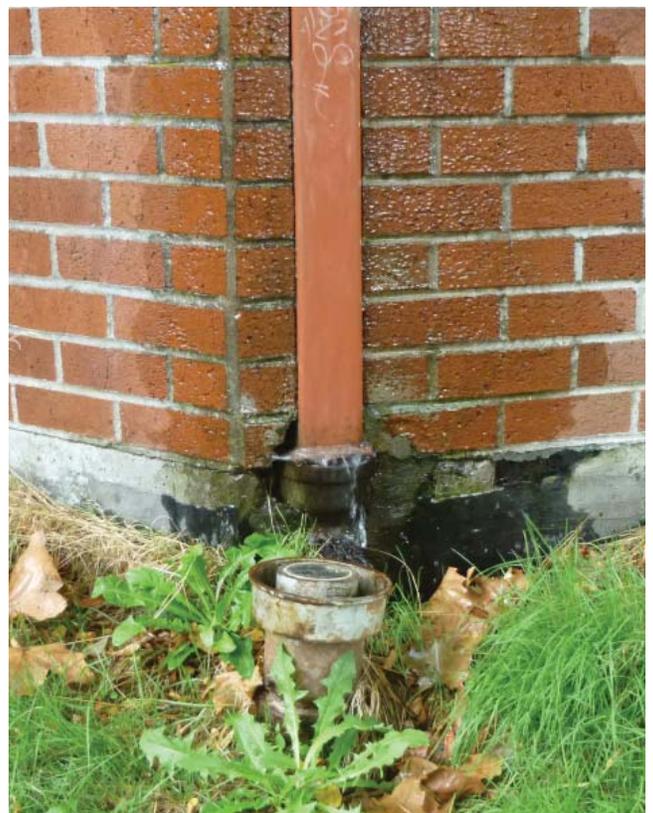
Downspout to stormwater connection

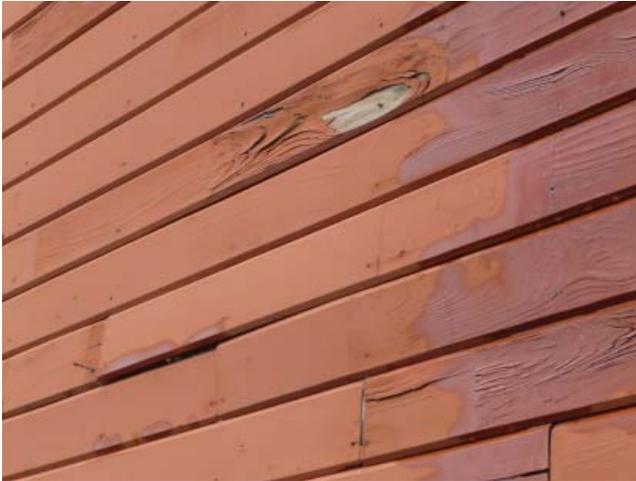
- 2) Majority of the wood siding showed signs of rot and warping indicating problems with water infiltration.
- 3) Aluminum framed single pane clerestory windows are at the end of their life and do not meet current energy codes. Standing seam metal panels located along clerestory at the roof are showing signs of aging.

Deterioration at wood siding

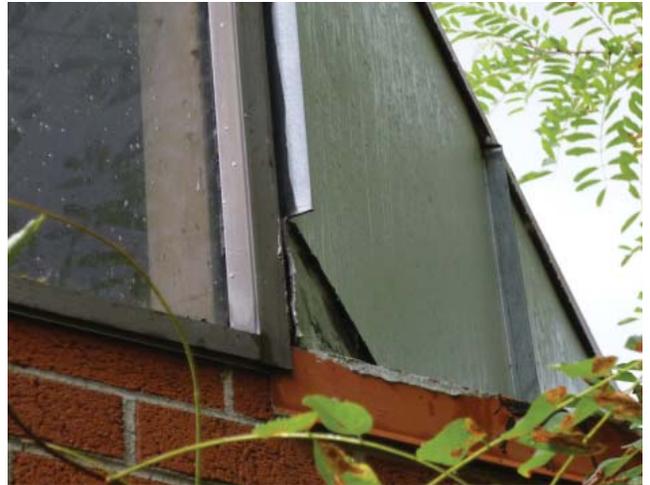
Flashing failure at window to metal panel siding and top of brick wall

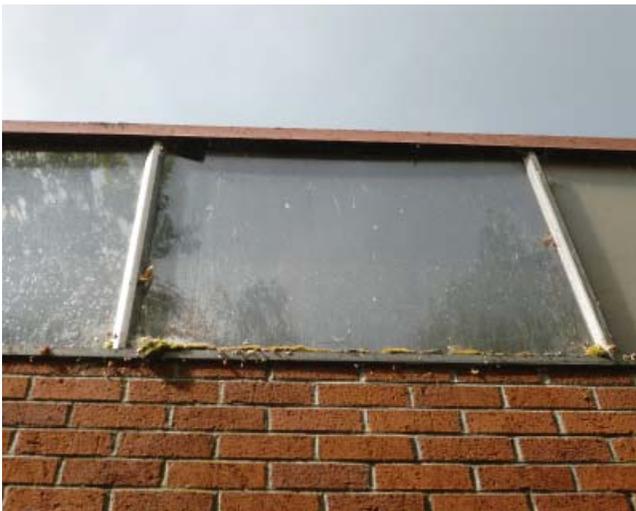
Clerestory aluminum window system

- 3) Replace storefront system with double pane insulated tempered glazing. In addition, remove any wire glass in building. Wire glass is no longer allowed by code.

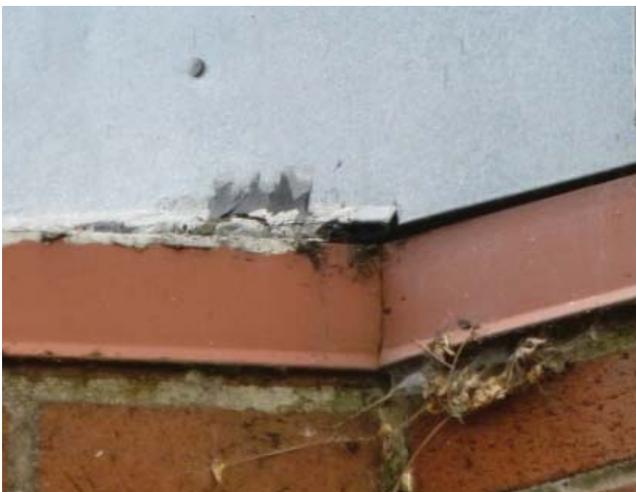
Flashing at intersection of metal panel to top of wall

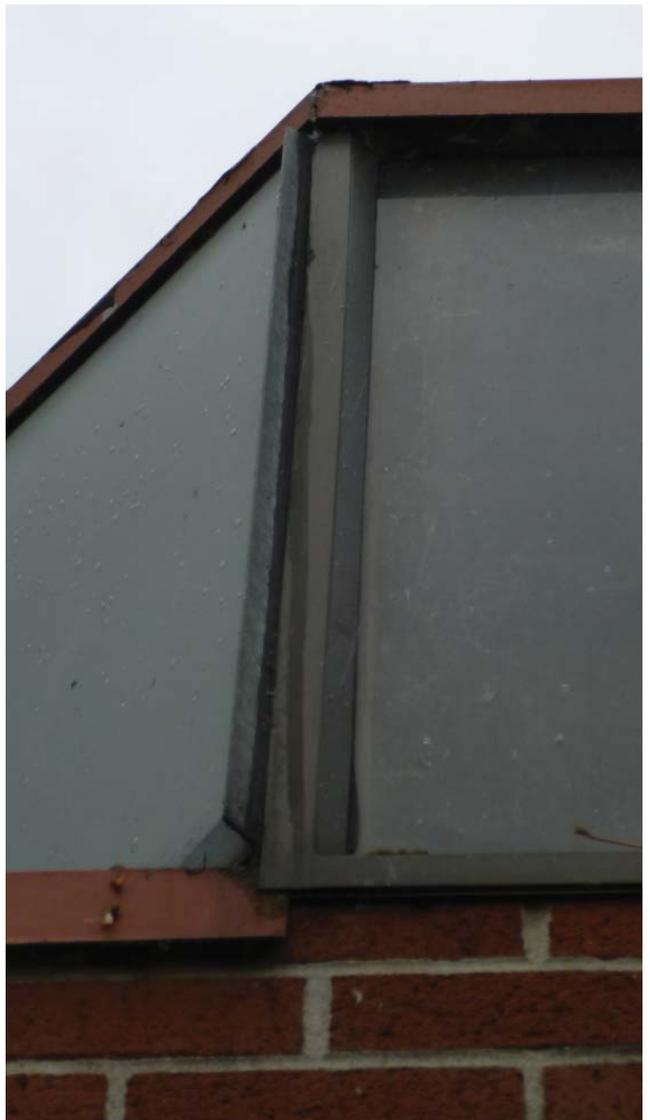
Metal panel to aluminum window and top of wall intersection

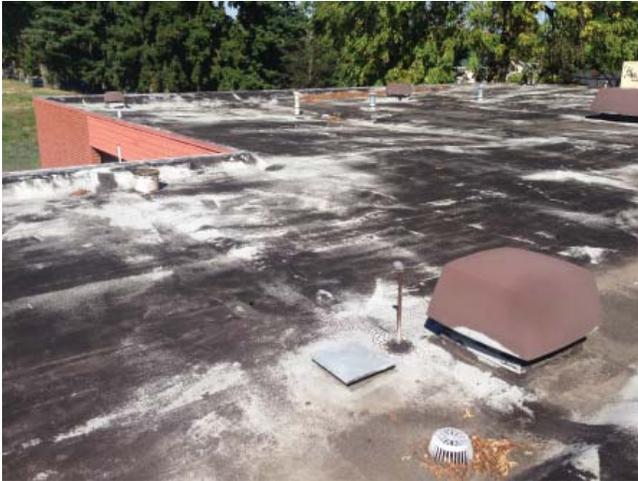
- 4) The roof is a built-up modified bitumen system directly adhered to the roof structure with no insulation above or below structure. The roof appears to be original from the 1970 construction and further investigation of archived documentation indicates it was never replaced. The overall condition is poor. The roofing system has gatored throughout and failed in several places, resulting in water damage to the roof structure below. The sheet metal flashing shows signs of corrosion. It was observed the modified bitumen roofing material has cracked at the intersection of the perimeter flashing allowing water to migrate into the building. The main problem areas are located above the welding exhaust and adjacent to the three large downspouts. Wood rot is visible at the exposed roof decking. The deterioration of the roof and structure below in this area has allowed water to penetrate the building causing further damage to the interior finishes.

Typical roof condition

- 4) Replace deteriorating standing seam metal panels and all sheet metal flashings as part of reroofing work.
- 5) Replace modified bitumen roofing to address multiple water intrusion issues. This would include inspecting the wood decking and replacing areas of water damage and rot.

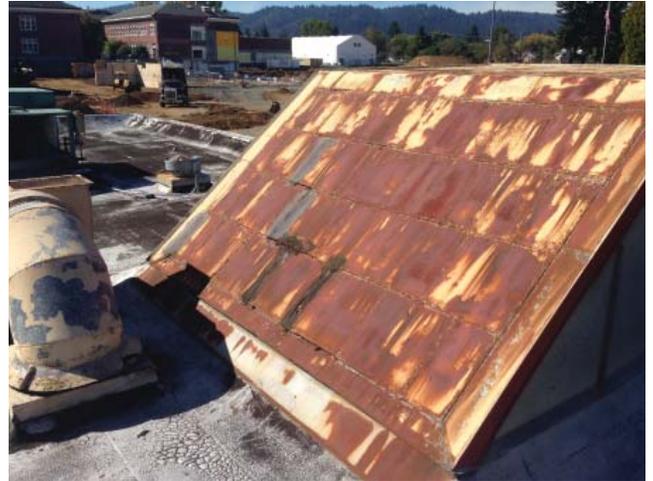
Metal roofing at clerestory areas

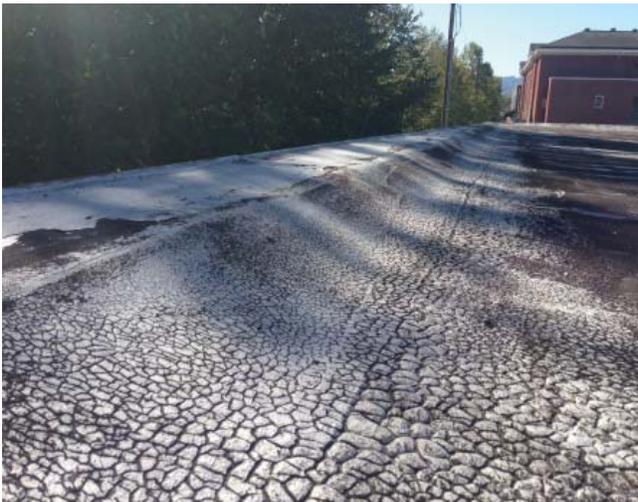
Gatoring at roof surface

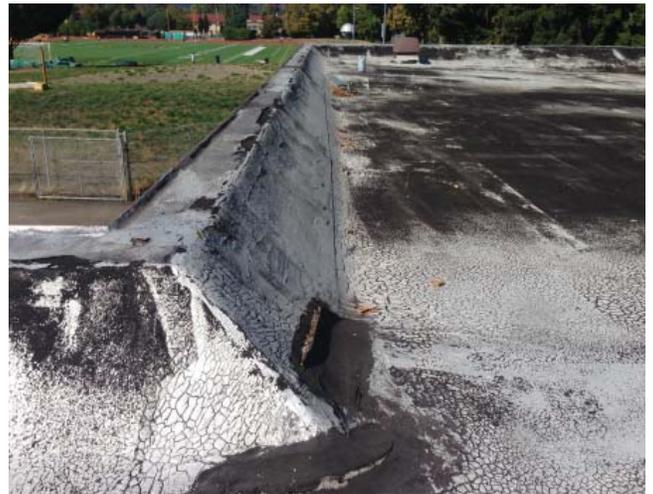
Overflow at roof edge

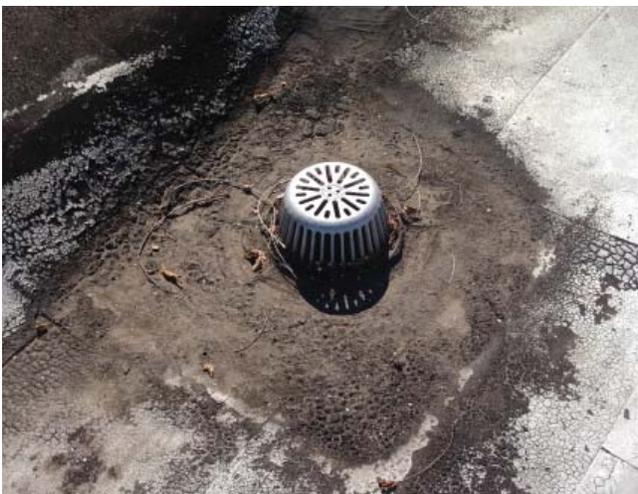
Internal roof drain

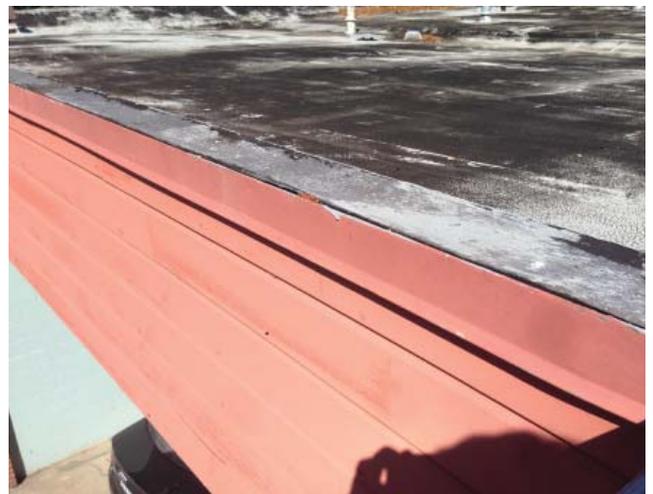
Edge of roof flashing

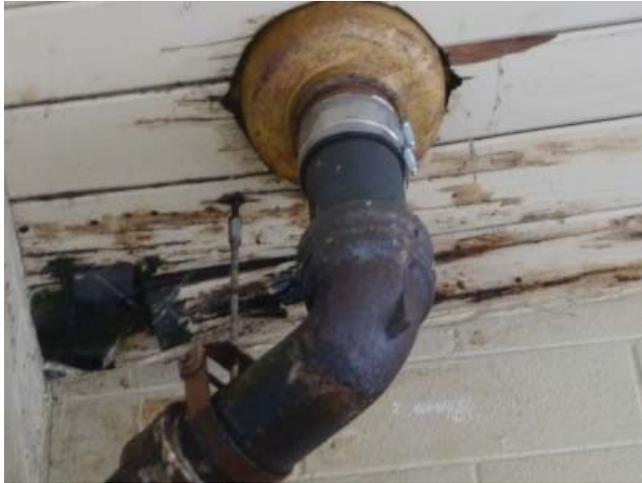
Roof deck deterioration at drainpipe

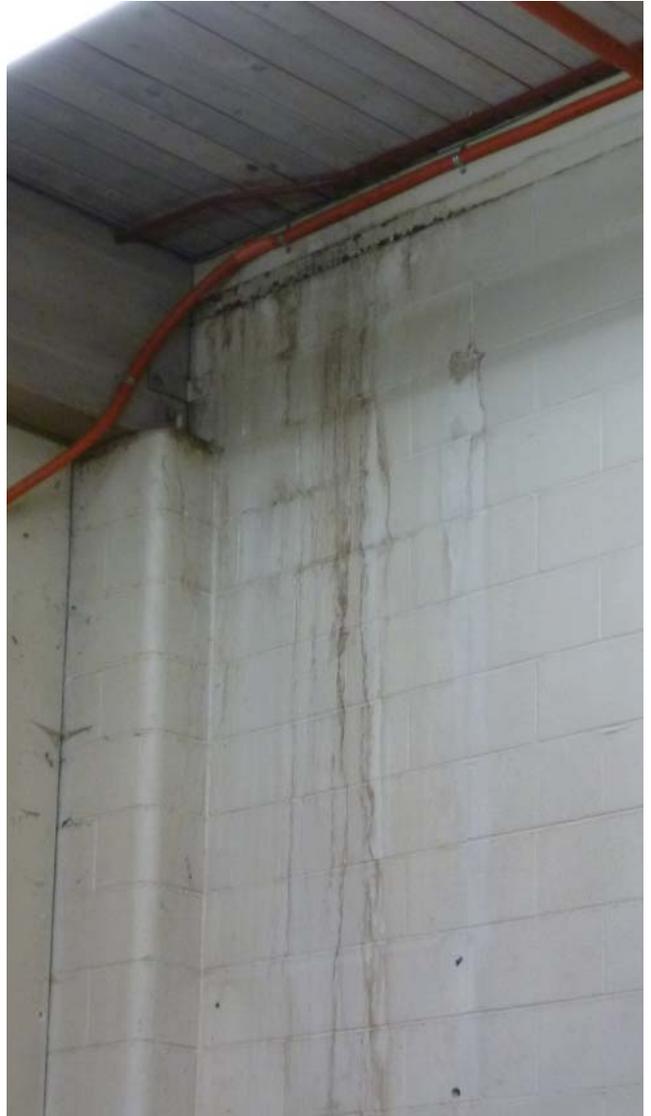
Water infiltration at interior

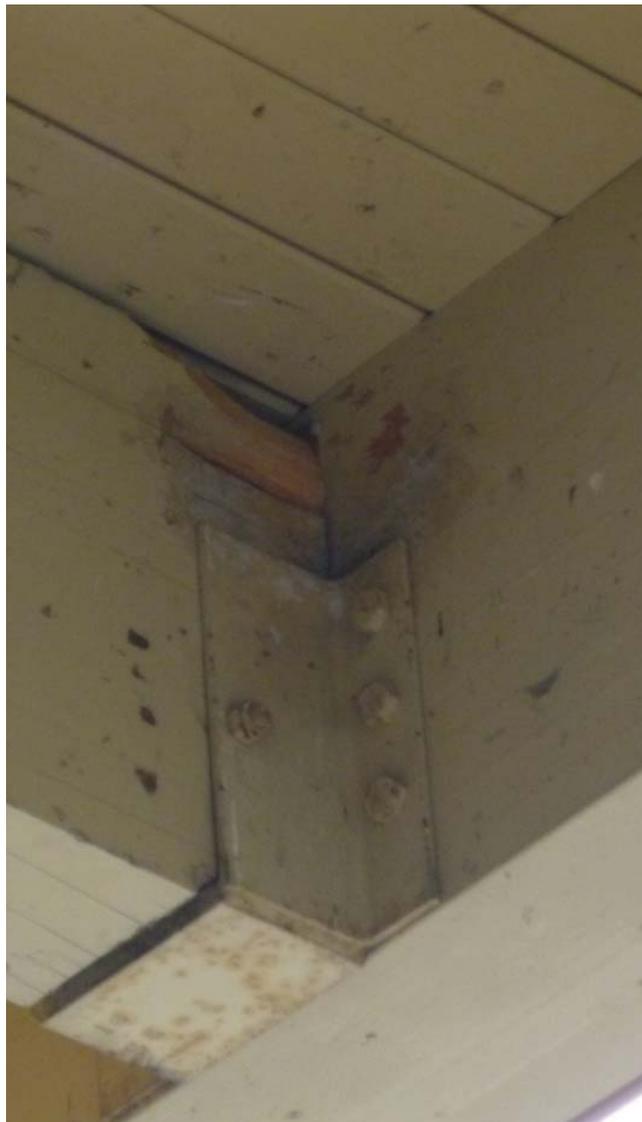
Deterioration at roof structure

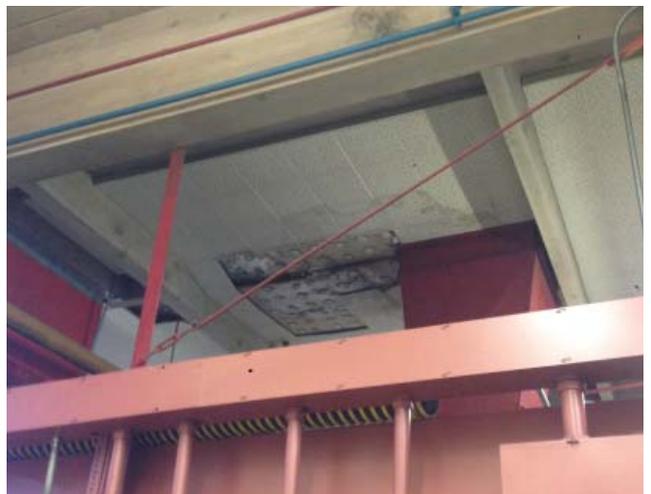
Ceiling failure due to water infiltration

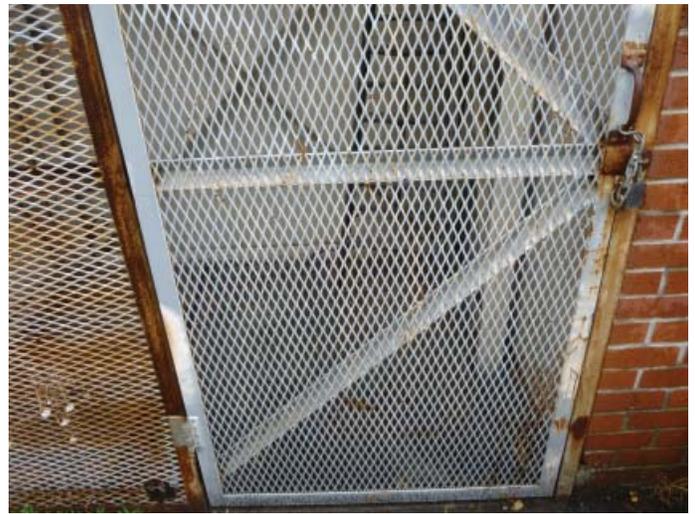
Painted metal grate enclosure at sawdust collector

- 7) Replace all existing exterior overhead doors and man doors.
- 8) Clean and paint corroded exterior metal grate structure at sawdust collector.
- 9) Refer to Electrical section for related work to the exterior lighting system.

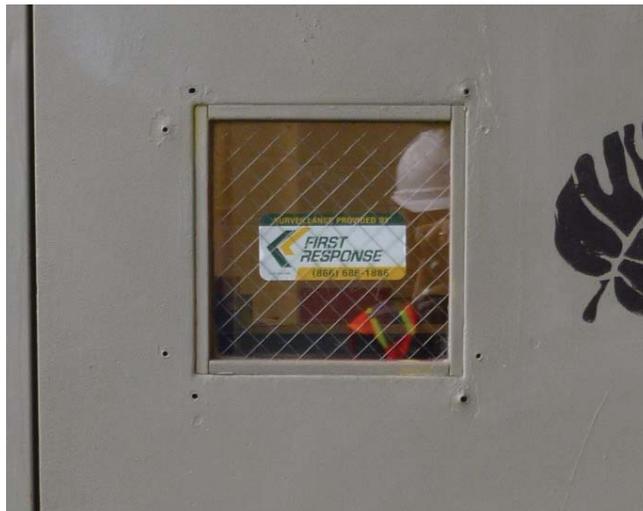
- 6) Overhead doors and man doors show signs of heavy use along with wear and tear. Several exit doors have wire glazing relites which is no longer allowed by code.

Exterior hollow metal door with wire glazing

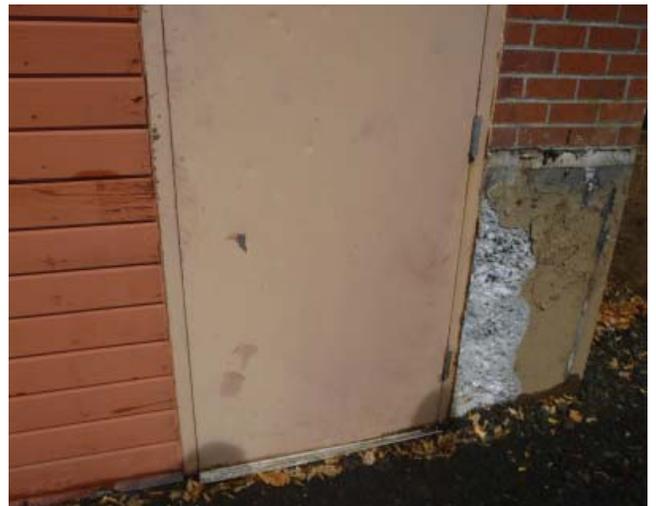
Exit door egresses directly to gravel pathway

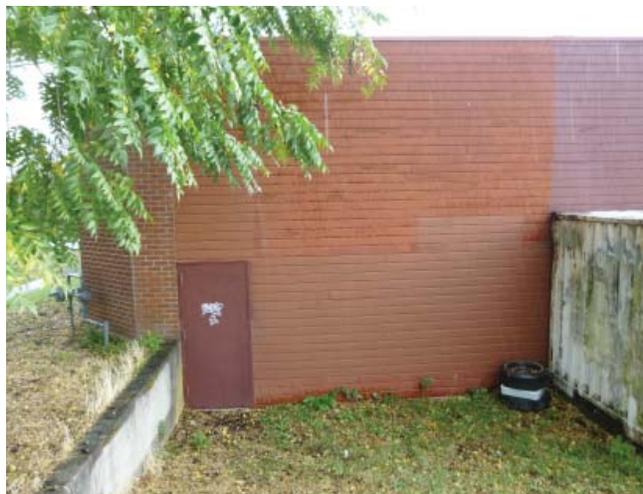
Exit door egress to lawn

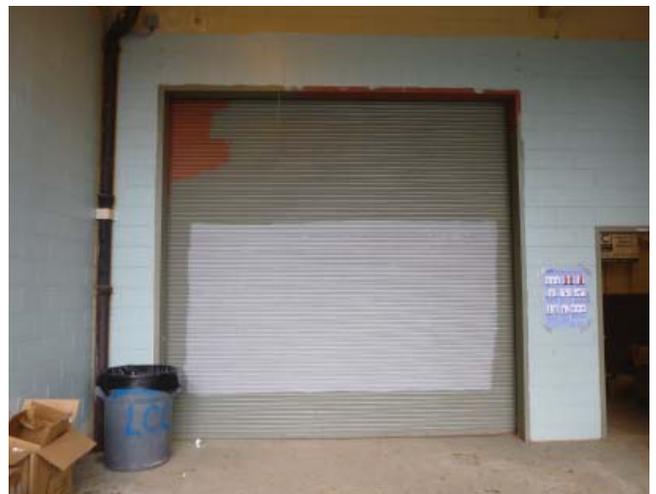
Overhead door, typical

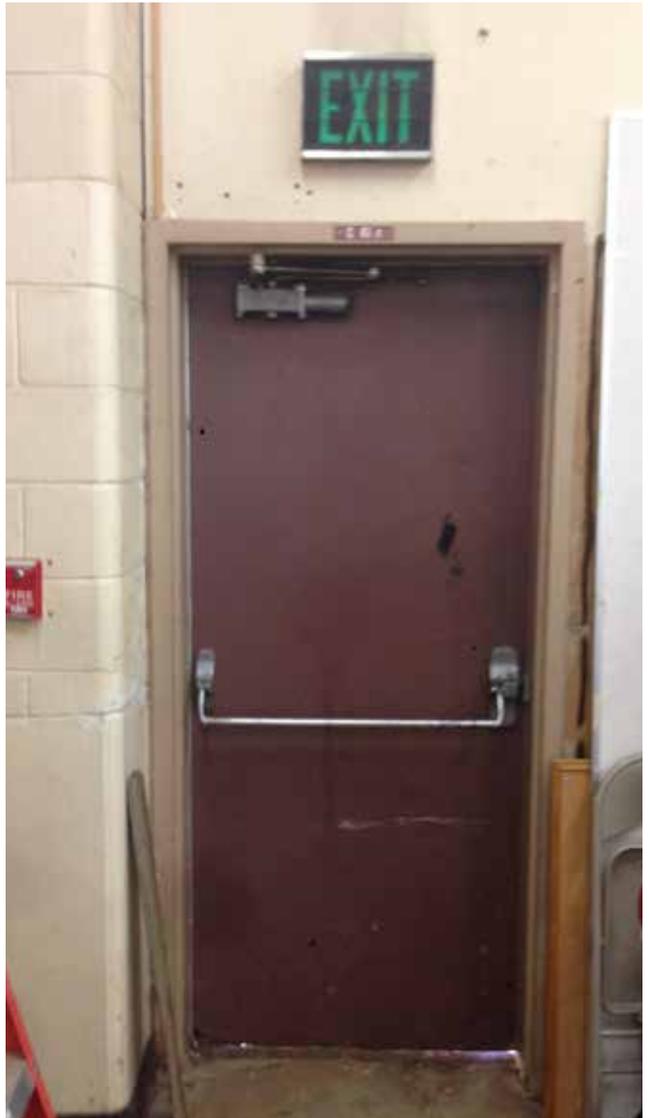
SE exit door - currently bracketed shut with no ADA access

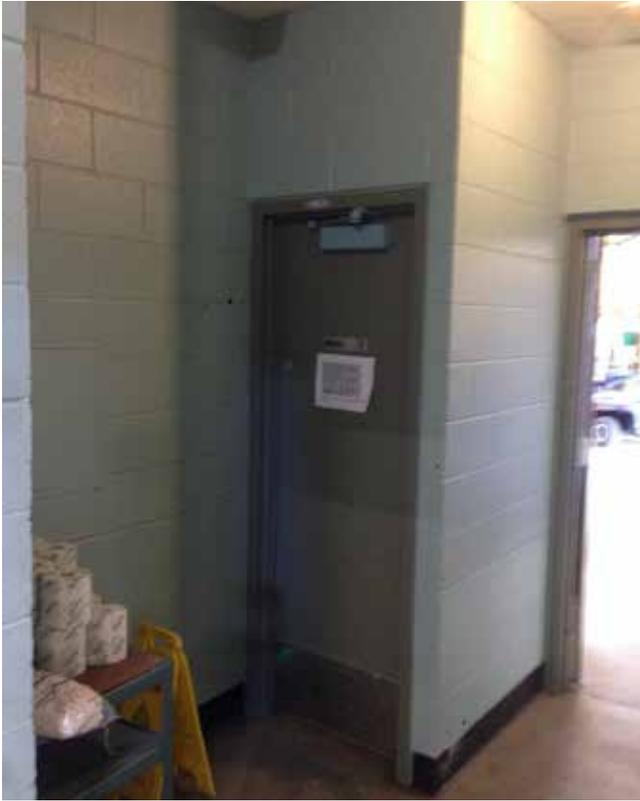
Restroom door - does not meet OSSC nor ADA codes

- 1) Relocate or replace doors and walls that do not meet ADA clearance requirements. These are primarily located in the central restroom and corridor area.
- 2) Reconfigure the restrooms and corridor to accommodate ADA clearances and required number of plumbing fixtures to meet current code. This requires extension of all utilities, and all new finishes and toilet accessories.
- 3) Delineate egress paths from exterior doors that travel through exterior carports so no parking would block these pathways. This would include painting stripes on the pavement and installing concrete filled bollards at 4'-0" on center. This may require an appeal with code officials.

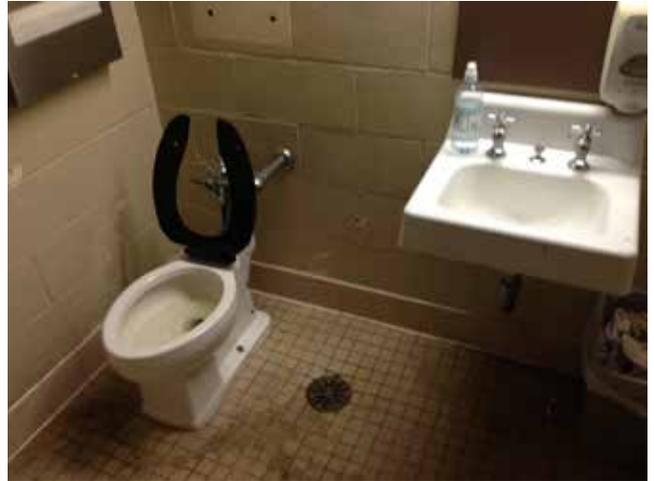
- 7) Restrooms are in poor condition, with areas of peeling and cracking paint on walls and ceilings, damaged or missing toilet accessories, and fixtures in poor condition. The restrooms do not appear to have been maintained for a long time. The restrooms are configured with one single-use female toilet room, one men's toilet room with a stall and two urinals, and one staff toilet room. The number and configuration of fixtures do not meet code. (see photos)

Typical restroom finishes and condition

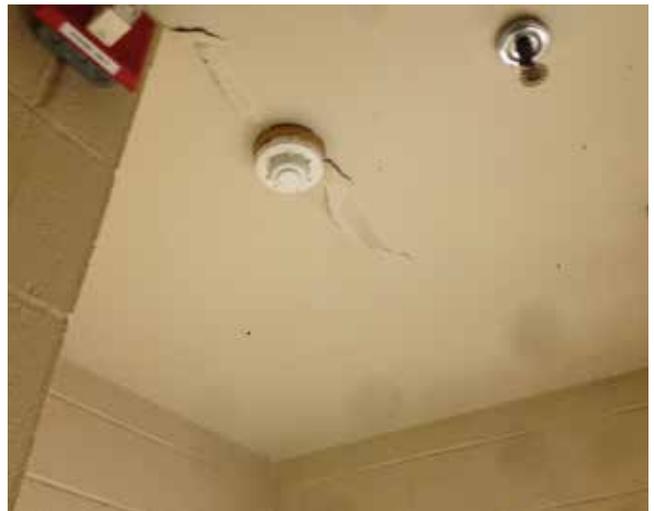
Ceiling in restroom

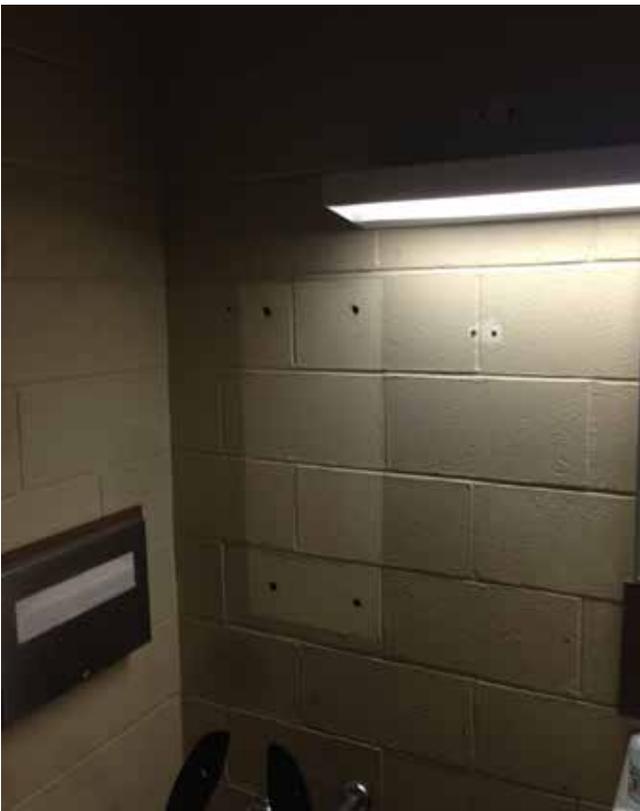
Typical restroom interior

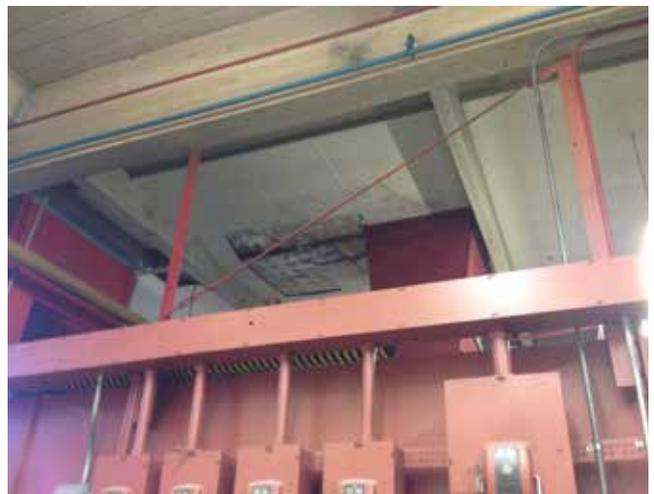
- 4) Ceilings are exposed Glulam and T&G decking with direct applied acoustical tiles. The decking and beams are generally in good condition, except where water intrusion has damaged from above. The acoustical tiles are in fair to poor condition, and are damaged in a few areas from water intrusion or have popped off the ceilings in areas, such as the classroom spaces. Per the HazMat Report, acoustical tiles contain asbestos and will be removed.

Example of ceiling damage from water intrusion, and typical acoustical panels

- 1) Provide new acoustical ceiling panels where asbestos containing tiles are removed. 1.5" thick foam panels, similar to those specified in the main project would be used. This is required as a LEED prerequisite.
- 2) Patch and repair water damaged walls and ceilings.
- 3) Refer to Structural, Mechanical, Electrical and Fire sections for related requirements.
