July 08, 2014

Re: Report of Geotechnical Engineering Services  
Vertical Settlement and Lateral Movement  
Tubman School Site for Portland Public Schools  
Portland, Oregon  
RhinoOne Project No. PPS-2013-003

Figure 1 - Current Conditions

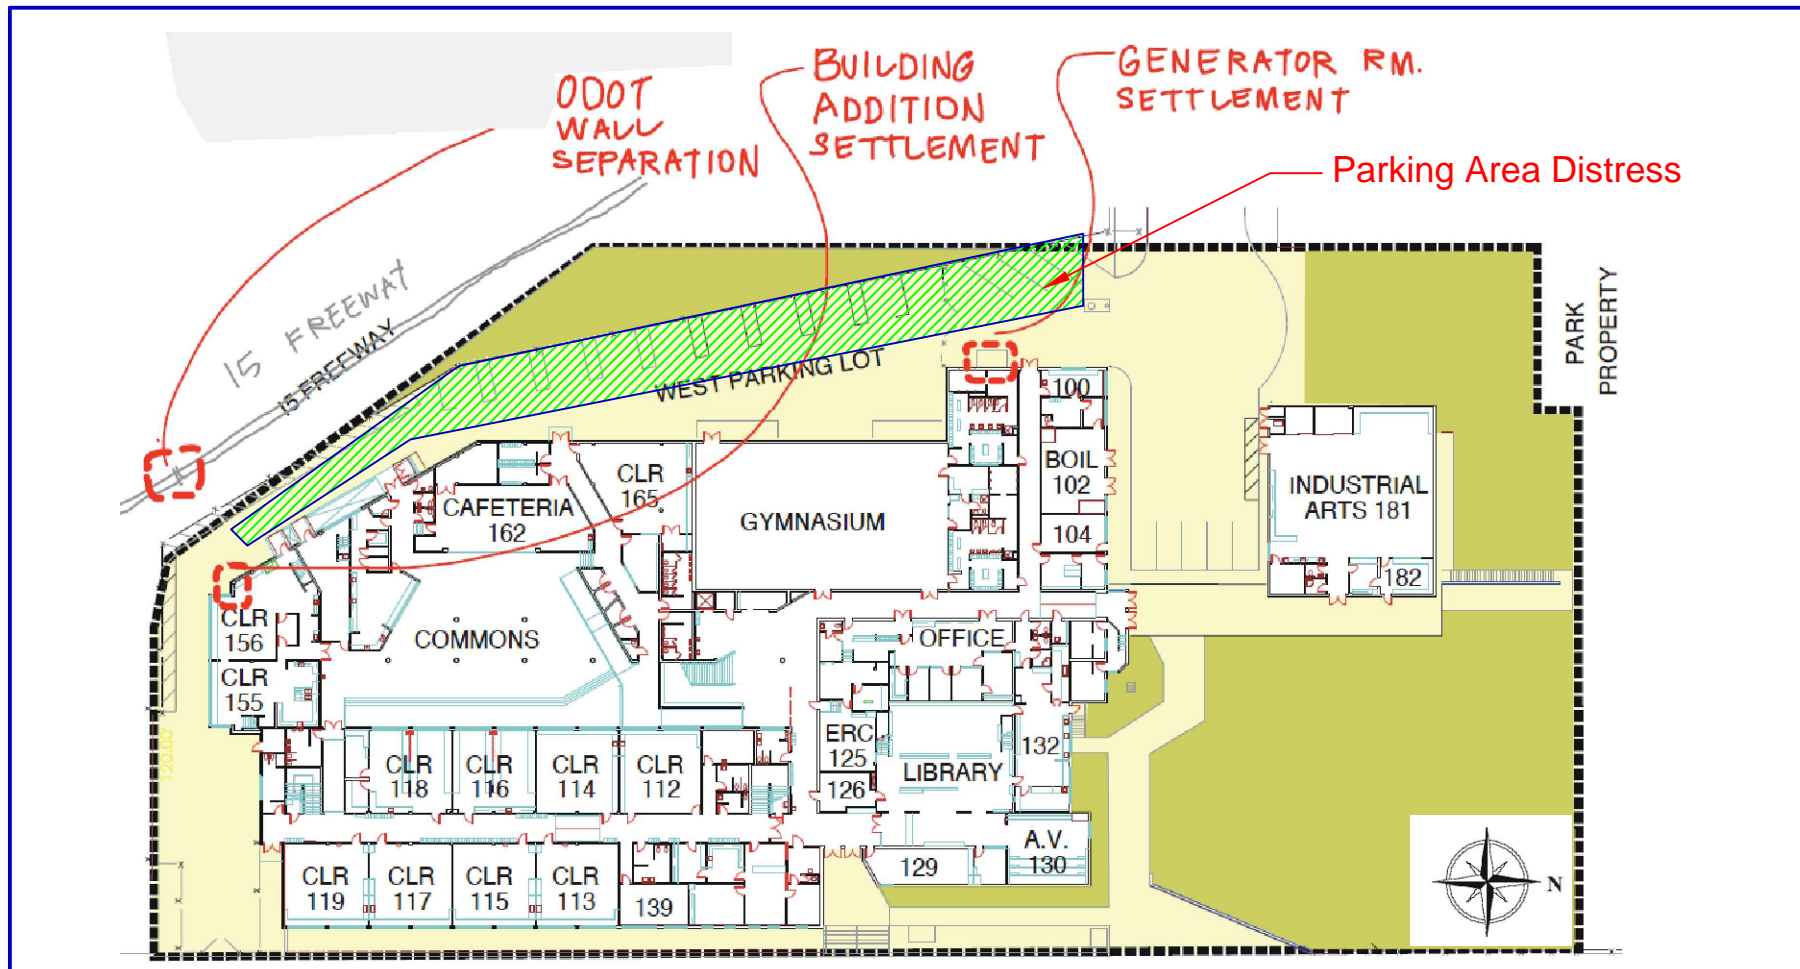
We completed a site walk with you and representatives of Oregon Department of Transportation (ODOT) on April 18, 2014. Building settlements were observed at the southwest corner and at the generator room with some additional distress observed between these two points. Distress was observed in the parking lot on the west side of the building as evidenced by various asphalt repairs over the years. Standing water was also observed in a clean-out which indicates that the water is not draining properly. A 2- to 4- inch crack running along the entire height was observed in the ODOT retaining wall downslope from the southwest corner of the building. Figure 1 shows a schematic of observed building movements. The pattern of movement appears to be lateral ground movement which subsequently causes vertical movements.

Based on our observation and discussions with you, it appears that most of the building distress is on the west wall with large settlements noted at the southwest corner. The parking area and the driveways are showing distress as indicated by un-even surface and previous asphalt patching. The generator room is also showing separation from the main building.

The effect of lateral movement is more pronounced in the parking lot area with uneven settlements, several asphalt patches and movement of the generator room. These movements have also changed the drainage patterns which may explain why standing water is observed in the cleanouts.

**Building Wall**– The west and south wall of the building in the impacted area is recommended to be underpinned using a micropile and grade beam system. The micropiles should be installed in groups of 2 at a spacing of approximately 6 feet on center. The first micropile installed inside the building should be vertical whereas the second micropile installed from outside the building should have a batter of 15 degrees. The micropiles should be a minimum of 8-inches in diameter with an outer casing for lateral loads installed to a minimum depth of 25 feet or possibly more in some areas. The total depth of micropile will be on the order of 45- to 50- feet. A continuous grade beam should be installed below the existing wall with the micropiles connected to it. For preliminary budget estimate, we have assumed a 200 feet length of wall will require remedial measures. The grade beam will most likely be 3 feet thick and 3- to 4- feet wide running along the entire length of the wall.

**Soldier Pile Wall for Slope Stabilization** – We recommend that a soldier pile wall system be constructed at the edge of the slope upslope from the ODOT retaining wall. The soldier pile wall system consists of steel beams installed in a drilled hole and backfilled with structural concrete. For this site, a soldier pile wall constructed from the top will be the most practical option. The soldier piles will be installed at spacing of 6- feet, with 30- to 36- inch diameter and to a depth of 45 to 50 feet. A steel beam like HP 14x117 will be placed entire depth. For preliminary budget purposes, assume that the length of this wall will be on the order of 200 feet.

**Parking Lot Reconstruction** – The district should decide on the potential use of the parking lot. If this lot will be used for bus traffic then remedial measures will be required. Most of the parking lot is located on un-documented fill. We recommend that five feet of this fill be removed. The exposed subgrade should then be compacted. A bi-axial geogrid with a geotextile composite should then be installed over the prepared subgrade. Four feet of 3" minus clean rock should then be installed over the geogrid and compacted in layers. The pavement structural section of asphalt concrete over crushed rock should then be installed. The actual design of the section should be done based on the intended use.

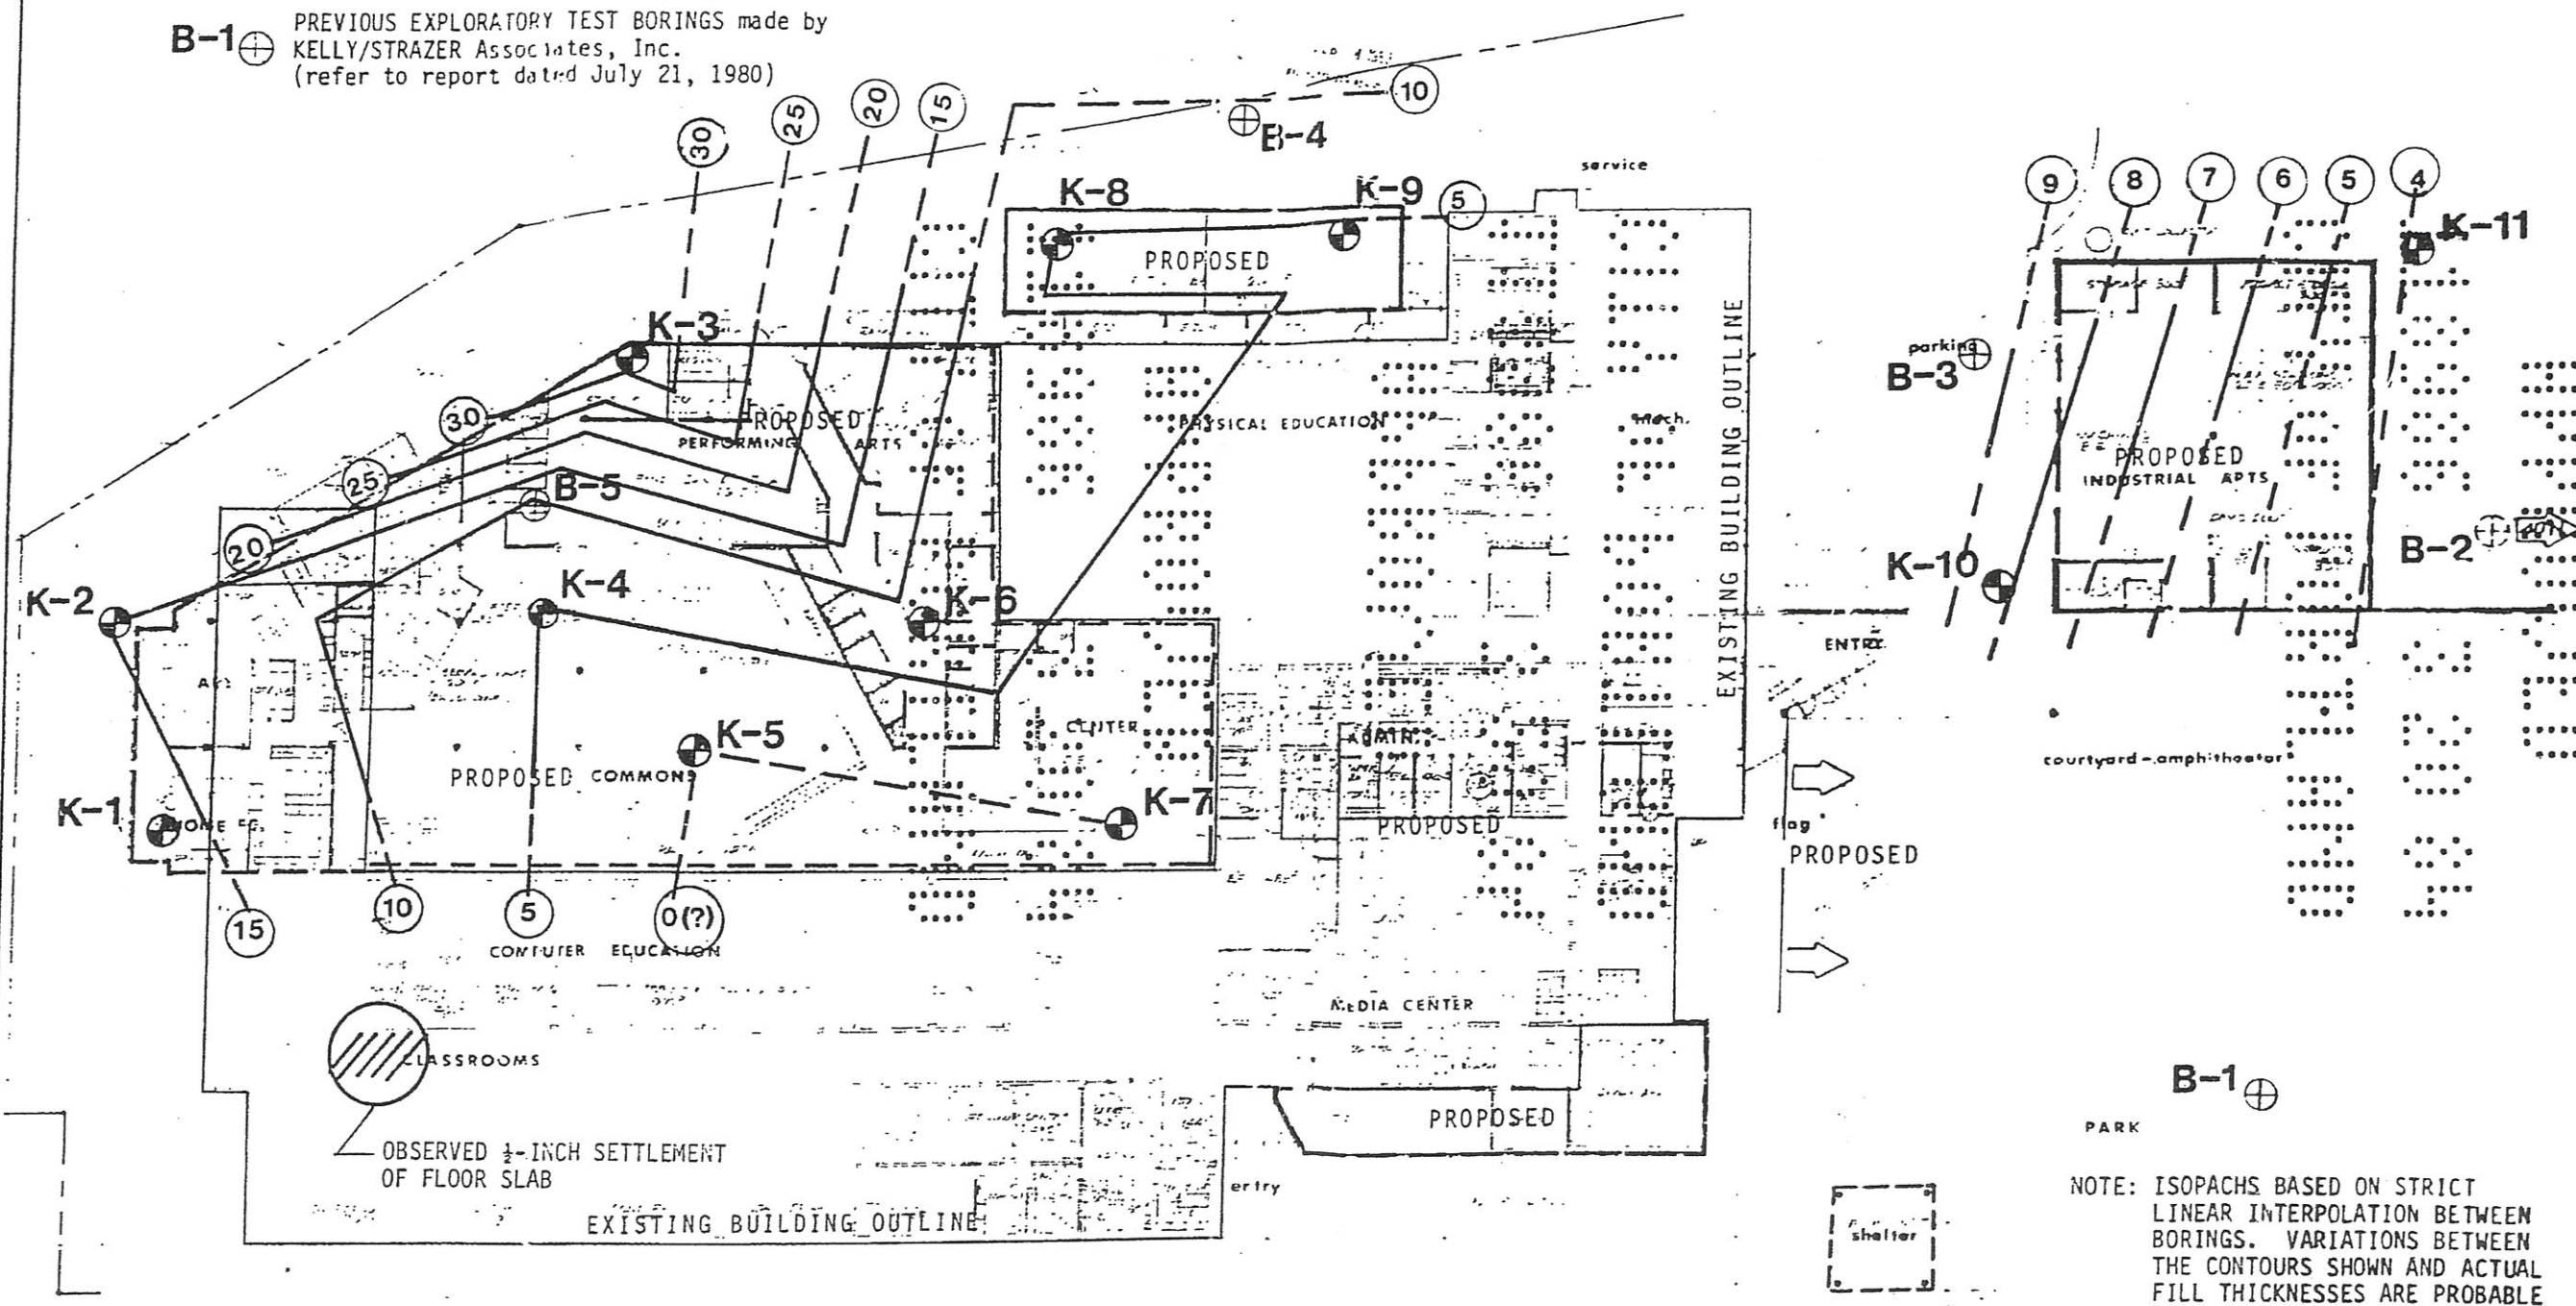
FIGURE  
14

The site has undergone several instances of filling. Based on the previous boring logs, it appears that 30 feet or more of fill is placed at some locations. In addition, the subgrade was not prepared for filling with the old topsoil and organics still present. We interpret that the fill slope is moving laterally. This lateral movement is causing large lateral loads on the piles. Timber piles with minimum embedment in the pile caps are not adequate to carry loads of this magnitude. The lateral movement is likely causing the piles to separate from the pile cap. This lateral movement with subsequent vertical settlement is most likely causing distress to the building as observed along the west wall.
