Jefferson High School

5210 N Kerby Ave., Portland, OR 97217

December 29, 2017

The installation of two sub-slab depressurization systems was used to reduce the radon below the EPA action level of 4 pCi/L. See attached pages for a description of the system components.

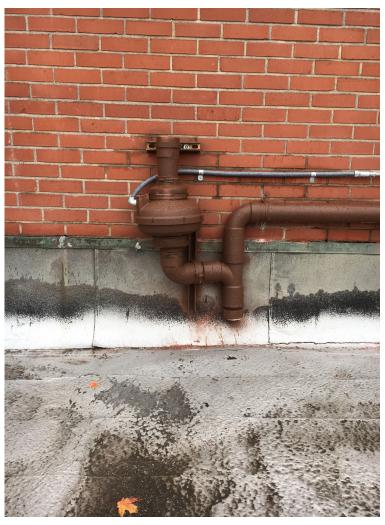
System #2 mitigation fan is located on the western roof of the building. Vent piping runs down the side of the building, into the receiving room and into the faculty dining room A75. This system was painted to help it blend in on the more visible western exterior.

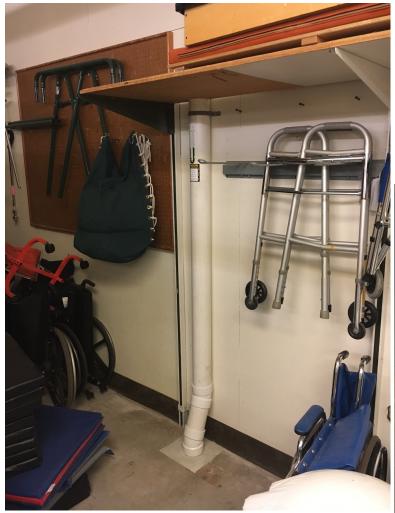
Suction point location in a storage coral of the wood shop.

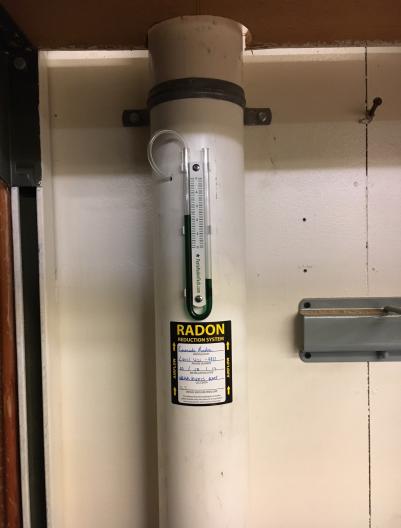
Pressure Gauge

System #1, initial suction point is located in a storage coral in the wood shop. The vent piping continues to the fan location on the roof above. The system includes a manometer (pressure gauge), which is a simple means of seeing the system is working mechanically. A manometer also shows how much negative pressure (depressurization) the system is creating. It is understood such a pressure gauge DOES NOT monitor radon levels.

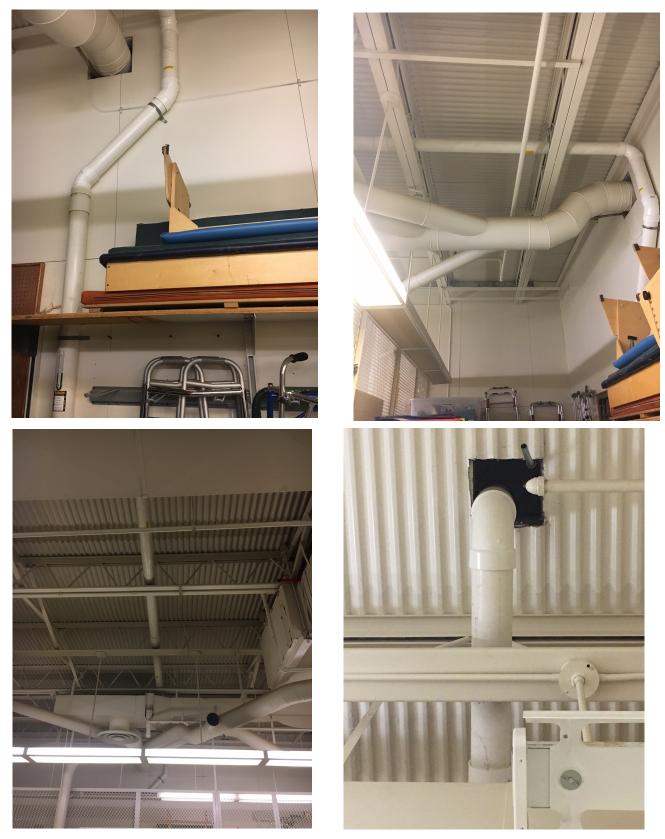
This portion of system #1 is the vent piping continuing from the suction point across the wood shop and through the roof deck to the mitigation fan on the roof.

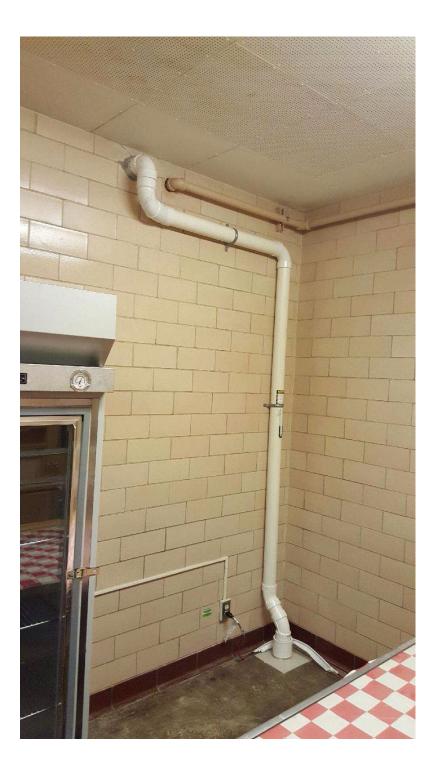
System #2, the suction point is located in The faculty serving room adjacent to room A75. The vent piping continues to the fan located on the western roofline. The system includes a manometer (pressure gauge), which is a simple means of seeing the system is working mechanically. A manometer also shows how much negative pressure (depressurization) the system is creating. It is understood such a pressure gauge DOES NOT monitor radon levels.

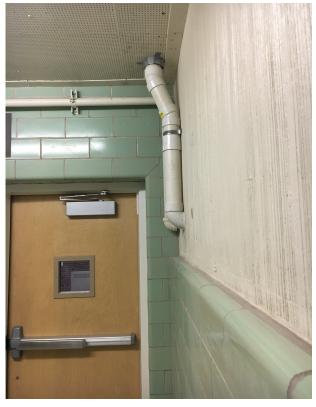
Vent routing from Faculty Serving room up into the drop ceiling of the corridor.

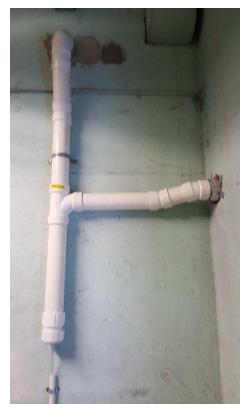
Vent piping coming through the foundation wall from the corridor drop ceiling and into the receiving room.

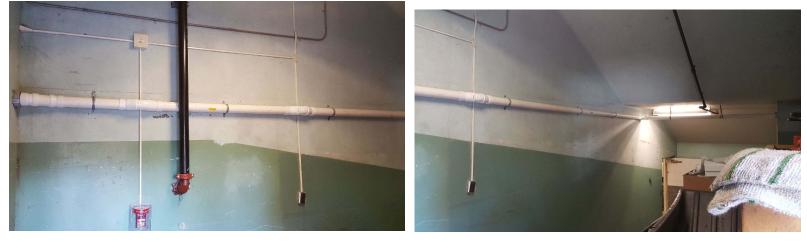
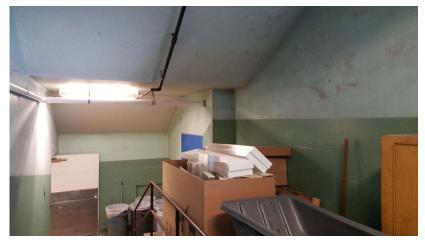
Vent routing from the receiving room through the receiving corridor and to the exterior foundation wall.

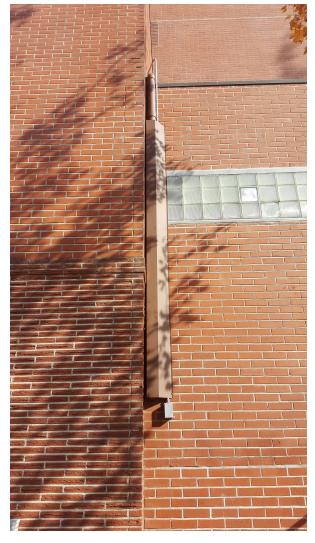
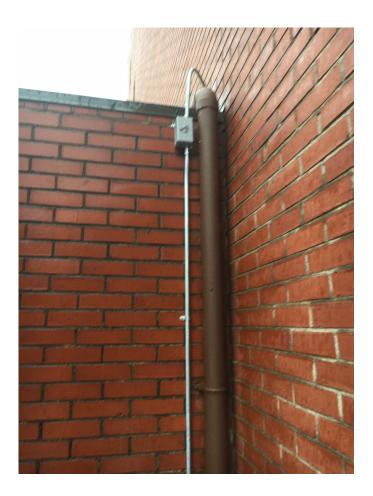
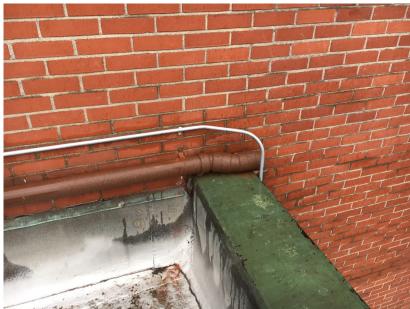
Exterior vent routing to the fan location on the western roof

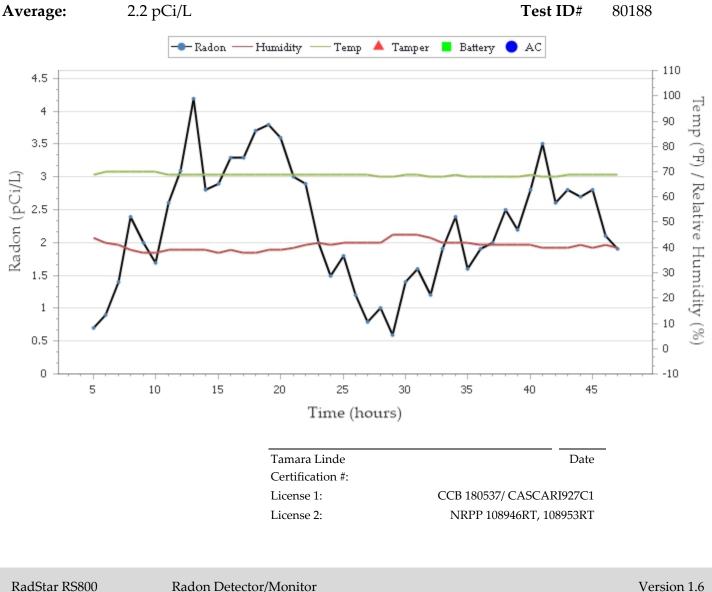
Location of Instrument: Woodshop Office (A41E)

| Hour T | B AC | | emp | Humd | Alpha | |
|---|---|---|---|---|---|---|
| Ainimum: | 0.6 pCi/L | Maximun | n: | 4.2 pCi/L | | Average: |

2.2 pCi/L

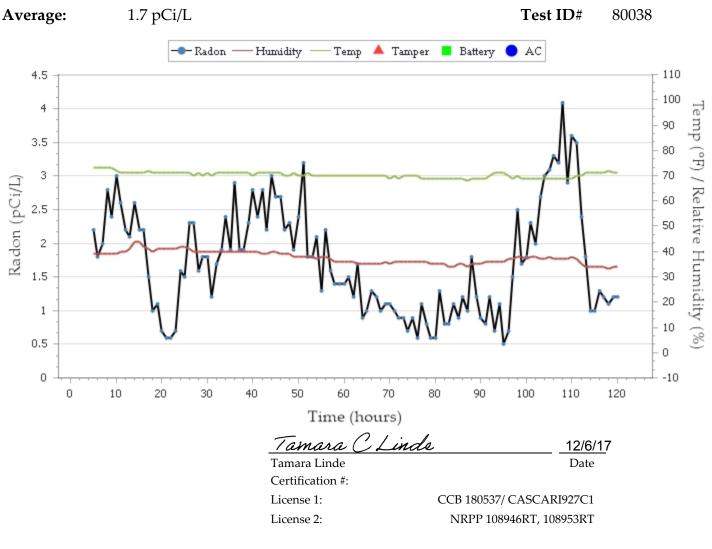
Location of Instrument: A75/Faculty Dining

| Tamara Linde Cascade Radon 12839 NE Airport W Portland, OR 97230 Phone: 503-421-4 office@cascaderador | 813 Fax: 5 | 03-281-6170 | | | | Rn | |
|--|---|---|---|---|---|---|---|
| Minimum: | 0.5 pCi/L | Maximum: | | 4.1 pCi/L | | Average: | 1.7 pCi/L |
