# PORTLAND PUBLIC SCHOOLS – FACILITY ADA ASSESSMENT

Holladay Annex      SPED 6-12  
 August 31, 2009

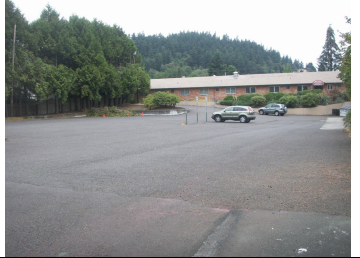
Southwest Parking	Restripe (1) accessible stall and related access aisle. Verify this space is marked as van parking and is 9 ft wide with an 8 ft wide access aisle.

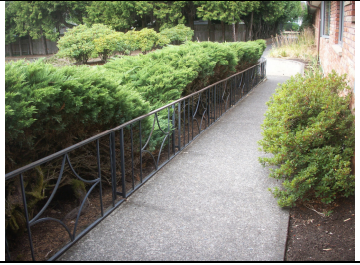
Southwest Parking	Locate and stripe a permanent pedestrian path from the parking access aisle to the closest accessible building entry.	
Handrails	Provide accessible handrails on each side of an existing ramp from the south parking lot to the south entry (approximately 60 lf of rail.)

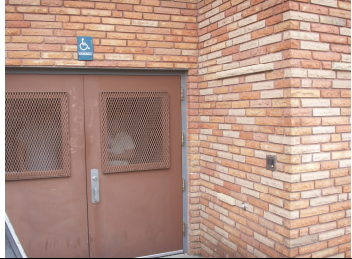
<p>Southwest Basement Entry</p>	<p>Add two-way visual equipment to the intercom communications equipment at this door.</p>
