PORTLAND PUBLIC SCHOOLS – FACILITY ADA ASSESSMENT

Holladay Center SPED K-5
 August 31, 2009

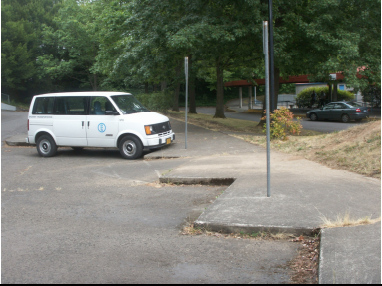
<p>North Parking</p>	<p>Restripe (1) required accessible stall and related access aisle. Verify that this space is marked as van parking and is 9 ft wide with an 8 ft wide access aisle.</p>

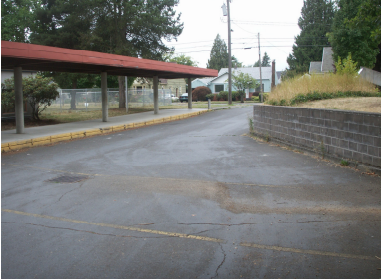
<p>Site Path</p>	<p>Repair root heaved concrete accessible path that leads down towards building. Maximum allowed vertical path height difference is ½-inch. Restripe crosswalk from path curb cut to building curb cut.</p>

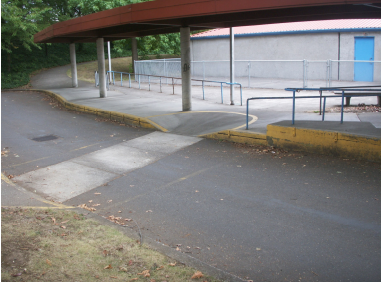
<p>Entry Drop-off Curbs</p>	<p>Rebuild (2) curb cuts that are non-compliant and too steep to compliant curb cuts with roll-across side slopes (all 1:12 slopes maximum). Existing drop-off curb height too tall (varies up to 14", average is 8"-9"). Repaving driveway with an added topping coat would mitigate curb height problem, and would solve/lessen the existing wavy finish grading.</p>

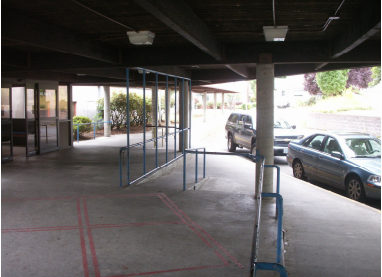
<p>Front Covered Entry</p>	<p>(2) existing ramps and curb railings non-compliant. Replace existing ramp railings with compliant double handrails each side. Replace existing curb railings with compliant railings for height and horizontal protection.</p>

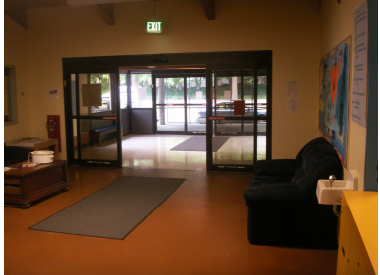
Entry Doors	All entry doors and classroom emergency exit doors are at grade and compliant.

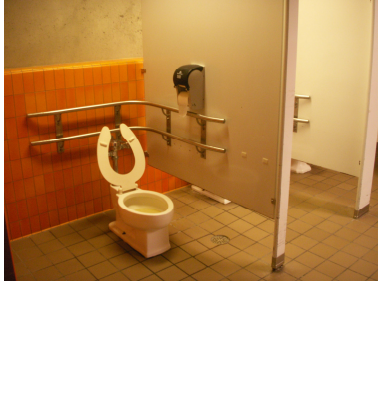
Restrooms	Existing restrooms and stalls have double grab rails designed and installed pre-ADA and are functional but no longer compliant. (i.e. no rear grab bars) Current room usage is inefficient and suggest a redesign of facilities to increase efficiency. (i.e. design of multiple user toilet facilities is currently only single user at a time, and produces corridor wait lines for students. Multiple unisex changing and restrooms in the existing space would increase efficiency of space and staff.

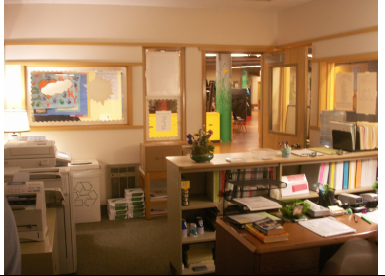
Office 23	Provide a lowered counter at 34 inches high.

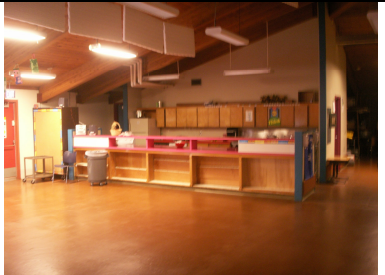
Serving Line	Provide a food serving line at the dining area at 30 inches high. Alternatively, staff assistance could be provided effectively at this serving area open to the dining space.

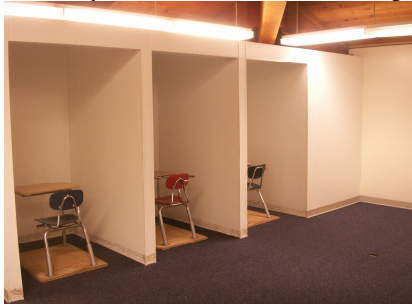
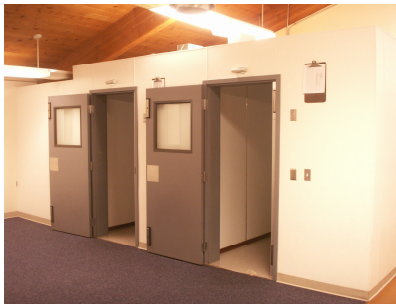
1. This facility includes the preferred examples of open decompression alcoves with seats and decompression rooms with mag locks.
