PORTLAND PUBLIC SCHOOLS – FACILITY ADA ASSESSMENT

Skyline School
August 31, 2009

Site Accessibility

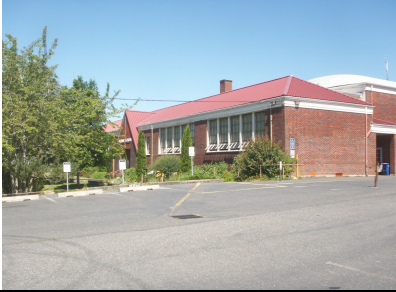
Parking, east lot	<p>No accessible parking exists at the main public entry parking lot. Several special monthly parking winner spaces have signs and stalls designated nearest the main walk-in entry. Add more directional signage to accessible entry parking and doorway located at back north of building.</p>

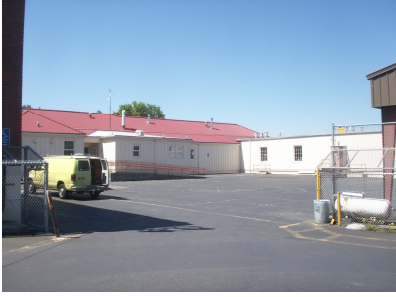
Parking, north	<p>Two ADA spaces exist at the north paved area shared with the play yard and next to the only fully accessible building entry. Parking stalls (adjacent to entry ramp) require parking signage, new striping, wheel stops. Add more directional signage from main east parking to accessible stalls, and to accessible entry doorway at north side back of building.</p>

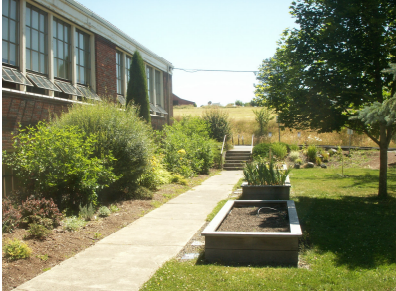
Parking/Entry	<p>Provide more signage at east lot walk entry to south front of building indicating the accessible building entrance at the north doors.</p>	
Entry Accessible Path	<p>Walk path to south main front entry door has 2 sets of exterior stairs with compliant handrails. Interior stairs also have compliant handrails up to Office at +28" AFF. Guardwall height is at +36" AFF.</p>

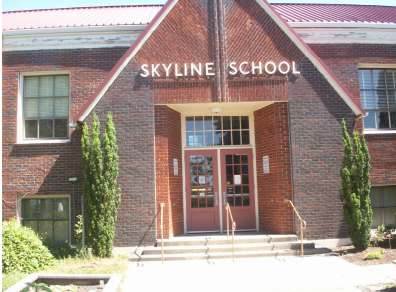
Entry, South Front	<p>This is the Main building entrance and is a walk-up entrance from the outside landscape walk. This is not the fully accessible entrance. Exterior pull handles, no thumb latch. Interior panic exit bars. ¾ divided lite glass and wood doors.</p>

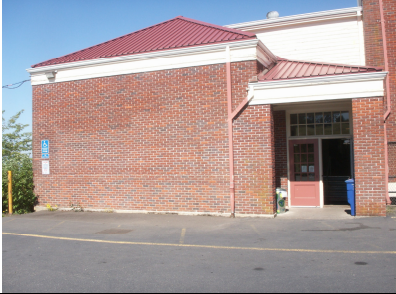
Entry, East End	Add signage indicating this entry is not a fully accessible entrance. Existing generic accessibility wall sign with arrow seems to point to this doorway. Provide better directions. This entry has interior steps with compliant handrails but no ramp.

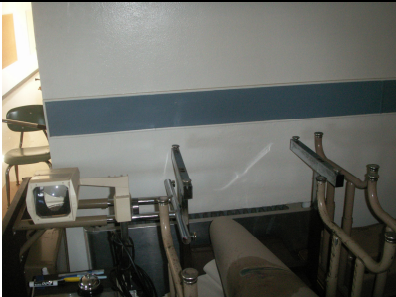
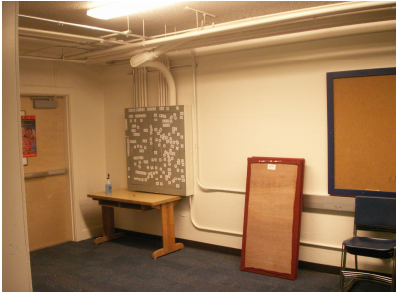
Elevator	Provide an elevator for access to the basement and second floor. One appropriate location for the elevator would be at the west inside corner of the main corridor outside. This would entail excavation work to access the basement. Relocation of a hydronic heater located in the wall at the first floor and relocation of a large electrical sub-panel in the basement will be required to make space for the elevator door location facing south. The basement sub-panel to be relocated to east of proposed elevator door. Subdivide Classroom 106 at existing column line to create elevator lobby/corridor separated from the classroom.

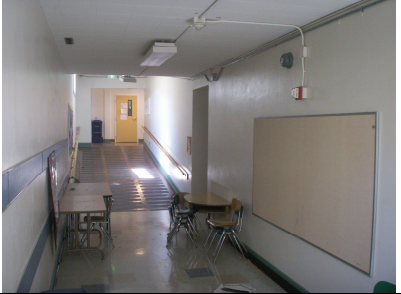
Basement ramp	Existing ramp to Classrooms 109 and 110 is compliant slope. Replace wood handrails with compliant metal rails with compliant top and bottom extensions (approximately 66 lf of rail.) Non-slip ramp surface is compliant.

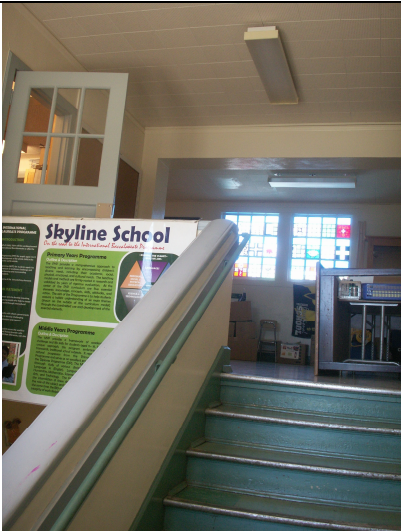
Classroom doors	Provide all classrooms with lever handle hardware.	
Cafeteria	Replace (2) 2-6 doors with unequal 3-0/2-0 pair with lever hardware.	
Gym	Provide lever hardware on a pair of doors.	
Stair Handrails, Interior	Existing south main stairs, and east and west end stairs have compliant metal handrails with extensions and correct height for children (+ 28" AFF). Add upper handrail at + 34"-38" for adult and older children at south stair (approximately 44 lf of rail.) Upgrading remaining wood handrails at west stairway to compliant handrails would improve accessibility.

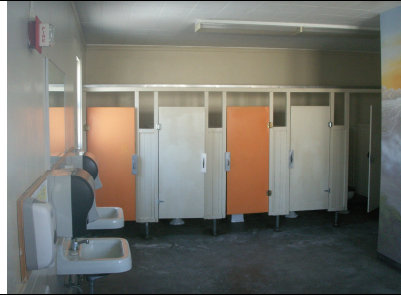
1st Floor Restroom, Boys 200	Provide accessible toilet stall, clearances, grab bars, lavatory and accessories within reach ranges.

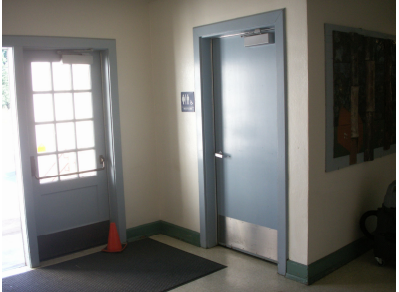
Basement, Girls 100A	Provide accessible toilet stall, clearances, grab bars, lavatory and accessories within reach ranges. Infill and finish wall opening to old lockers. Verify and correct entry door clearances.	
Unisex Restroom 206	Accessible unisex restroom has been subdivided into an outer Nurses office with access through to the accessible restroom. Provide access aisle clearances within the rooms. Remove signage on exterior since this unisex restroom is no longer available without key access and permission. Location by accessible entrance has been invalidated. Option is to modify unisex restroom back to accessible standards and move Nurses office to another location.

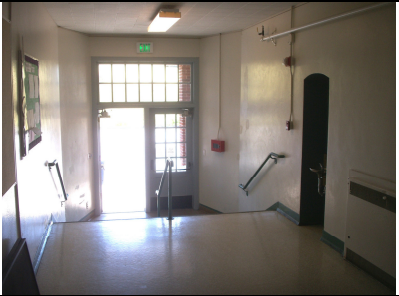
Drinking Fountains	Verify that at least one corridor DF on each floor complies with clearances. Existing DF's at +32" AFF, but one at east entry is in non-compliant recess, and non-compliant push button fount. Replace with PPS extended reach standard fount.

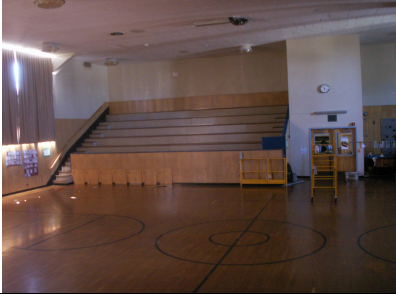
Bleachers	<p>Revise built-in fixed wood bleachers at southeast corner of Gym to provide accessible seating and sight lines at this raised portion of the Gym/ Auditorium. It would improve accessibility to provide a ramped approach to the lower tier of seating (with compliant handrails).</p>
