PORTLAND PUBLIC SCHOOLS – FACILITY ADA ASSESSMENT

Sunnyside School K-8
August 31, 2009

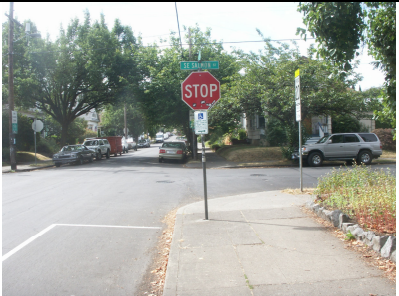
Parking	<p>No on-site parking is available for this school.</p> <p>A 38 ft double length ADA on-street parking space is marked and signed at SE 36th Ave at the corner of SE Salmon St. There is an adjacent compliant corner curbcut for access to the sidewalk.</p> <p>Add directional signage to indicate direction of fully accessible building entry.</p>

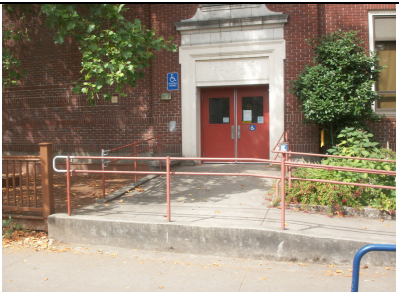
East Entry	<p>Existing accessible entry is closest to on-street parking. Provide directional signage to accessible south entry.</p>

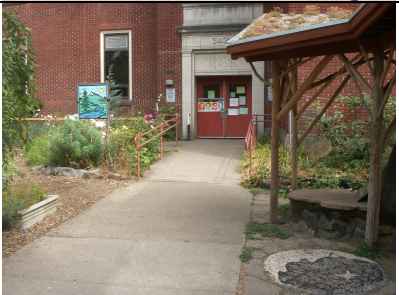
South Building Entry	<p>The south entry has a compliant ramp with double handrails leading up from the sidewalk to the raised doorway. This is the closest building entry to the office and is marked by a community seating gazebo at the sidewalk edge.</p> <p>Add directional signage near sidewalk.</p> <p>Provide accessible entry sign.</p>

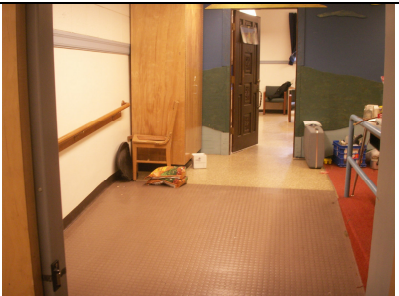
Auditorium 120	<p>Replace existing wood/metal handrails at the ramp in the auditorium at north doors with compliant metal double handrails (approximately 30 lf of rail.) Leave right side metal protection railing as-is.</p> <p>Raised Auditorium floor has created exit doors in “holes” with steps leading down to them.</p> <p>Add compliant guardrails and double handrails at steps to 3 exits doors (approximately 20 lf of rail.)</p>

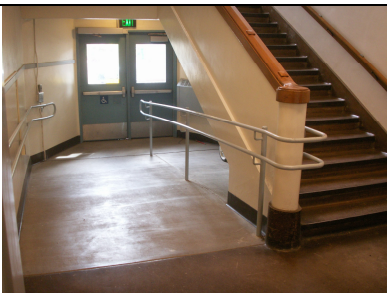
Interior Ramps	Compliant ramp with double handrails at east entry stairs. Compliant ramp with double handrails at south main office stairs.	
Stairs	Main south stairs by office already have compliant double handrails at lower ramp continuing up stair runs.

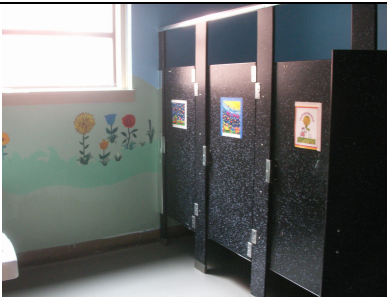
Second Floor Boys, West End, N/S Corridor	Modify toilet partitions to provide an accessible stall, and provide accessible toilet, grab bars, lavatory and accessories. Verify entry door for width and required clearances.	
Second Floor Girls, West End, E/W Corridor	Modify toilet partitions to provide an accessible stall, and provide accessible toilet, grab bars, lavatory and accessories. Verify entry door for width and required clearances.

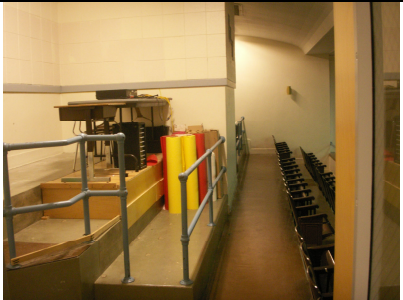
Auditorium Balcony Room 219	If possible given existing building structure limitation, providing (1) wheelchair accessible space with adjacent companion seating would improve accessibility.
