Portland Public Schools District Assessments

2024 PPS Seismic Assessments All Schools

Version 1.0
5/15/2024

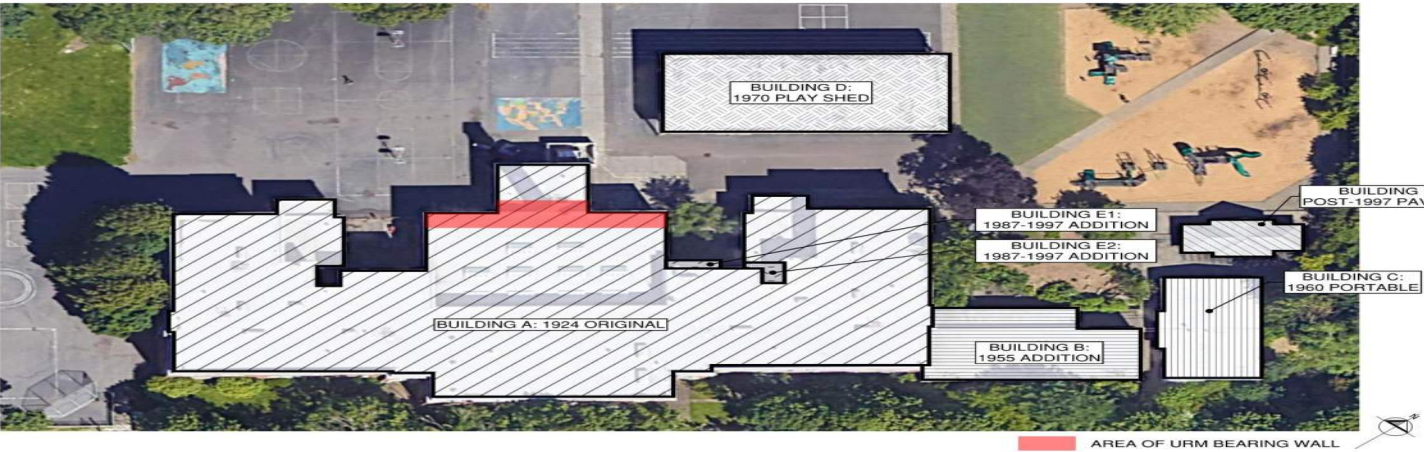
Building Year Plan:
(see below for deficiencies)

Building Part (See Diagram Above)	Year Built	URM (SF)	ROM URM Only Retrofit	ROM Total Retrofit	No. of Stories	Basement	Penthouse	Drawings Referenced	Structural Horizontal Gravity System(s)	Structural Vertical Gravity System(s)	Lateral System (ASCE Designation)	Lateral System (Description)	Likely Deficiencies	Deficiency Notes	Additional Notes
Bldg. A	1924	1800	\$450,000	\$11,525,000	2	Crawlspace	No	Approximately Complete Original Documents	Concrete 1-way Slab, Concrete Beams, Wood Trusses	Conc. CIP Walls, Concrete Columns	C2	Concrete Shear Walls (Stiff Diaphragms)	Inadequate Foundation Ties Split Levels Reentrant Corners Misc. Plan Irregularity Masonry Partition Walls Concrete Parapets exceed 2.5:1 URM Chimneys Inadequate In-Plane Shear Under-Reinforced Walls Under-Reinforced Flat Slabs No Diaphragm-Wall Connection Deflection Compatibility Diaphragm Reinforcement at Openings URM Bearing Wall Likely	End of wings soft HCT walls Rear wall of gym, End of wing walls	recommend monitoring possible settlement at SW corner recommend further investigation of cracking/damage observed in 1st floor central corridor & adjacent rooms recommend verifying construction of rear (NW) wall of gym

Building Part (See Diagram Above)	Year Built	URM (SF)	ROM URM Only Retrofit	ROM Total Retrofit	No. of Stories	Basement	Penthouse	Drawings Referenced	Structural Horizontal Gravity System(s)	Structural Vertical Gravity System(s)	Lateral System (ASCE Designation)	Lateral System (Description)	Likely Deficiencies	Deficiency Notes	Additional Notes
Bldg. B	1955	0	\$0	\$360,000	1	None	No	Approximately Complete Original Documents	Wood T+G Plank, Wood Beams	Conc. CIP Walls, Steel Columns	C2a	Concrete Shear Walls (Flexible Diaphragms)	Misc. Plan Irregularity Seismic Separation (< 1%) Concrete Parapets exceed 2.5:1 Inadequate In-Plane Shear Under-Reinforced Walls Under-Reinforced Flat Slabs No Diaphragm-Wall Connection Deflection Compatibility Discontinuous Cross Ties Straight Sheathing (2:1, 24')	porch roof lateral support Adjacent & untied to Bldg. A	recommend monitoring possible settlement at NE classroom

Bldg. C	1960	0	\$0	\$142,500	1	None	No	None	Wood Plywood/OSB, Steel Truss, Steel Beams	CFS Walls	CFS1	Sheathed Shear Wall System	Inadequate In-Plane Shear Plaster or Gypsum Shear Walls Large Unbraced Openings No Floor-to-Floor Connections (Shear and OT) Inadequate Sill-Foundation Connections (6 ft) Roof Chord Discontinuity		Unit appears to be built directly on SOG
Bldg. D	1970	0	\$0	\$250,000	1	None	No	None	Wood Plywood/OSB, Wood Trusses, Wood Beams	Timber Frame	Non-compliant	Cantilevered Wood Posts	Post Capacity Foundation Capacity

Building Part (See Diagram Above)	Year Built	URM (SF)	ROM URM Only Retrofit	ROM Total Retrofit	No. of Stories	Basement	Penthouse	Drawings Referenced	Structural Horizontal Gravity System(s)	Structural Vertical Gravity System(s)	Lateral System (ASCE Designation)	Lateral System (Description)	Likely Deficiencies	Deficiency Notes	Additional Notes
Bldg. E	1987	0	\$0	\$15,000	1	None	No	None	Wood Plywood/OSB, Wood Joists	Wood Framed Walls	W2	Wood Frames (Commercial and Industrial Buildings)	Seismic Separation (< 1%) Wood Ledgers loaded across grain		
Bldg. F	1997	0	\$0	\$75,000	1	None	No	None	Wood Plywood/OSB, Wood Trusses, Wood Beams	Timber Frame	Non-compliant	Cantilevered Wood Posts	Post Capacity Foundation Capacity

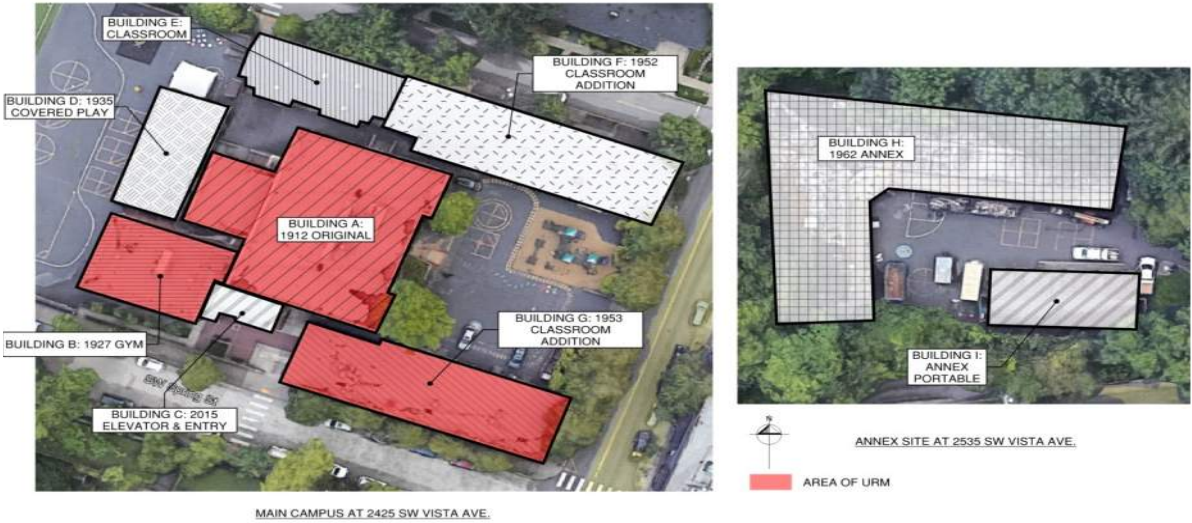
Building Year Plan:
(see below for deficiencies)

Building Part (See Diagram Above)	Year Built	URM (SF)	ROM URM Only Retrofit	ROM Total Retrofit	No. of Stories	Basement	Penthouse	Drawings Referenced	Structural Horizontal Gravity System(s)	Structural Vertical Gravity System(s)	Lateral System (ASCE Designation)	Lateral System (Description)	Likely Deficiencies	Deficiency Notes	Additional Notes
Bldg. A	1912	26000	\$6,500,000	\$6,500,000	2	Full	No	Insufficient Original Documents	Concrete Pan-Joists	Unreinforced Brick Walls	URMa	Unreinforced Masonry Bearing Walls (Stiff Diaphragms)	Inadequate Foundation Ties Inadequate Wall Anchorage Reentrant Corners Inadequate In-Plane Shear Beams, Girders, or Trusses bear on URM wall/pilaster No Diaphragm-Wall Connection Masonry Partition Walls	At bottom of URM Some locations improved in 2004 In N/S direction 2004 Retrofit of E/W direction only added concrete wall piers Retrofit at the roof 2015, not at second floor

Building Part (See Diagram Above)	Year Built	URM (SF)	ROM URM Only Retrofit	ROM Total Retrofit	No. of Stories	Basement	Penthouse	Drawings Referenced	Structural Horizontal Gravity System(s)	Structural Vertical Gravity System(s)	Lateral System (ASCE Designation)	Lateral System (Description)	Likely Deficiencies	Deficiency Notes	Additional Notes
Bldg. B	1927	3150	\$945,000	\$945,000	1	None	No	Insufficient Original Documents	Wood T+G Plank, Steel Beams	Unreinforced Brick Walls	Wood T+G Plank, Steel Beams	Unreinforced Brick Walls	Inadequate Foundation Ties Beams, Girders, or Trusses bear on URM wall/pilaster Inadequate In-Plane Shear	At bottom of URM Parapets and roof to wall connections retrofit 2004	
Bldg. C	2015	0	\$0	\$0	2	None	No	Approximately Complete Original Documents	Steel Beams	Reinforced CMU Walls, Steel Columns	Reinforced Masonry Bearing Walls (Stiff Diaphragms)	Reinforced Masonry Bearing Walls (Stiff Diaphragms)		Benchmark building

Bldg. D	1935 +/-	0	\$0	\$135,000	1	None	No	None	Wood Trusses	Timber Frame	Wood Trusses	Timber Frame		Poles likely to have deterioration at or below grade

2024 Assessment Summary: Ainsworth															
Building Part (See Diagram Above)	Year Built	URM (SF)	ROM URM Only Retrofit	ROM Total Retrofit	No. of Stories	Basement	Penthouse	Drawings Referenced	Structural Horizontal Gravity System(s)	Structural Vertical Gravity System(s)	Lateral System (ASCE Designation)	Lateral System (Description)	Likely Deficiencies	Deficiency Notes	Additional Notes
Bldg. E	Pre-1950	0	\$0	\$345,000	1	None	No	None	Wood Trusses	Wood Framed Walls	W2	Wood Frames (Commercial and Industrial Buildings)	Inadequate In-Plane Shear Plaster or Gypsum Shear Walls Diagonal Sheathing (4:1, 40')	Wall sheathing unknown	
Bldg. F	1952	0	\$0	\$810,000	1	None	No	Partial Set of Original Documents	Wood Beams	Timber Frame, Wood Framed Walls	W2	Wood Frames (Commercial and Industrial Buildings)	Inadequate In-Plane Shear Diagonal Sheathing (4:1, 40')	Interior is let-in bracing	
Bldg. G	1953	2800	\$420,000	\$420,000	1	None	No	Partial Set of Original Documents	Wood Beams	Timber Frame, Wood Framed Walls, Unreinforced Brick Walls	URM	Unreinforced Masonry Bearing Walls (Flexible Diaphragms)	Beams, Girders, or Trusses bear on URM wall/pilaster		Wall anchorage retrofit in 2015 Parapets braced in 2015

Building Part (See Diagram Above)	Year Built	URM (SF)	ROM URM Only Retrofit	ROM Total Retrofit	No. of Stories	Basement	Penthouse	Drawings Referenced	Structural Horizontal Gravity System(s)	Structural Vertical Gravity System(s)	Lateral System (ASCE Designation)	Lateral System (Description)	Likely Deficiencies	Deficiency Notes	Additional Notes
Bldg. H	1962	0	\$0	\$830,000	1	Crawlspace	No	None	Wood Truss-Joists, Wood Joists	Wood Framed Walls, Steel Columns	W2, S2a	Wood frame over steel braced frame	Sloping Site (full story difference across site) Misc. Moderate Vertical Irregularity Inadequate In-Plane Shear Inadequate Brace Capacity Non-compact Braces Slender Braces Inadequate brace connections	Shear wall system atop braced frame Wall sheathing unknown	
Bldg. I	1962	0	\$0	\$135,000	1	Crawlspace	No	None	Wood Trusses	Wood Framed Walls	W2	Wood Frames (Commercial and Industrial Buildings)	Inadequate In-Plane Shear	Unknown sheathing

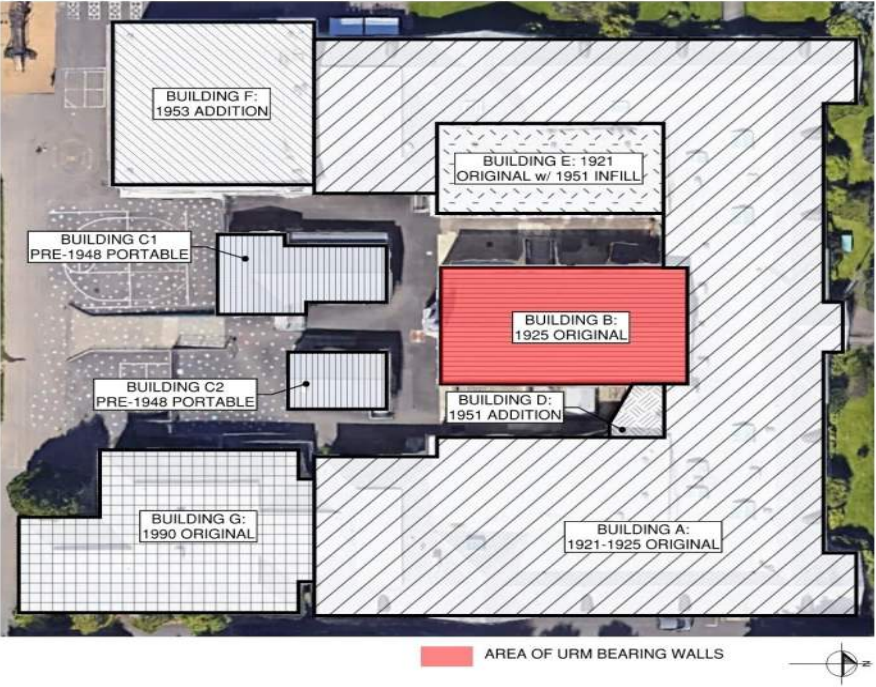
Building Year Plan:
(see below for deficiencies)

Building Part (See Diagram Above)	Year Built	URM (SF)	ROM URM Only Retrofit	ROM Total Retrofit	No. of Stories	Basement	Penthouse	Drawings Referenced	Structural Horizontal Gravity System(s)	Structural Vertical Gravity System(s)	Lateral System (ASCE Designation)	Lateral System (Description)	Likely Deficiencies	Deficiency Notes	Additional Notes
Bldg. A	1921	0	\$0	\$4,175,000	1	Crawlspace	No	Approximately Complete Original Documents	Wood Battens, Wood Joists, Wood Beams, Wood Straight/Diag Sheathing	Wood Framed Walls, Timber Frame	W2	Wood Frames (Commercial and Industrial Buildings)	Inadequate Foundation Ties Severe Vertical Element Size Discontinuity (<50%) Reentrant Corners Inadequate In-Plane Shear Plaster or Gypsum Shear Walls Unbraced Cripple Walls Large Unbraced Openings No Floor-to-Floor Connections (Shear and OT) No Wood Post-Foundation Connections Inadequate Wood Sill-Foundation Connections (6 ft) No Girder-Column Connections Roof Chord Discontinuity Straight Sheathing (2:1, 24')	interior walls not cont. to foundation	Constructed in 1921 & 1925

Building Part (See Diagram Above)	Year Built	URM (SF)	ROM URM Only Retrofit	ROM Total Retrofit	No. of Stories	Basement	Penthouse	Drawings Referenced	Structural Horizontal Gravity System(s)	Structural Vertical Gravity System(s)	Lateral System (ASCE Designation)	Lateral System (Description)	Likely Deficiencies	Deficiency Notes	Additional Notes
Bldg. B	1925	7000	\$1,400,000	\$1,400,000	1	Partial	No	Approximately Complete Original Documents	Wood T+G Plank, Wood Joists, Wood Trusses, Wood Straight/Diag Sheathing, Concrete 1-way Slab, Concrete Beams	Concrete Columns, Unreinforced Brick Walls, Timber Frame	URM	Unreinforced Masonry Bearing Walls (Flexible Diaphragms)	Inadequate Foundation Ties Inadequate Wall Anchorage Seismic Separation (< 1%) URM Parapets exceed 1.5:1 URM Chimneys Beams, Girders, or Trusses bear on URM wall/pilaster Walls Spaced Far Apart Inadequate In-Plane Shear Thin Walls (9 top, 15 first, 13 other/single) Unbraced Gable Walls No Diaphragm-Wall Connection No Girder-Column Connections Discontinuous Cross Ties Straight Sheathing (2:1, 24')	Adjacent to part A

Bldg. C1	1930	0	\$0	\$135,000	1	Crawlspace	No	None	Wood Straight/Diag Sheathing, Wood Trusses, Wood Joists, Wood Beams	Wood Framed Walls	W2	Wood Frames (Commercial and Industrial Buildings)	Sloping Site (full story difference across site) Inadequate Foundation Ties Reentrant Corners Inadequate In-Plane Shear Plaster or Gypsum Shear Walls Narrow Wood Shear Walls No Floor-to-Floor Connections (Shear and OT) Inadequate Wood Sill-Foundation Connections (6 ft) Roof Chord Discontinuity Straight Sheathing (2:1, 24')		
Bldg. C2	1930	0	\$0	\$67,500	1	Crawlspace	No	None	Wood Straight/Diag Sheathing, Wood Trusses, Wood Joists, Wood Beams	Wood Framed Walls	W2	Wood Frames (Commercial and Industrial Buildings)	Inadequate Foundation Ties Inadequate In-Plane Shear Plaster or Gypsum Shear Walls Narrow Wood Shear Walls No Floor-to-Floor Connections (Shear and OT) Inadequate Wood Sill-Foundation Connections (6 ft) Roof Chord Discontinuity Straight Sheathing (2:1, 24')

2024 Assessment Summary: Alameda															
Building Part (See Diagram Above)	Year Built	URM (SF)	ROM URM Only Retrofit	ROM Total Retrofit	No. of Stories	Basement	Penthouse	Drawings Referenced	Structural Horizontal Gravity System(s)	Structural Vertical Gravity System(s)	Lateral System (ASCE Designation)	Lateral System (Description)	Likely Deficiencies	Deficiency Notes	Additional Notes
Bldg. D	1951	0	\$0	\$50,000	1	Crawlspace	No	Approximately Complete Original Documents	Wood Straight/Diag Sheathing, Wood Joists, Wood Beams	Wood Framed Walls	W2	Wood Frames (Commercial and Industrial Buildings)	Inadequate Foundation Ties Seismic Separation (< 1%) Inadequate In-Plane Shear Large Unbraced Openings No Floor-to-Floor Connections (Shear and OT) Inadequate Wood Sill-Foundation Connections (6 ft) Roof Chord Discontinuity Straight Sheathing (2:1, 24')	Inadequate ties to parts A, B	
Bldg. E	1921	0	\$0	\$437,500	1	Crawlspace	No	Approximately Complete Original Documents	Wood Battens, Wood Joists, Wood Beams, Wood Straight/Diag Sheathing	Wood Framed Walls, Timber Frame	W2	Wood Frames (Commercial and Industrial Buildings)	Inadequate Foundation Ties Severe Vertical Element Size Discontinuity (<50%) Inadequate In-Plane Shear Plaster or Gypsum Shear Walls Unbraced Cripple Walls Large Unbraced Openings No Floor-to-Floor Connections (Shear and OT) No Wood Post-Foundation Connections Inadequate Wood Sill-Foundation Connections (6 ft) No Girder-Column Connections Roof Chord Discontinuity Straight Sheathing (2:1, 24')		1955 playroom/cafeteria portion of original building infilled with classrooms

Bldg. F	1953	0	\$0	\$2,340,000	3	None	No	Approximately Complete Original Documents	Concrete 1-way Slab, Concrete Pan-Joists, Concrete Beams	Concrete Columns, Conc. CIP Walls	C2	Concrete Shear Walls (Stiff Diaphragms)	Sloping Site (full story difference across site) Inadequate Foundation Ties Severe Vertical Element Size Discontinuity (<50%) Torsional Irregularity Seismic Separation (< 1%) Deep Spandrels/Narrow Piers (50%, interfering walls) Inadequate In-Plane Shear Under-Reinforced Walls Under-Reinforced Flat Slabs No Diaphragm-Wall Connection Inadequate Wall-Foundation Connection Deflection Compatibility Diaphragm Reinforcement at Openings	open ground floor adjacent to part A thin slabs	1987 - first floor infill appears to not have been constructed

2024 Assessment Summary: Alameda															
Building Part (See Diagram Above)	Year Built	URM (SF)	ROM URM Only Retrofit	ROM Total Retrofit	No. of Stories	Basement	Penthouse	Drawings Referenced	Structural Horizontal Gravity System(s)	Structural Vertical Gravity System(s)	Lateral System (ASCE Designation)	Lateral System (Description)	Likely Deficiencies	Deficiency Notes	Additional Notes
Bldg. G	1990	0	\$0	\$832,500	2	None	No	Approximately Complete Original Documents	Wood Plywood/OSB, Wood Joists, Wood Truss-Joists, Wood Beams	Wood Framed Walls	W2	Wood Frames (Commercial and Industrial Buildings)	Sloping Site (full story difference across site) Reentrant Corners Seismic Separation (< 1%) Inadequate In-Plane Shear Unblocked Diaphragms (4:1, 40')	adjacent to part A

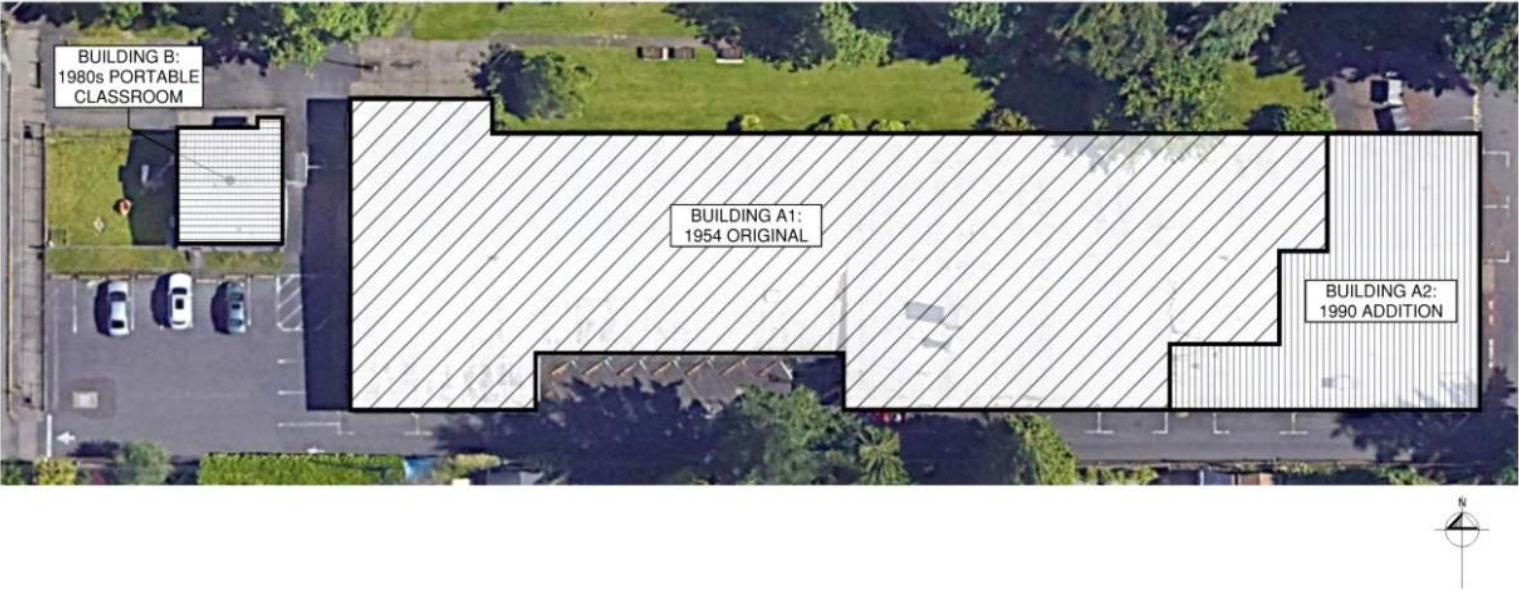
Building Year Plan:
(see below for deficiencies)

Building Part (See Diagram Above)	Year Built	URM (SF)	ROM URM Only Retrofit	ROM Total Retrofit	No. of Stories	Basement	Penthouse	Drawings Referenced	Structural Horizontal Gravity System(s)	Structural Vertical Gravity System(s)	Lateral System (ASCE Designation)	Lateral System (Description)	Likely Deficiencies	Deficiency Notes	Additional Notes
Bldg. A1	1954	0	\$0	\$1,871,000	1	None	No	Approximately Complete Original Documents	Wood Straight/Diag Sheathing, Wood Beams	Wood Framed Walls	W2	Wood Frames (Commercial and Industrial Buildings)	URM Chimneys Inadequate In-Plane Shear Roof Chord Discontinuity Straight Sheathing (2:1, 24')	1" sheathing	Original structure.

2024 Assessment Summary: Applegate															
Building Part (See Diagram Above)	Year Built	URM (SF)	ROM URM Only Retrofit	ROM Total Retrofit	No. of Stories	Basement	Penthouse	Drawings Referenced	Structural Horizontal Gravity System(s)	Structural Vertical Gravity System(s)	Lateral System (ASCE Designation)	Lateral System (Description)	Likely Deficiencies	Deficiency Notes	Additional Notes
Bldg. A2	1990	0	\$0	\$402,000	1	None	No	Approximately Complete Original Documents	Wood Plywood/OSB, Wood Truss-Joists, Wood Joists	Wood Framed Walls	W2	Wood Frames (Commercial and Industrial Buildings)	Inadequate In-Plane Shear Roof Chord Discontinuity		Addition on east end of building
Bldg. B	1980s	0	\$0	\$73,500	1	Crawlspace	No	None	Unknown	Unknown	0				Portable building added in the 1980s. No drawings available.

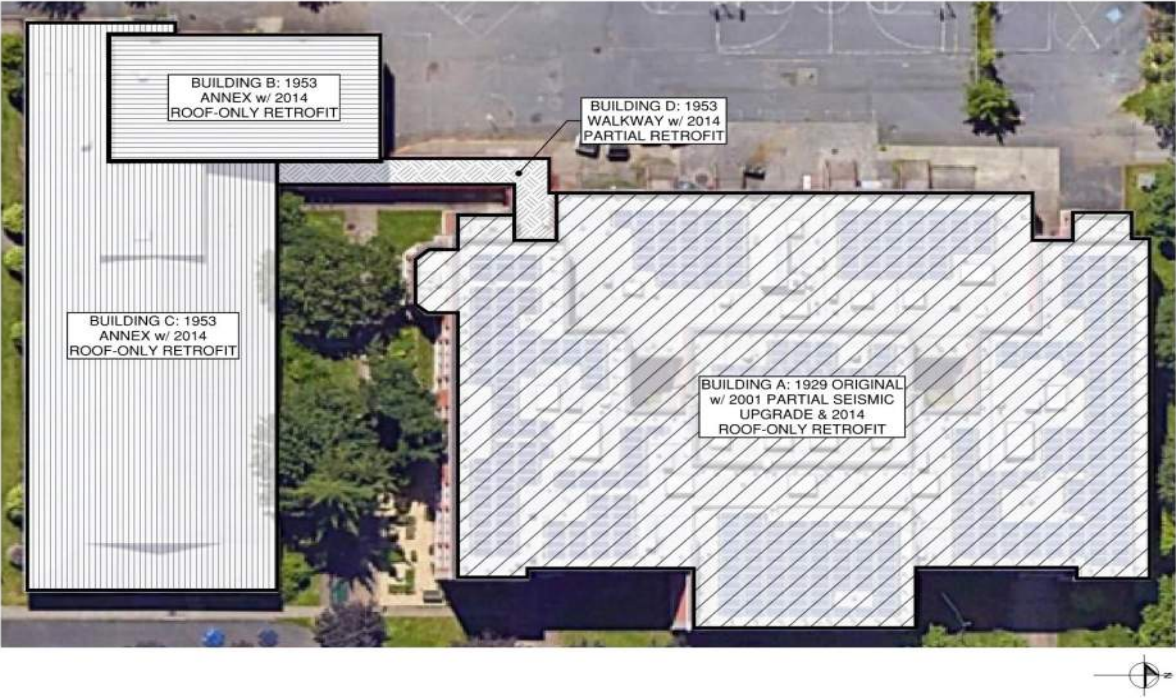
Building Year Plan:
(see below for deficiencies)

Building Part (See Diagram Above)	Year Built	URM (SF)	ROM URM Only Retrofit	ROM Total Retrofit	No. of Stories	Basement	Penthouse	Drawings Referenced	Structural Horizontal Gravity System(s)	Structural Vertical Gravity System(s)	Lateral System (ASCE Designation)	Lateral System (Description)	Likely Deficiencies	Deficiency Notes	Additional Notes
Bldg. A	1929	0	\$0	\$11,025,000	2	Crawlspace	No	Approximately Complete Original Documents	Concrete 1-way Slab, Concrete Beams, Steel Truss	Conc. CIP Walls, Concrete Columns, Unreinforced Brick Walls	C2	Concrete Shear Walls (Stiff Diaphragms)	Inadequate Foundation Ties Reentrant Corners Masonry Partition Walls URM Chimneys Heavy Cladding System Inadequate In-Plane Shear Under-Reinforced Walls Under-Reinforced Flat Slabs No Diaphragm-Wall Connection Inadequate Wall-Foundation Connection Deflection Compatibility URM bearing walls	partly braced in 2001 and 2014 thin slabs only roof upgraded in 2014 at West oriels/frmr conservatories	2001 - partial seismic bracing upgrade 2014 - roof-only seismic upgrade

2024 Assessment Summary: Arleta															
Building Part (See Diagram Above)	Year Built	URM (SF)	ROM URM Only Retrofit	ROM Total Retrofit	No. of Stories	Basement	Penthouse	Drawings Referenced	Structural Horizontal Gravity System(s)	Structural Vertical Gravity System(s)	Lateral System (ASCE Designation)	Lateral System (Description)	Likely Deficiencies	Deficiency Notes	Additional Notes
Bldg. B	1953	0	\$0	\$315,000	1	None	No	Insufficient Original Documents	Wood T+G Plank, Steel Joists	Conc. CIP Walls	C2a	Concrete Shear Walls (Flexible Diaphragms)	Heavy Cladding System Under-Reinforced Walls Inadequate Wall-Foundation Connection	incl. glass block	2014 - roof-only seismic upgrade
Bldg. C	1953	0	\$0	\$945,000	1	None	Yes	Insufficient Original Documents	Wood Straight/Diag Sheathing, Wood Trusses	Wood Framed Walls	W2	Wood Frames (Commercial and Industrial Buildings)	Split Levels Reentrant Corners Non-redundant (< 2 bays in < 2 lines) Heavy Cladding System Inadequate In-Plane Shear Plaster or Gypsum Shear Walls Large Unbraced Openings No Floor-to-Floor Connections (Shear and OT) Inadequate Wood Sill-Foundation Connections (6 ft)	only roof upgraded in 2014	2014 - roof-only seismic upgrade

Bldg. D	1953	0	\$0	\$70,000	1	None	Yes	Insufficient Original Documents	Wood Straight/Diag Sheathing, Wood Joists	Steel Columns	Non-compliant	Cantilevered Steel Posts	Seismic Separation (< 1%) Inadequate base connection Inadequate foundation	Inadequate tie-back	2014 - partial seismic upgrade

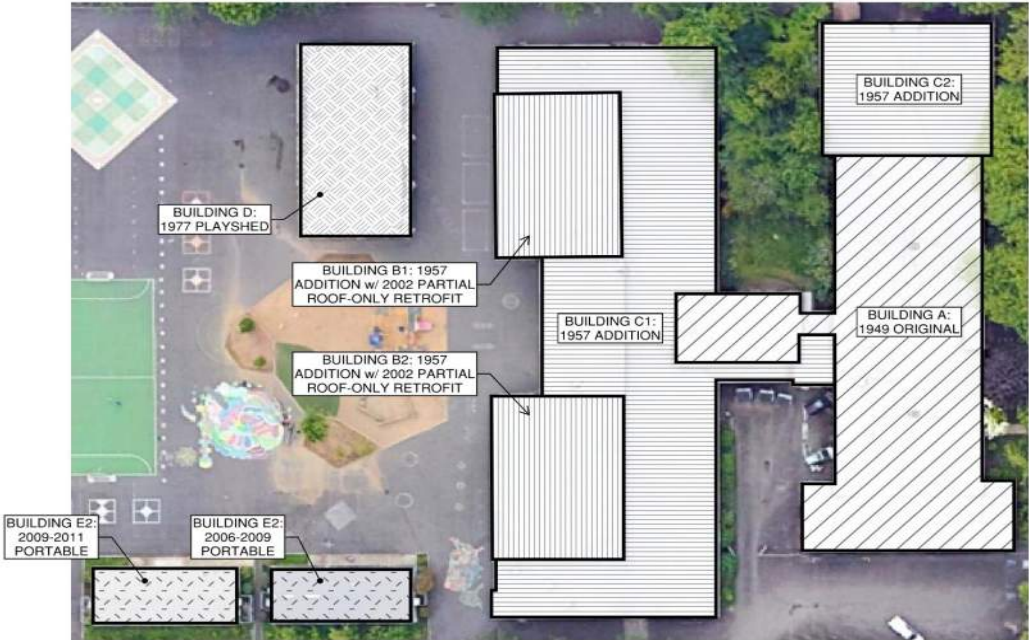
Building Year Plan:
(see below for deficiencies)

Building Part (See Diagram Above)	Year Built	URM (SF)	ROM URM Only Retrofit	ROM Total Retrofit	No. of Stories	Basement	Penthouse	Drawings Referenced	Structural Horizontal Gravity System(s)	Structural Vertical Gravity System(s)	Lateral System (ASCE Designation)	Lateral System (Description)	Likely Deficiencies	Deficiency Notes	Additional Notes
Bldg. A	1949	0	\$0	\$1,570,000	1	None	No	Insufficient Original Documents	Wood Straight/Diag Sheathing, Wood Joists	Wood Framed Walls	W2	Wood Frames (Commercial and Industrial Buildings)	Near-fault location (250ft, DOGAMI Active Faults) Split Levels Reentrant Corners Non-redundant (< 2 bays in < 2 lines) URM Appendages over Exitway Inadequate In-Plane Shear Plaster or Gypsum Shear Walls Narrow Wood Shear Walls Large Unbraced Openings No Floor-to-Floor Connections (Shear and OT) Inadequate Wood Sill-Foundation Connections (6 ft) Roof Chord Discontinuity Diagonal Sheathing (4:1, 40')	brick at entry

2024 Assessment Summary: Astor															
Building Part (See Diagram Above)	Year Built	URM (SF)	ROM URM Only Retrofit	ROM Total Retrofit	No. of Stories	Basement	Penthouse	Drawings Referenced	Structural Horizontal Gravity System(s)	Structural Vertical Gravity System(s)	Lateral System (ASCE Designation)	Lateral System (Description)	Likely Deficiencies	Deficiency Notes	Additional Notes
Bldg. B1	1957	0	\$0	\$537,500	1	None	No	Approximately Complete Original Documents	Wood Straight/Diag Sheathing, Wood Joists, Wood Beams	Conc. CIP Walls	C2a	Concrete Shear Walls (Flexible Diaphragms)	Near-fault location (250ft, DOGAMI Active Faults) Inadequate Foundation Ties Inadequate Wall Anchorage Under-Reinforced Walls Inadequate Wall-Foundation Connection Discontinuous Cross Ties Straight Sheathing (2:1, 24')	Keyway Only	2002 partial roof-only seismic upgrade (not re-sheathed)
Bldg. B2	1957	0	\$0	\$562,500	1	None	No	Approximately Complete Original Documents	Wood Straight/Diag SheathingWood JoistsWood Beams	Conc. CIP Walls	C2a	Concrete Shear Walls (Flexible Diaphragms)	Near-fault location (250ft, DOGAMI Active Faults) Inadequate Foundation Ties Inadequate Wall Anchorage Under-Reinforced Walls Inadequate Wall-Foundation Connection Discontinuous Cross Ties Straight Sheathing (2:1, 24')	Keyway Only	2002 partial roof-only seismic upgrade (not re-sheathed)

Bldg. C1	1957	0	\$0	\$1,690,000	1	None	Yes	Approximately Complete Original Documents	Wood Straight/Diag Sheathing, Wood Joists	Wood Framed Walls	W2	Wood Frames (Commercial and Industrial Buildings)	Near-fault location (250ft, DOGAMI Active Faults) Split Levels Reentrant Corners Masonry Partition Walls Inadequate In-Plane Shear Plaster or Gypsum Shear Walls Large Unbraced Openings No Floor-to-Floor Connections (Shear and OT) Roof Chord Discontinuity Straight Sheathing (2:1, 24')

2024 Assessment Summary: Astor															
Building Part (See Diagram Above)	Year Built	URM (SF)	ROM URM Only Retrofit	ROM Total Retrofit	No. of Stories	Basement	Penthouse	Drawings Referenced	Structural Horizontal Gravity System(s)	Structural Vertical Gravity System(s)	Lateral System (ASCE Designation)	Lateral System (Description)	Likely Deficiencies	Deficiency Notes	Additional Notes
Bldg. C2	1957	0	\$0	\$450,000	1	None	No	Approximately Complete Original Documents	Wood Straight/Diag SheathingWood JoistsWood Beams	Conc. CIP Walls	C2a	Wood Frames (Commercial and Industrial Buildings)	Near-fault location (250ft, DOGAMI Active Faults) Split Levels Reentrant Corners Masonry Partition Walls Inadequate In-Plane Shear Plaster or Gypsum Shear Walls Large Unbraced Openings No Floor-to-Floor Connections (Shear and OT) Roof Chord Discontinuity Straight Sheathing (2:1, 24')		
Bldg. D	1977	0	\$0	\$250,000	1	None	No	None	Wood Straight/Diag Sheathing, Wood Truss-Joists	Timber Frame	Non-compliant	Cantilevered Wood Posts	Near-fault location (250ft, DOGAMI Active Faults) Post Capacity Foundation Capacity

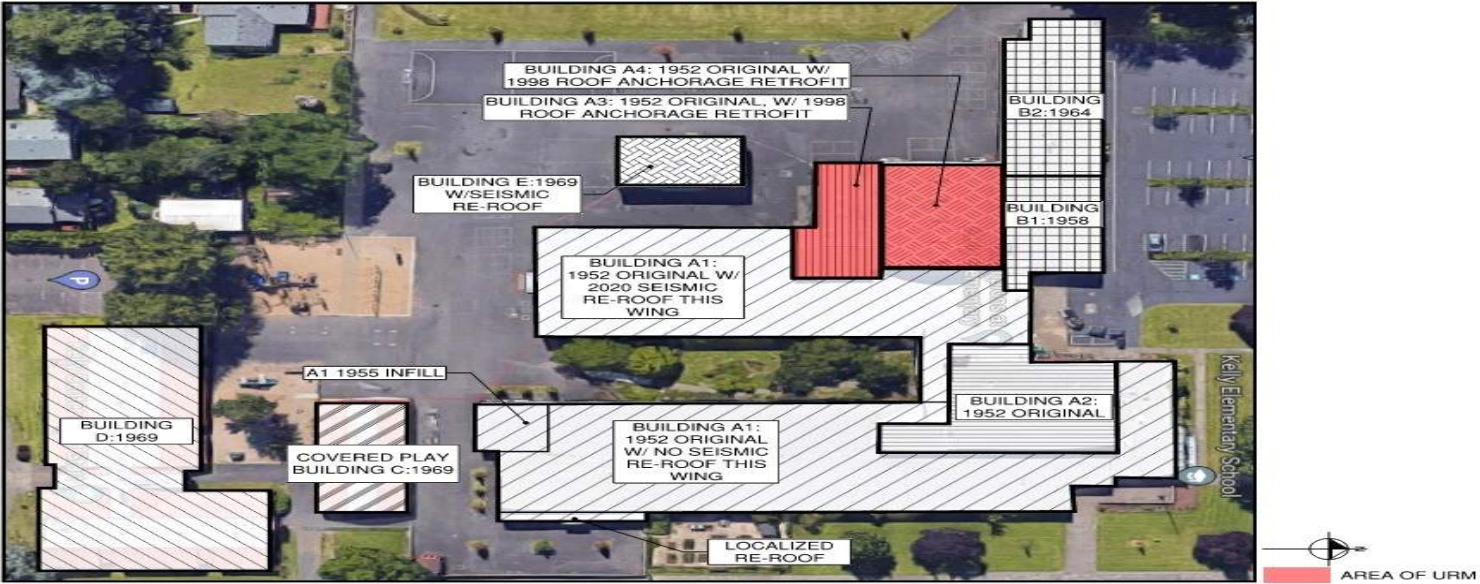
Building Year Plan:
(see below for deficiencies)

Building Part (See Diagram Above)	Year Built	URM (SF)	ROM URM Only Retrofit	ROM Total Retrofit	No. of Stories	Basement	Penthouse	Drawings Referenced	Structural Horizontal Gravity System(s)	Structural Vertical Gravity System(s)	Lateral System (ASCE Designation)	Lateral System (Description)	Likely Deficiencies	Deficiency Notes	Additional Notes
Bldg. A1	1952	0	\$0	\$2,812,500	1	None	No	Approximately Complete Original Documents	Wood Straight/Diag Shtg, Wood Joists, Wood Beams	Wood Framed Walls	W2	Wood Frames (Commercial and Industrial Buildings)	Misc. Load Path Issue Inadequate Foundation Ties Split Levels Reentrant Corners Seismic Separation (< 1%) Heavy Cladding System Inadequate In-Plane Shear Plaster or Gypsum Shear Walls No Floor-to-Floor Connections (Shear and OT)	Steps in roof None Roman brick veneer, attachment unknown Walls have dapped in wood bracing only

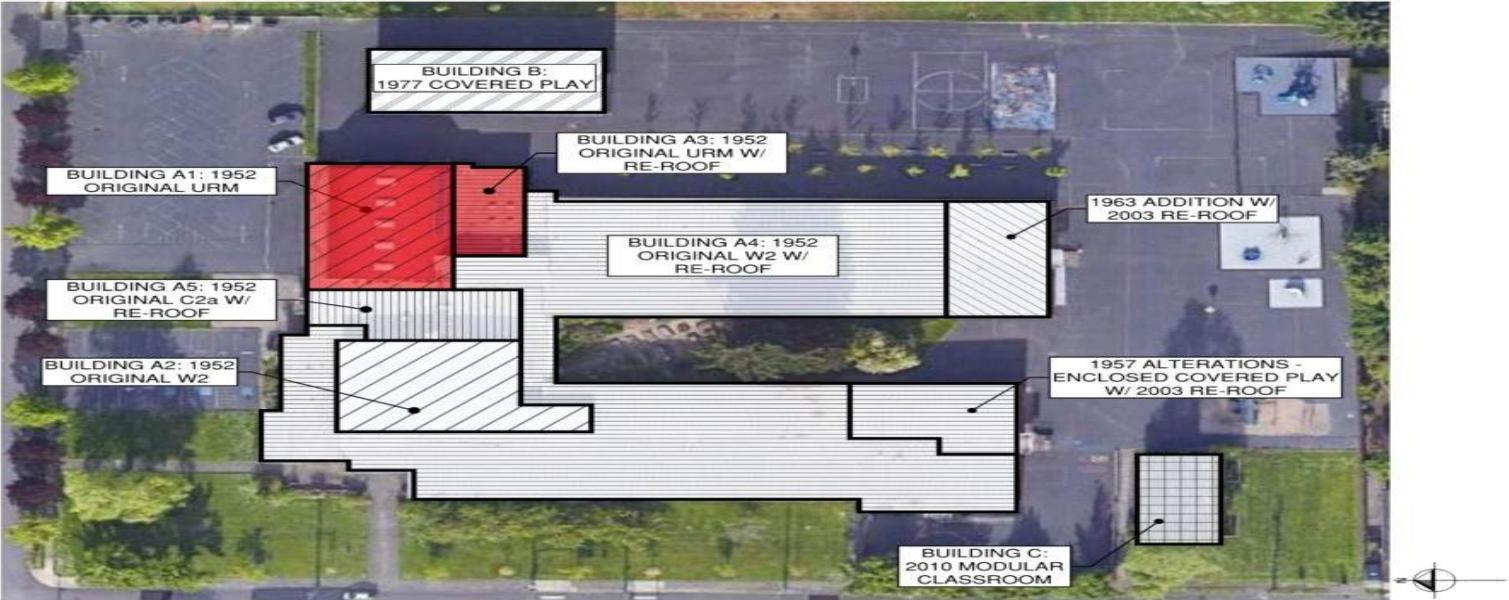
Building Year Plan:
(see below for deficiencies)

Building Part (See Diagram Above)	Year Built	URM (SF)	ROM URM Only Retrofit	ROM Total Retrofit	No. of Stories	Basement	Penthouse	Drawings Referenced	Structural Horizontal Gravity System(s)	Structural Vertical Gravity System(s)	Lateral System (ASCE Designation)	Lateral System (Description)	Likely Deficiencies	Deficiency Notes	Additional Notes
Bldg. A1	1952	5700	\$1,430,000	\$1,430,000	1	None	No	Approximately Complete Original Documents	Wood Straight/Diag Sheathing, Wood Joists, Wood Beams	Unreinforced Brick Walls	URM	Unreinforced Masonry Bearing Walls (Flexible Diaphragms)	Inadequate Foundation Ties Inadequate Wall Anchorage Vertical LRFS elements are offset Heavy Cladding System Beams, Girders, or Trusses bear on URM wall/pilaster Walls Spaced Far Apart Inadequate In-Plane Shear Thin Walls (9 top, 15 first, 13 other/single) Cavity Wall Construction No Diaphragm-Wall Connection Straight Sheathing (2:1, 24')	Doesn't appear to be a positive connection between foundation base and stem 2003 upgrade did not include OOP connection @ gym walls Wood walls on roof arch are offset from brick walls Rafters for hallway to west bear on URM Perimeter walls only b=8", h=10.583', h/b=15.9>13 Exterior walls appear to have cavity w/ ties only at the top Non-quantifiable load paths - no nailing info	Gym. Walls are unreinforced brick masonry (double leaf w/ cavity). Roof is comprised of large glulam arch. NOT part of 2003 re-roof/seismic strengthening project.
