Pre-Design Diligence Report
Benson Polytechnic High School
June 12, 2017

TABLE OF CONTENTS

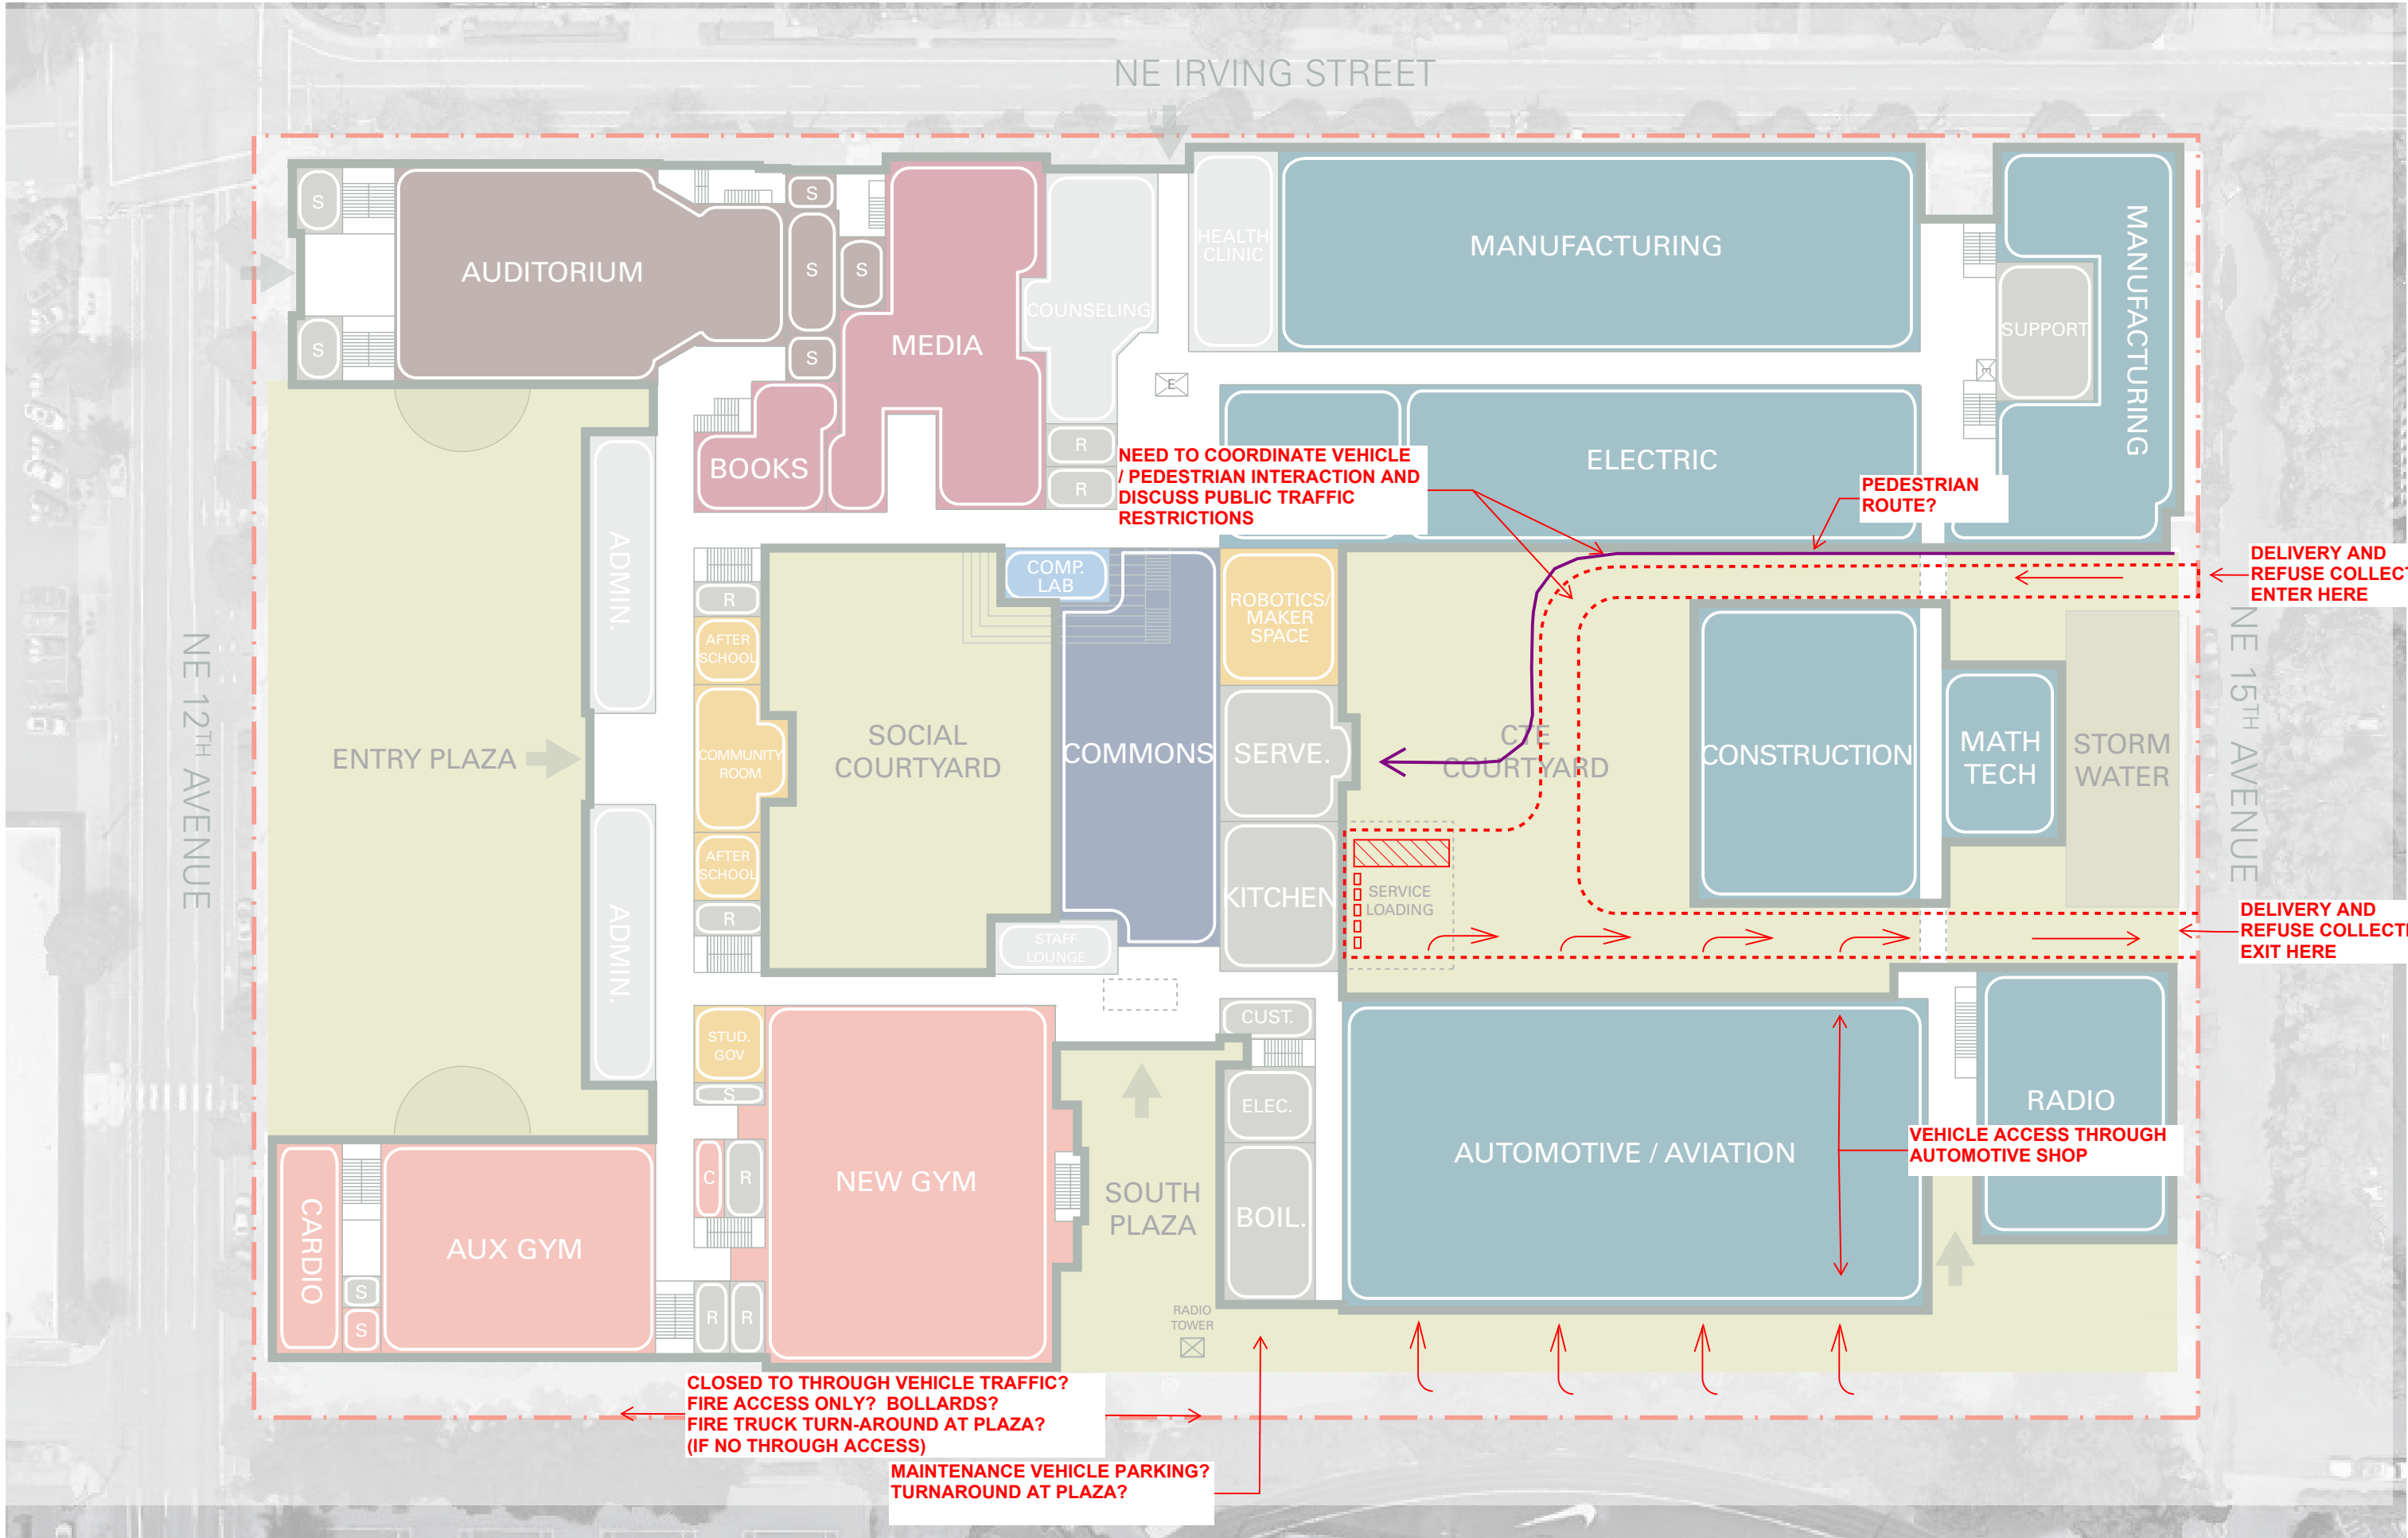
but the status of the LUST record is “Closed”. It is recommended that PPS retain an environmental consultant to perform a Phase I Environmental Site Assessment (ESA).

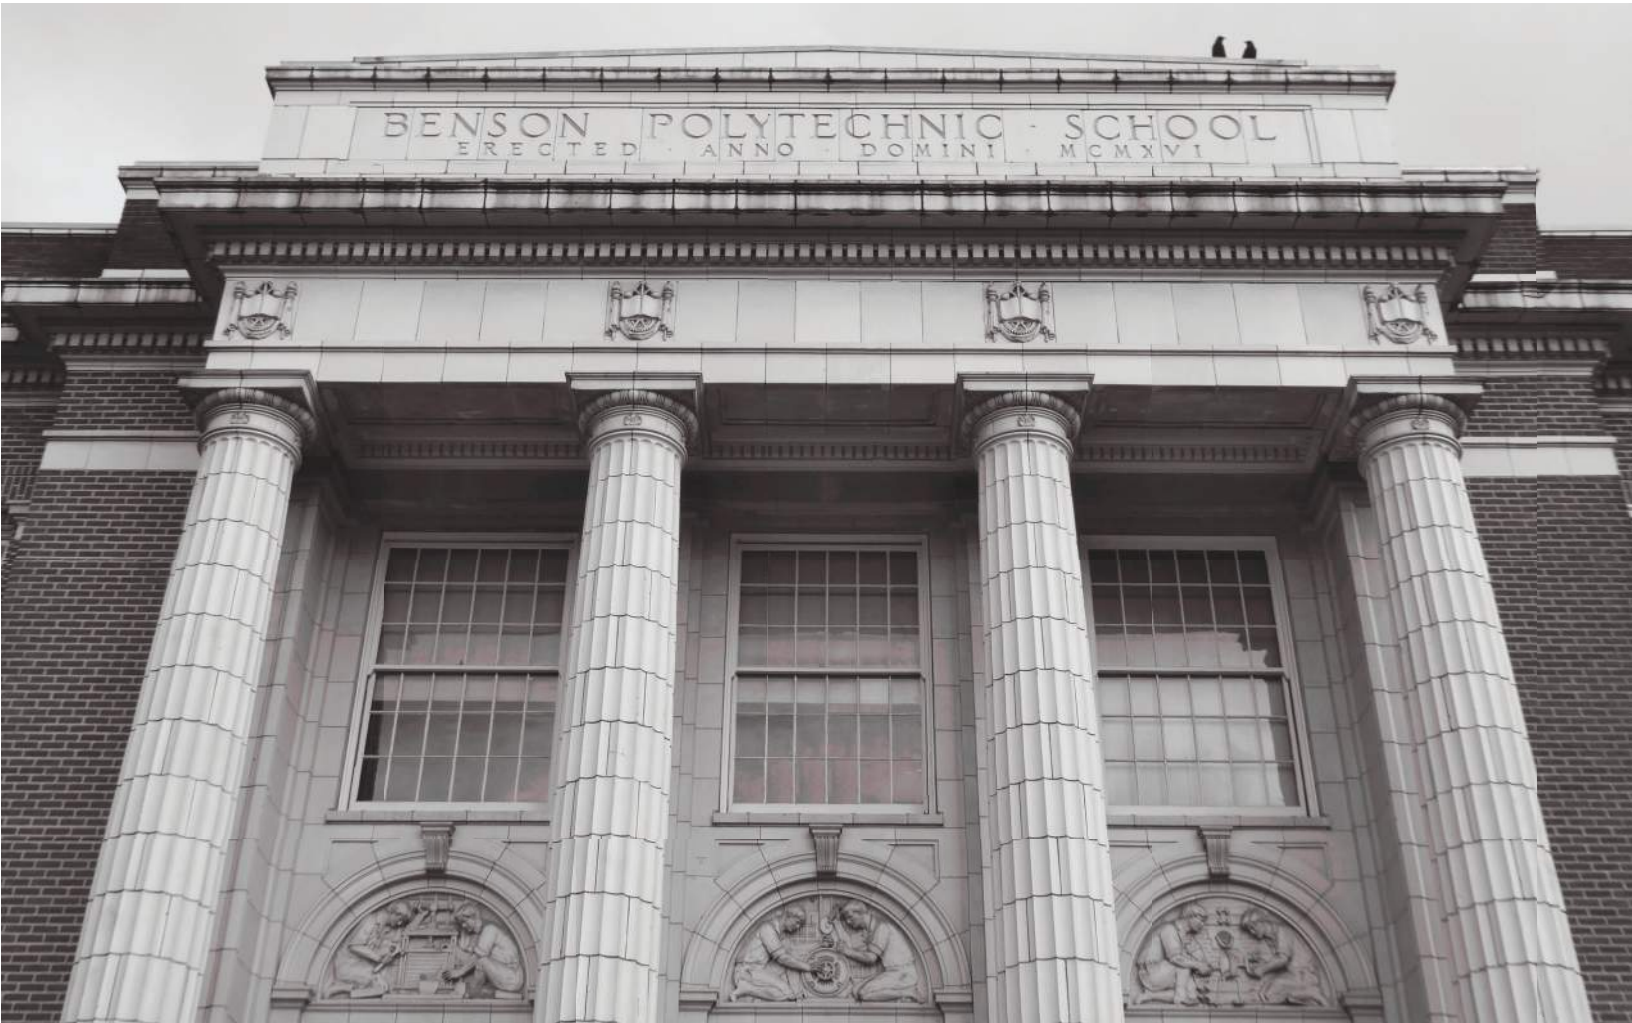
Historic Resource Assessment

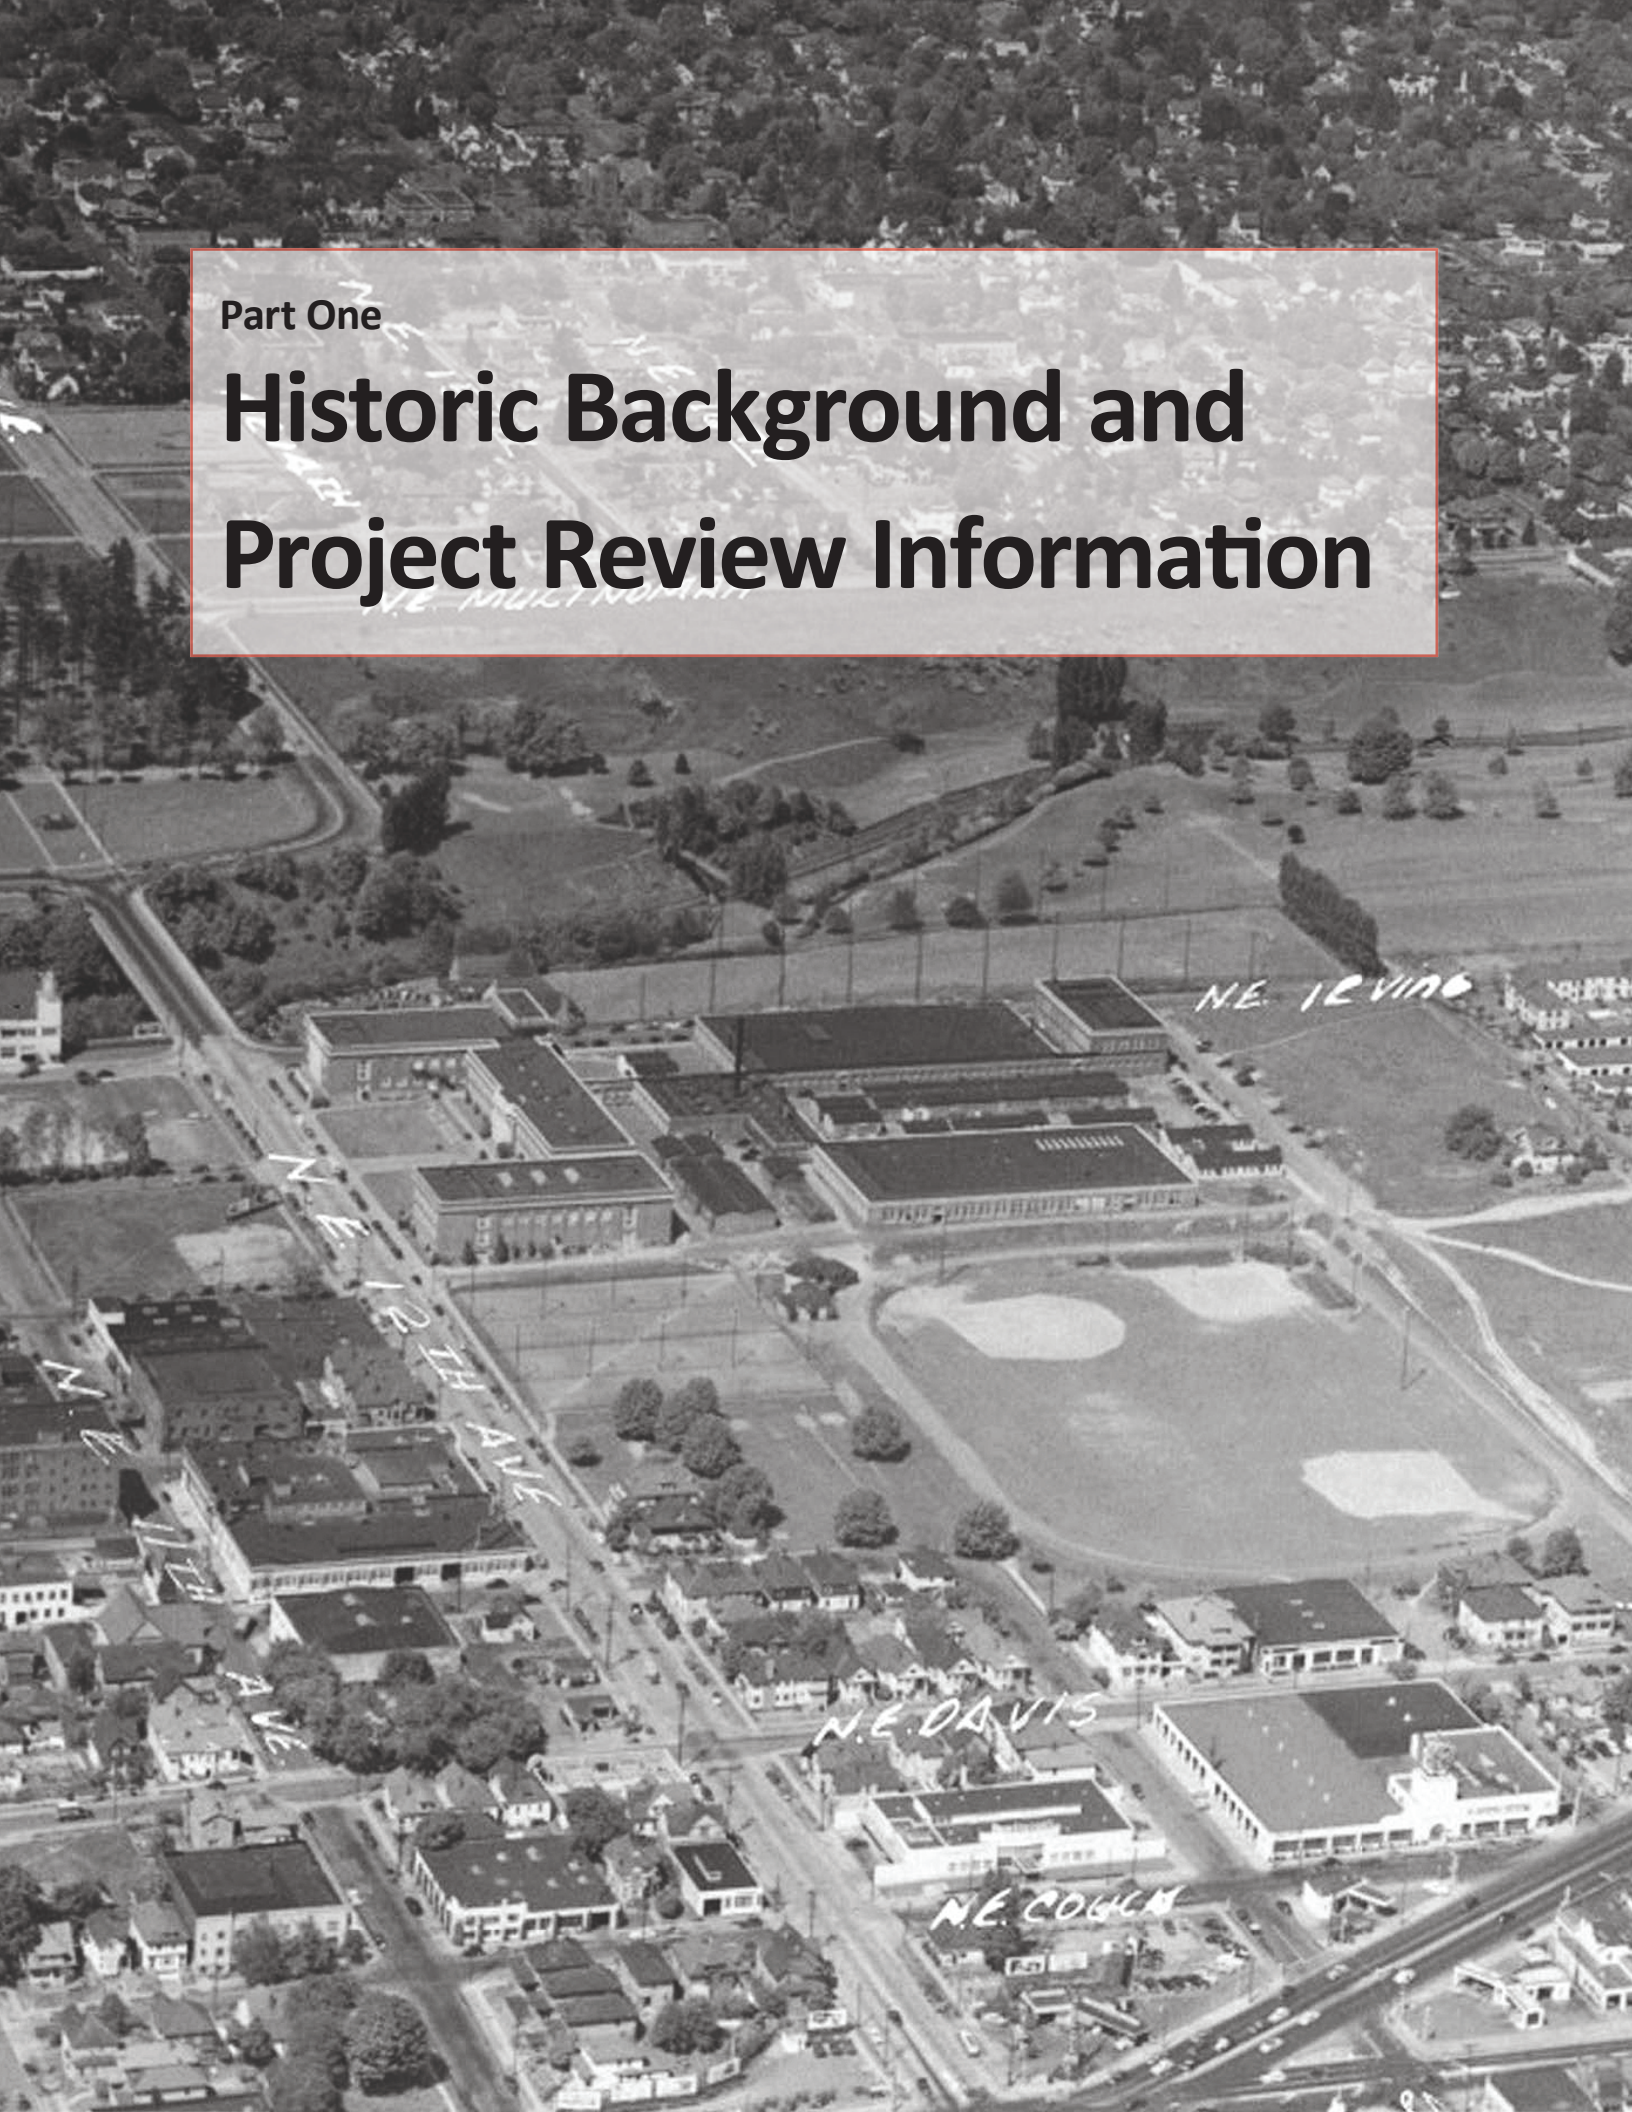
Historic Background and Project Review Information

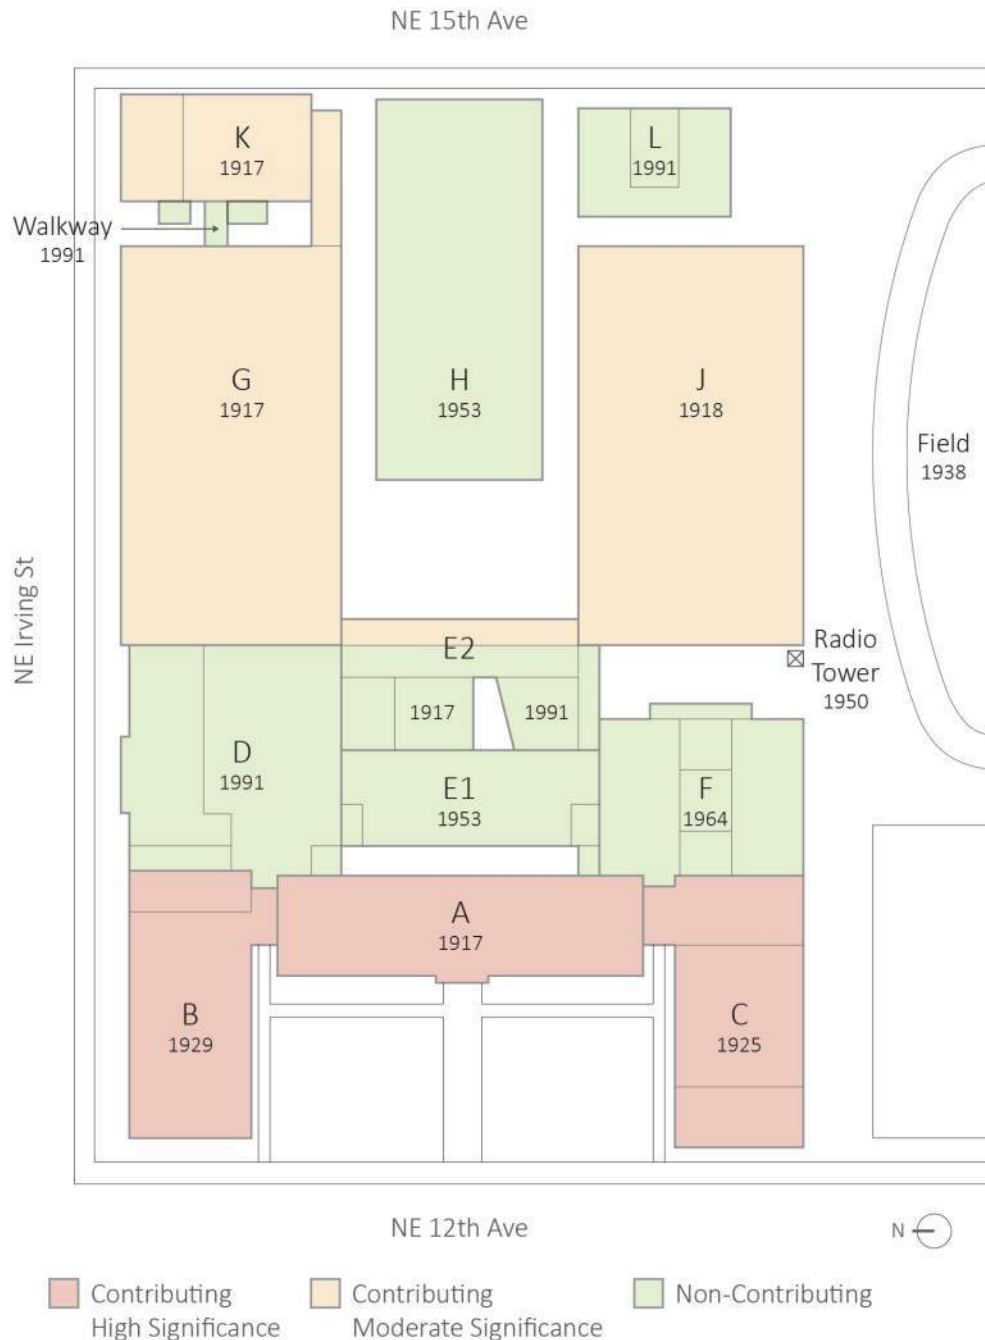
1.3 Summary of Major Alterations

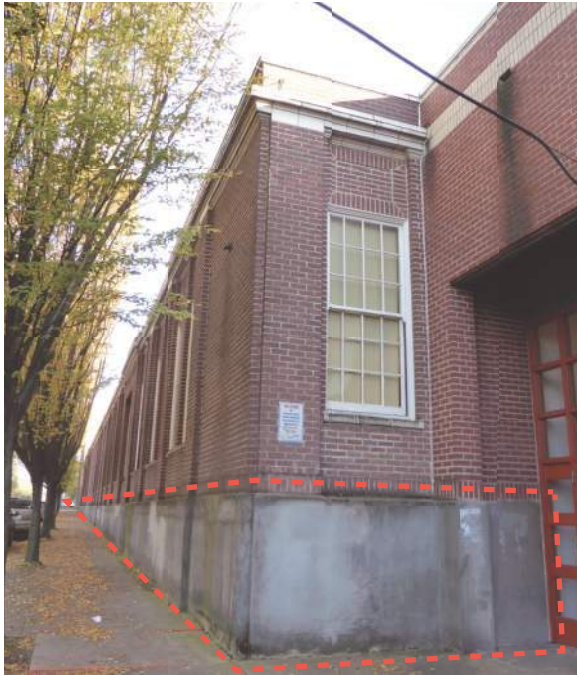
Photo 2.2.2/3 Above-grade foundation wall.

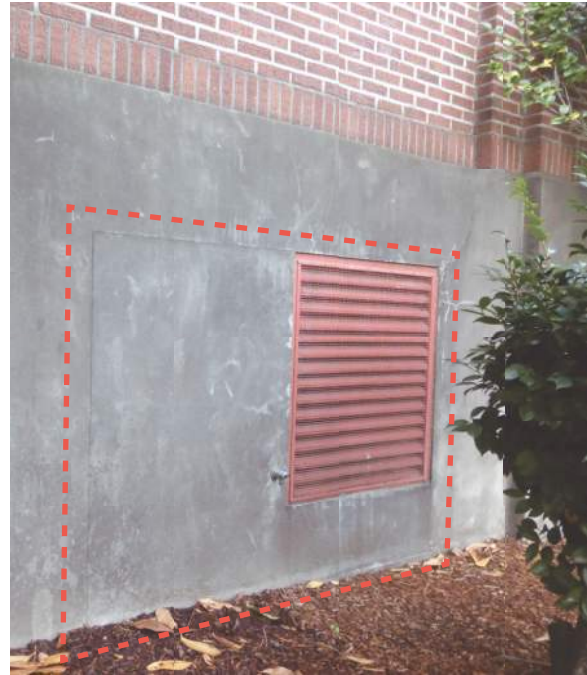
Photo 2.2.2/4 Window infill area.

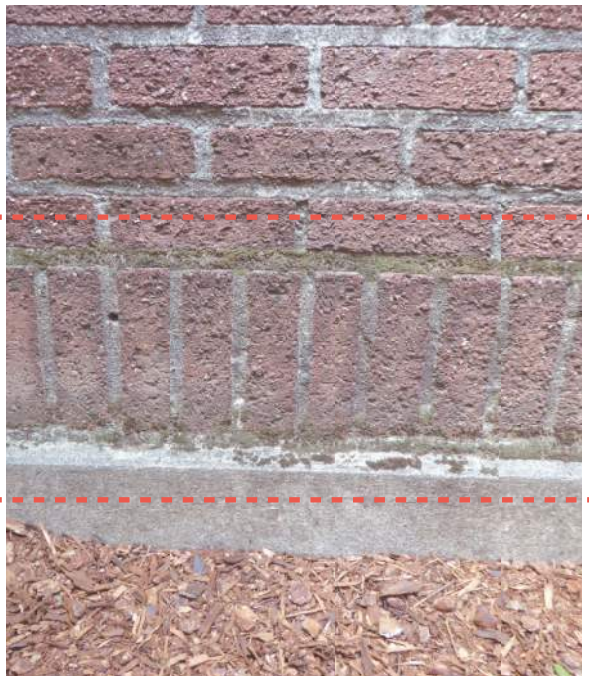
2.2.3/1 Light biogrowth at soldier course.

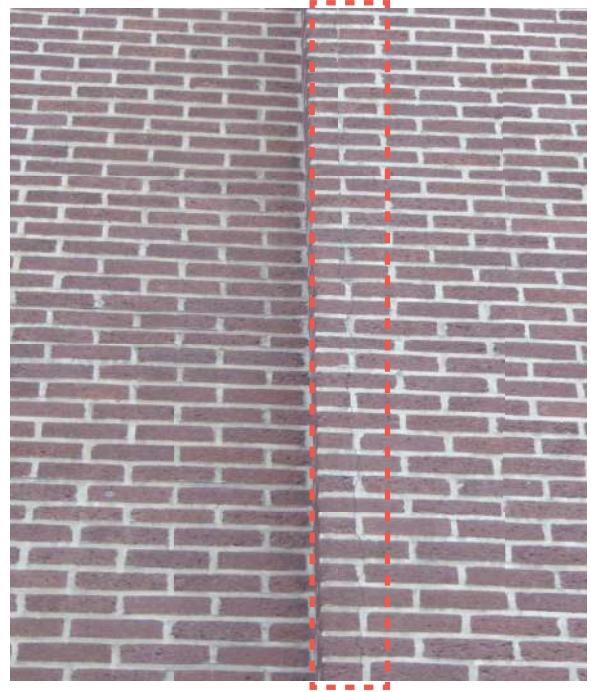
2.2.3/4 Long structural crack at north elevation of Building B.

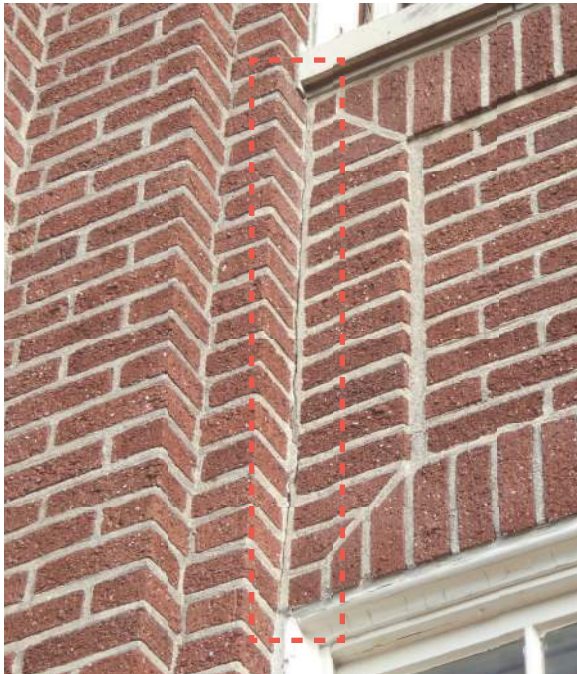
2.2.3/5 Vertical crack at mortar joint.

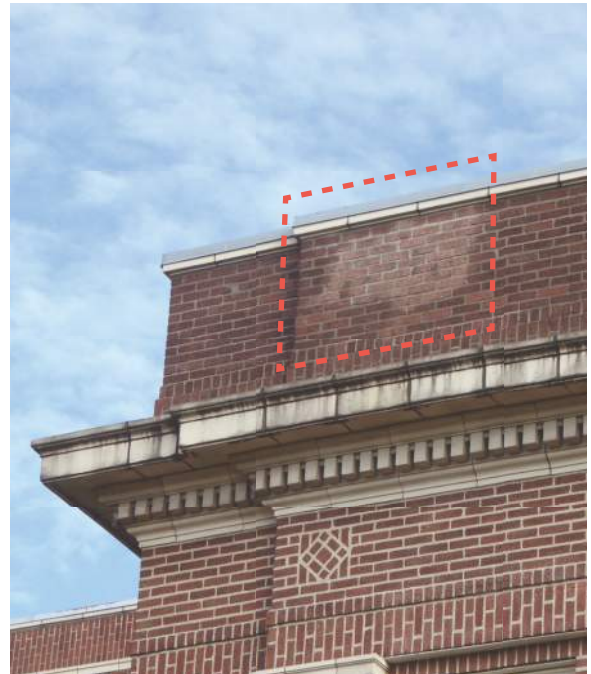
2.2.3/6 "Overcleaned" graffiti.

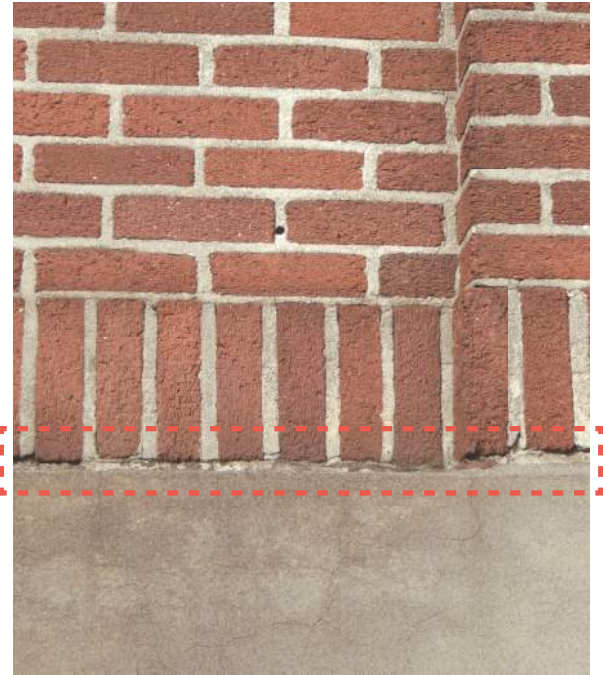
2.2.3/8 Deteriorated mortar joint.

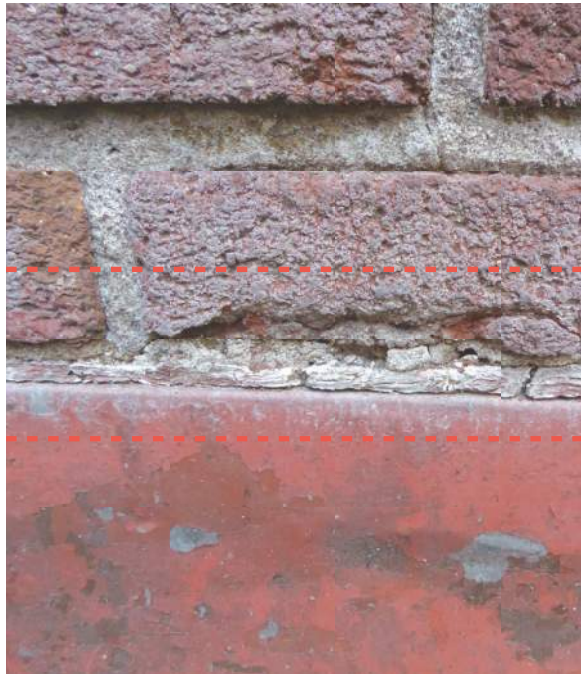
2.2.3/9 Dry/cracked sealant joint.

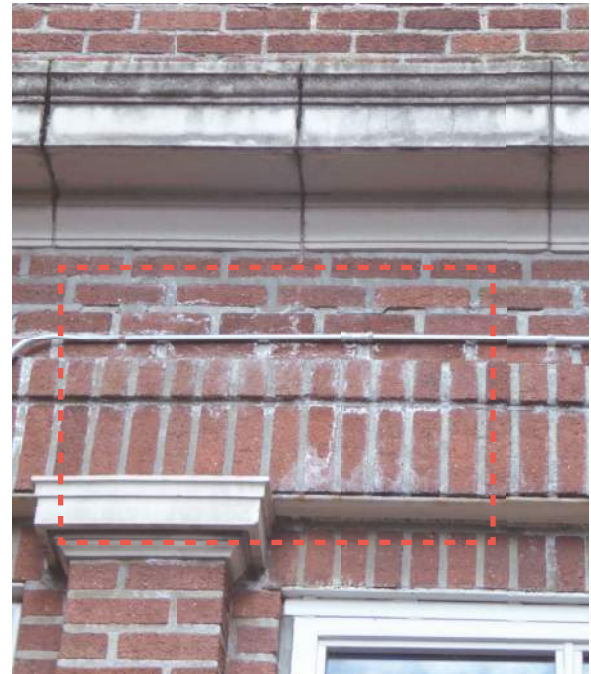
2.2.3/10 Area showing heavy efflorescence at mortar joints.

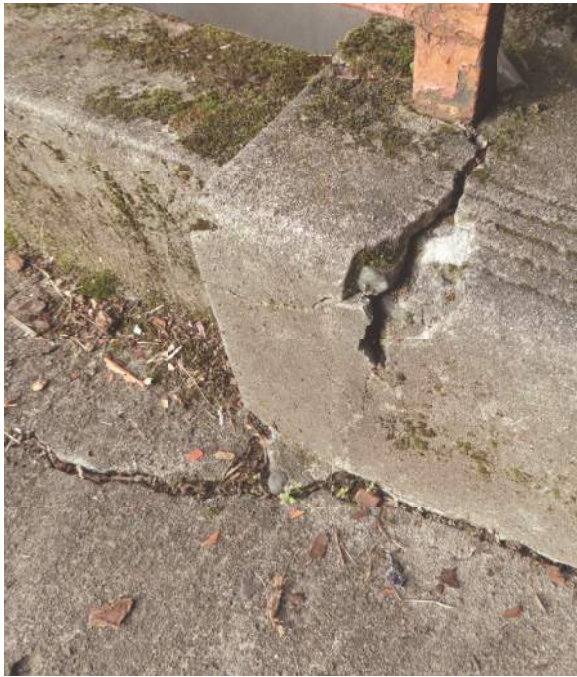
2.2.3/13 Concrete spalls and cracking.

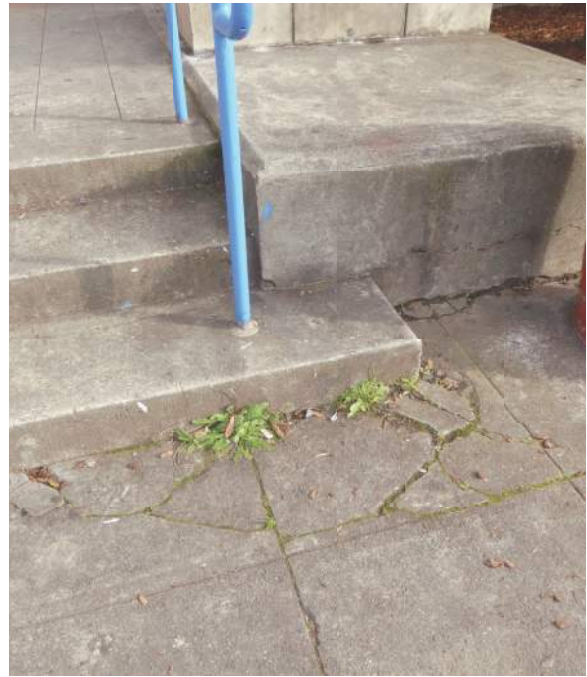
2.2.3/14 Cracks and biogrowth seen at walkway pavers.

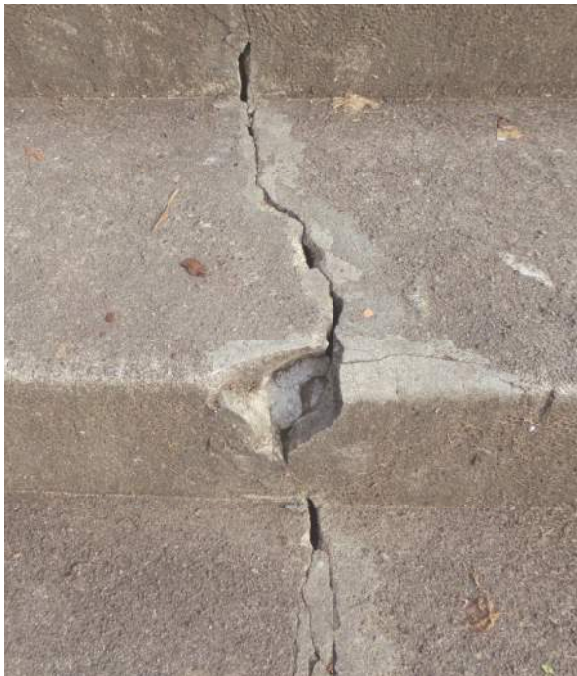
2.2.3/15 Failed concrete patch at exterior stairs.

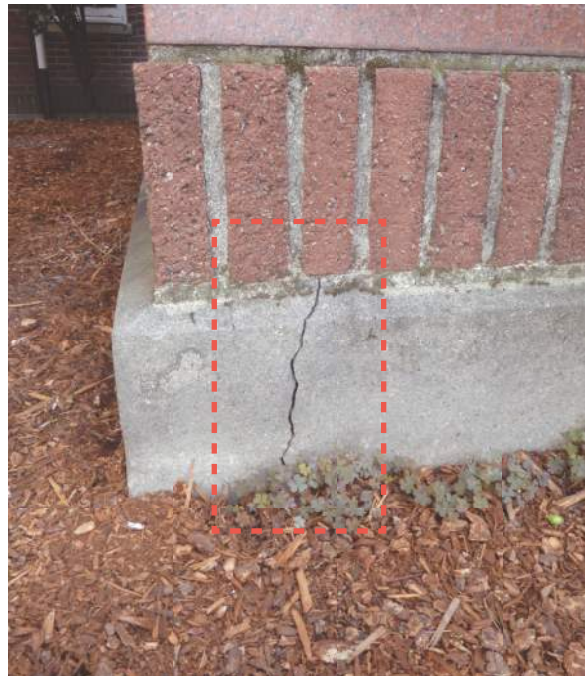
2.2.3/16 Structural crack in foundation at the NW corner of Building A.

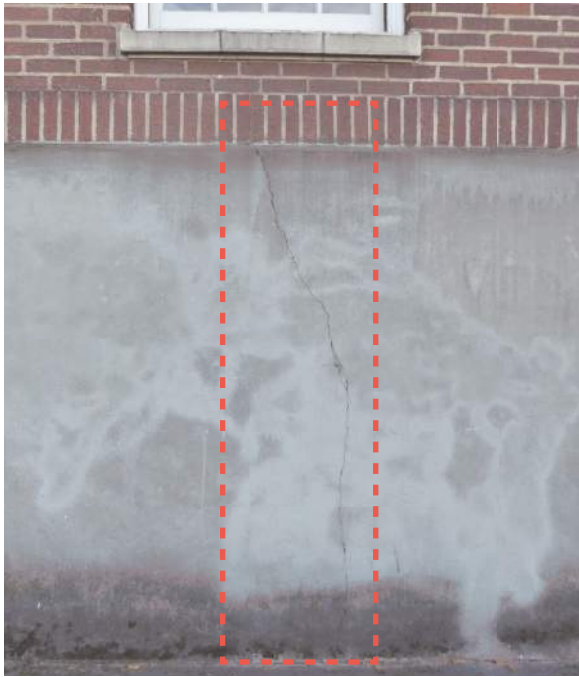
2.2.3/17 Structural crack in foundation at the north side of Building B.

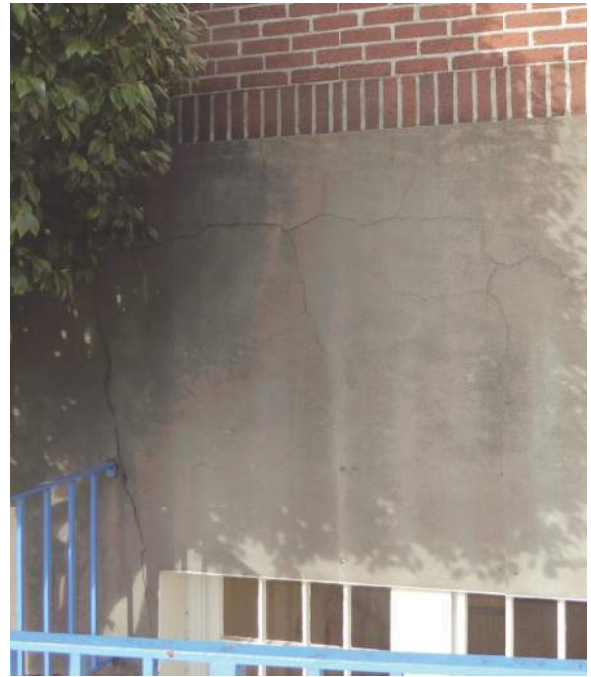
2.2.3/18 Superficial parge coat cracks.

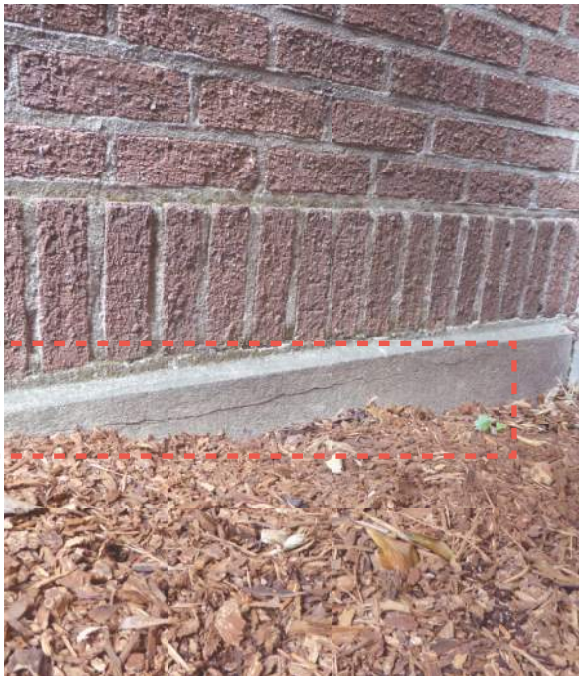
2.2.3/19 Crack in concrete sill.

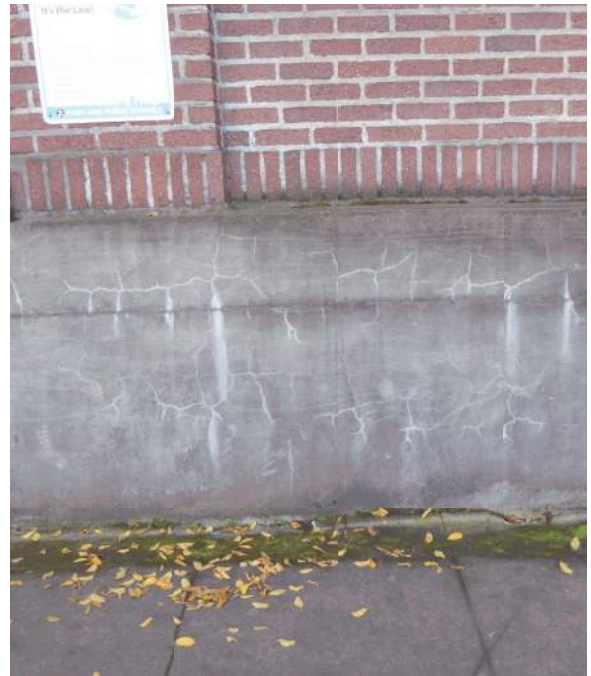
2.2.3/20 Cracks and efflorescence at parge coat.

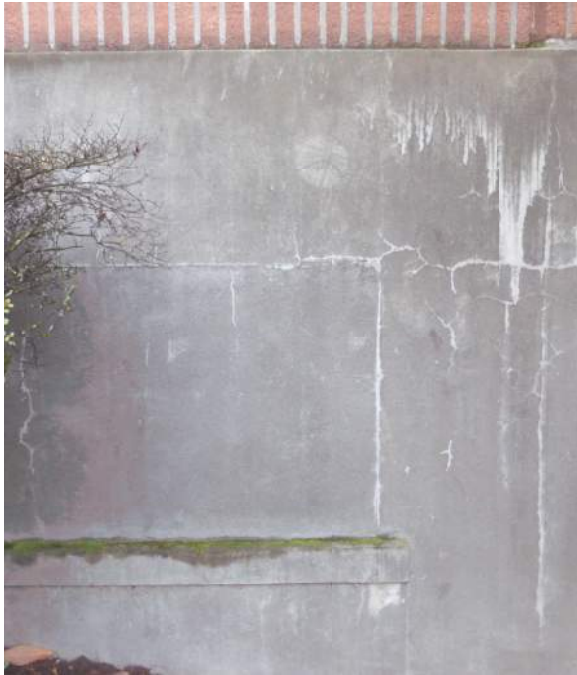
2.2.3/21 Crack in parge coat following outline of window infill.

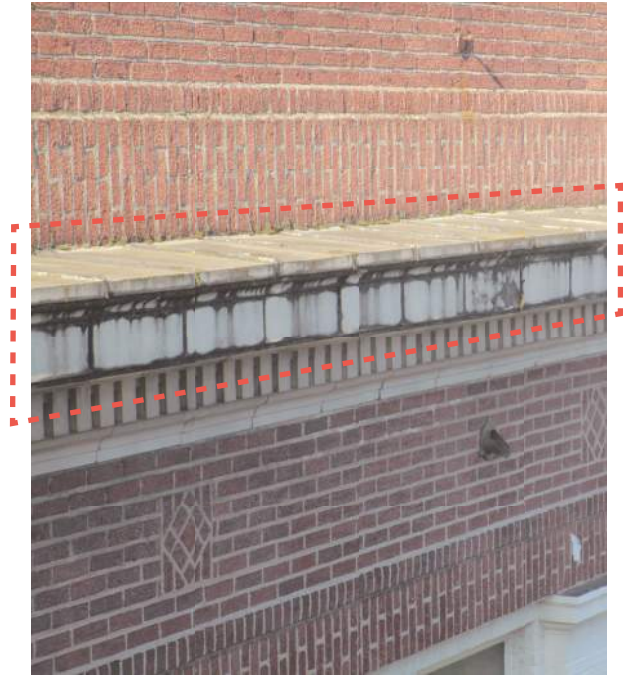
2.2.3/22: Heavy soiling, stains and biological growth at terra cotta cornice, Building C - north elevation.

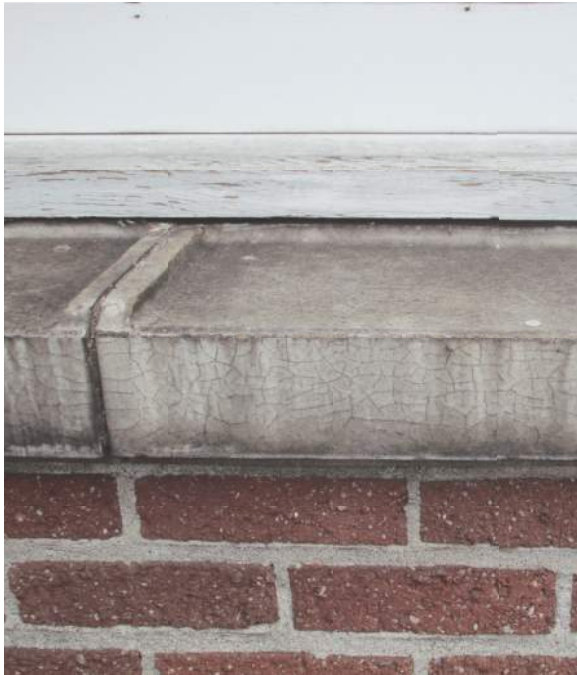
2.2.3/23: Crazing at first floor window sill units, Building A - west elevation.

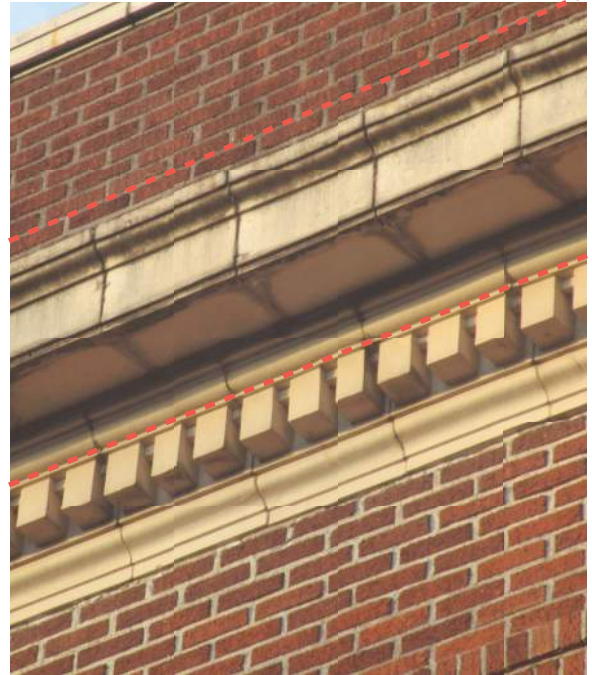
2.2.3/24: Eroded mortar and associated staining and glaze spalls at terra cotta cornice, Building C - north elevation.

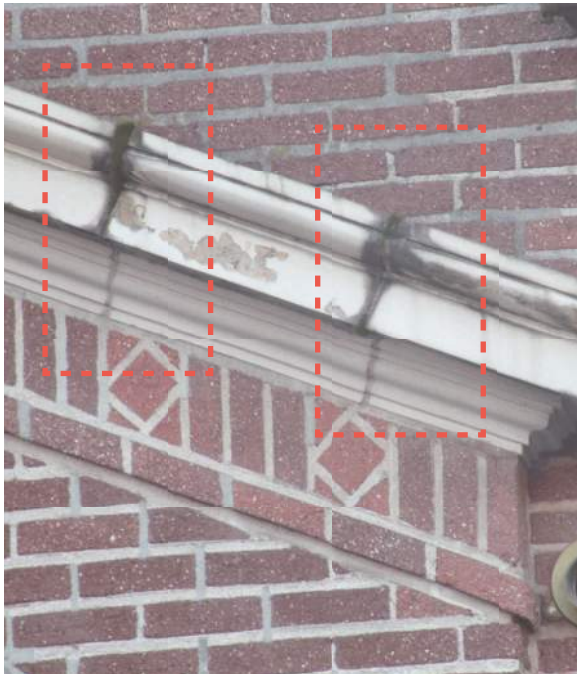
2.2.3/25: Detail of eroded mortar and associated staining and glaze spalls at terra cotta pediment, Building E - east elevation.

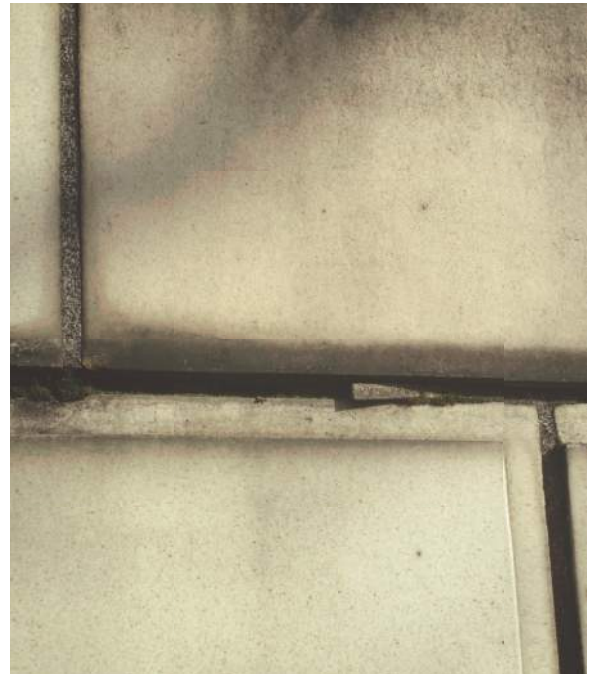
2.2.3/26: Detail of loose/spalling mortar at terra cotta stair wall, Building B - west elevation.

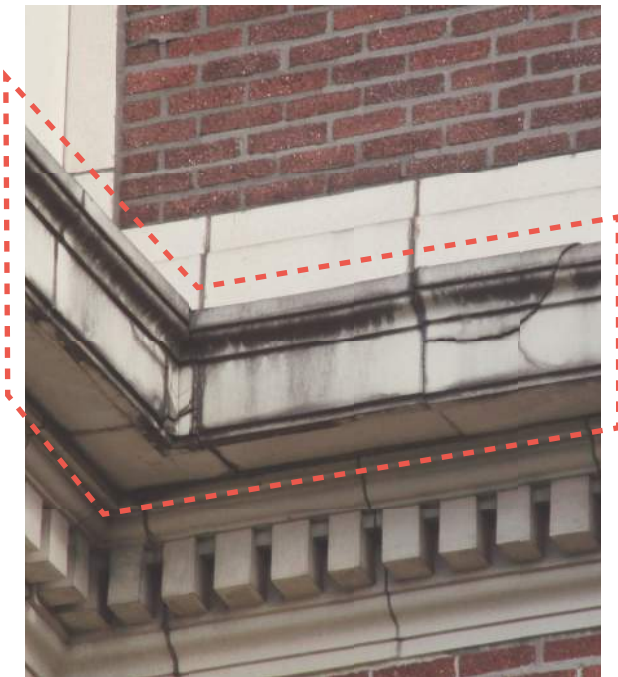
2.2.3/27: Three cracked cornice units at Building A - west elevation. Note unit on right is slightly displaced and possibly hazardous.

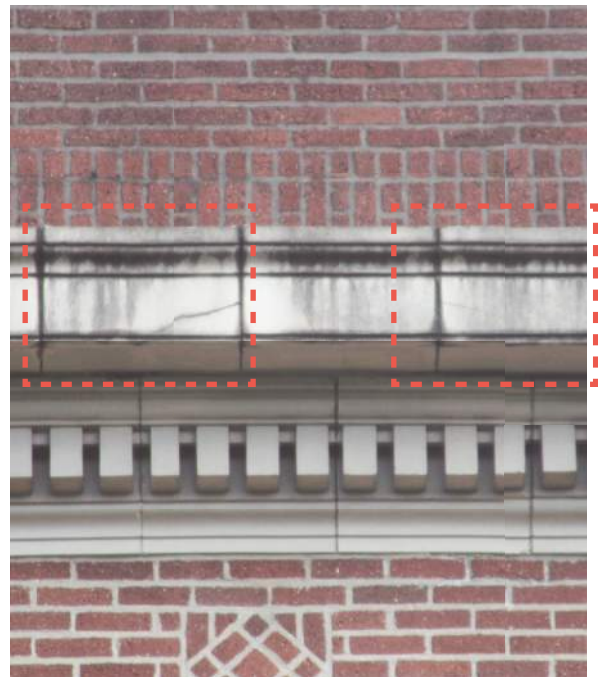
2.2.3/28: Two cracked cornice units at Building A - west elevation.

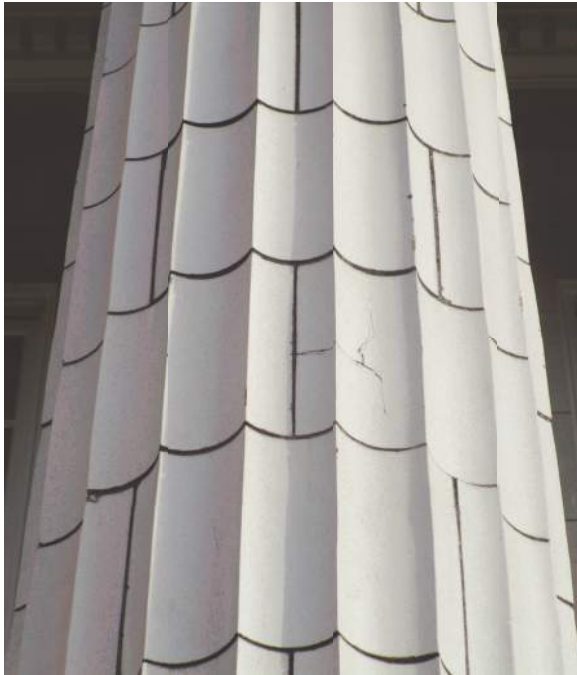
2.2.3/29: Cracks at fluted column unit, Building A - west elevation.

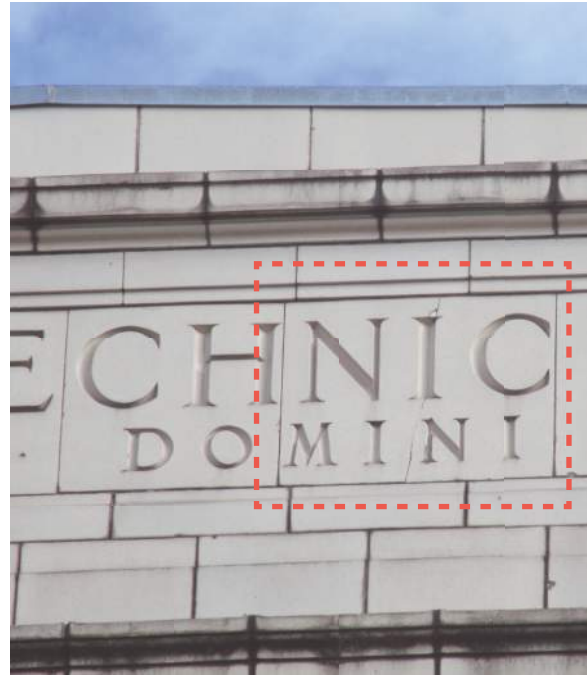
2.2.3/30: Two cracked cornice units at Building A - west elevation.

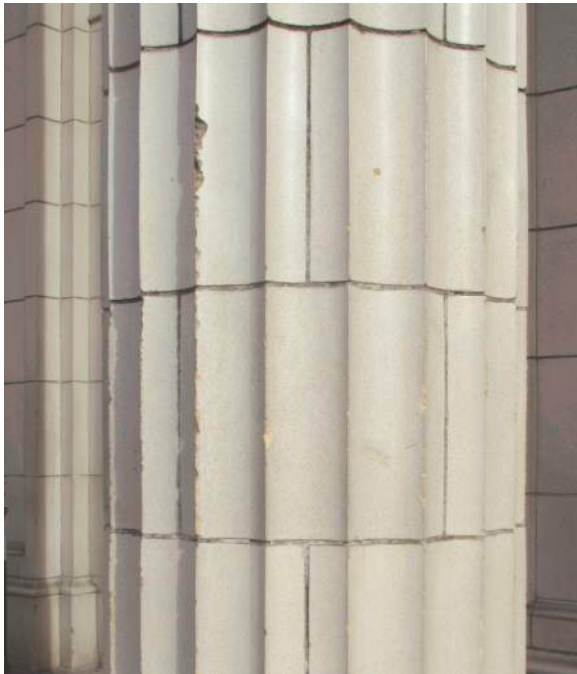
2.2.3/31: Chip losses and abraded edges at fluted column units, Building A - west elevation portico.

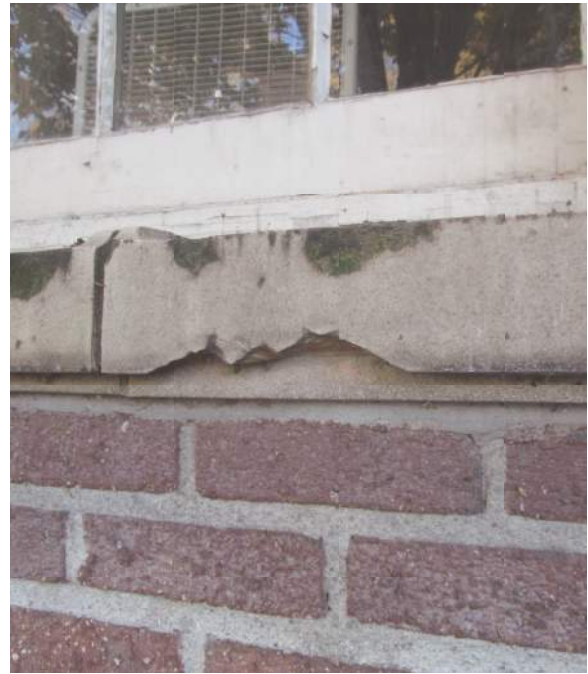
2.2.3/32: Large losses at terra cotta window sills, Building G - north elevation. Also note soiling and biological growth. Spall damage most likely related to vandalism.

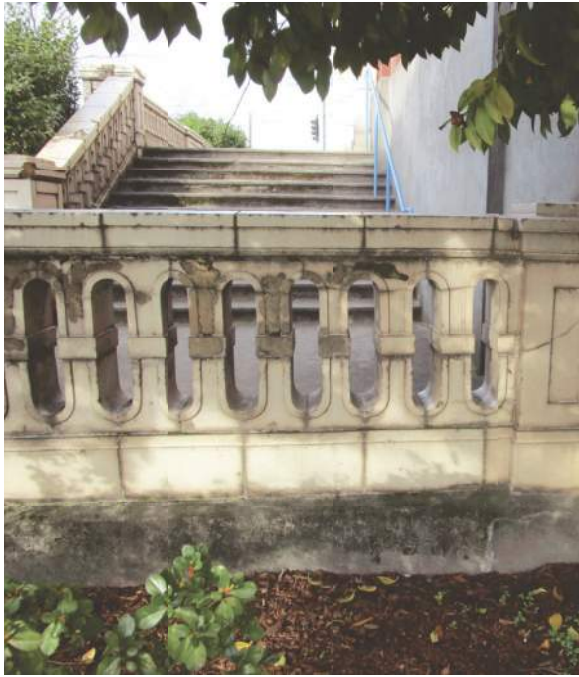
2.2.3/33: Cracking, glaze spalls, heavy soiling and biological growth at stair balustrade, Building B - south elevation.

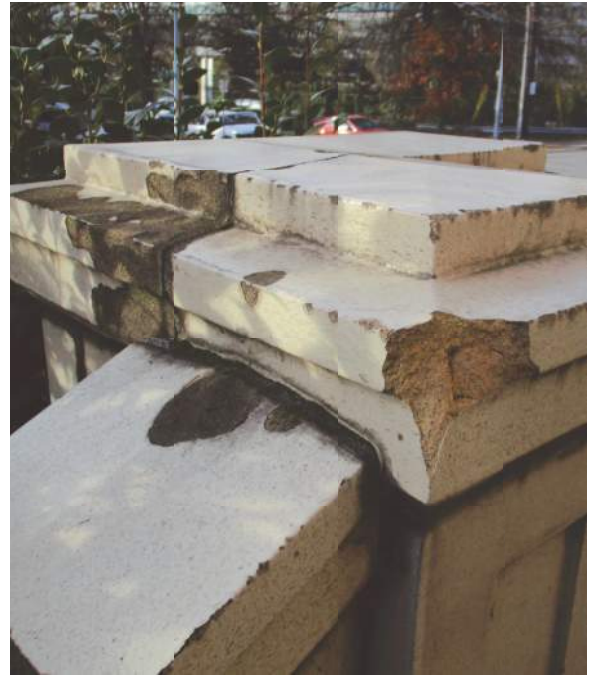
2.2.3/34: Large losses at terra cotta balustrade pier, Building B - west elevation.
