Pre-Design Diligence Report
Benson Polytechnic High School
June 12, 2017

TABLE OF CONTENTS

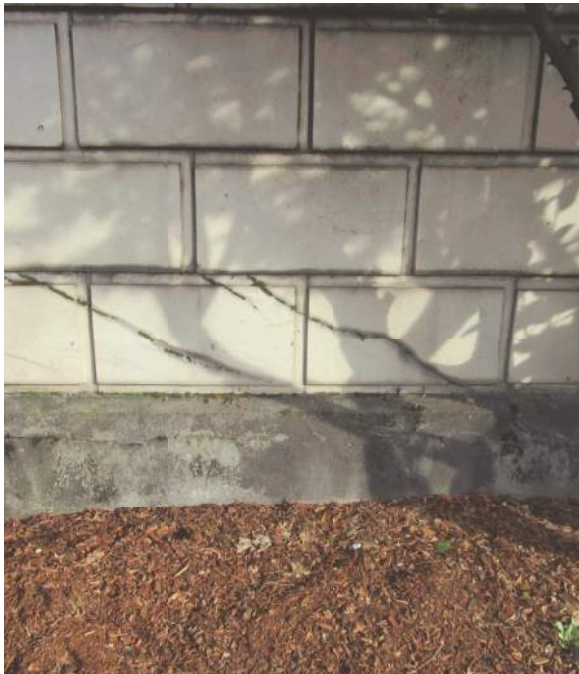
2.2.3/35: Cracking, crazing, soiling and biological growth at stair wall, Building B - west elevation.

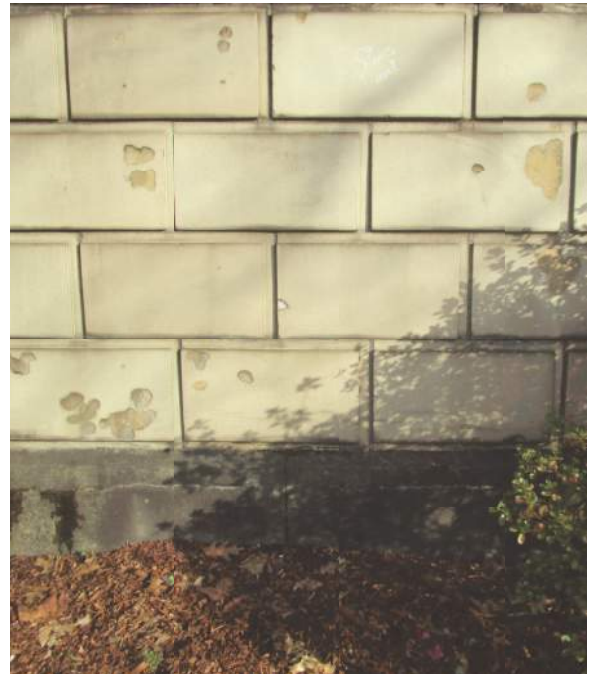
2.2.3/36: Glaze spalls at terra cotta stair wall, and cracking, water stains and efflorescence at concrete base, Building B - west elevation.

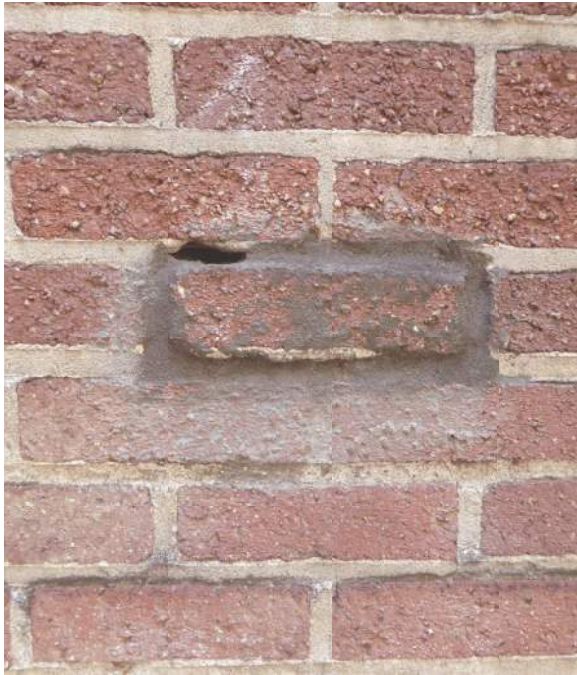
2.2.4/1 Brick unit needing to be removed and reinstalled with new mortar.

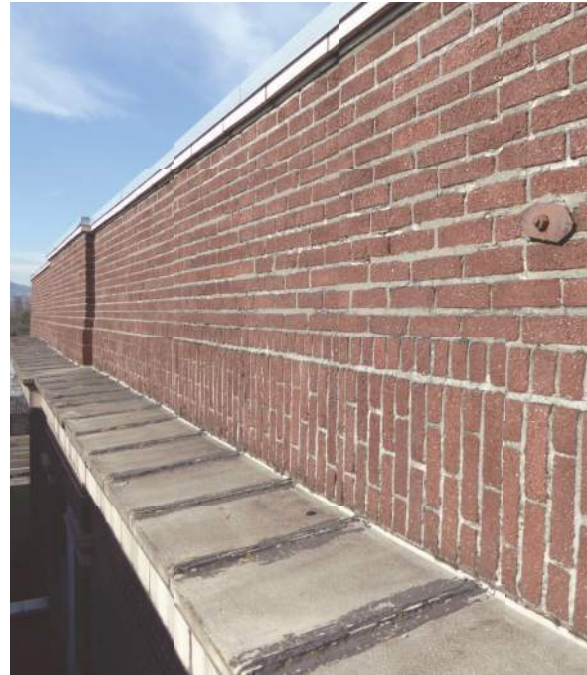
2.2.4/2 Mortar deterioration at parapet terra cotta unit joints.

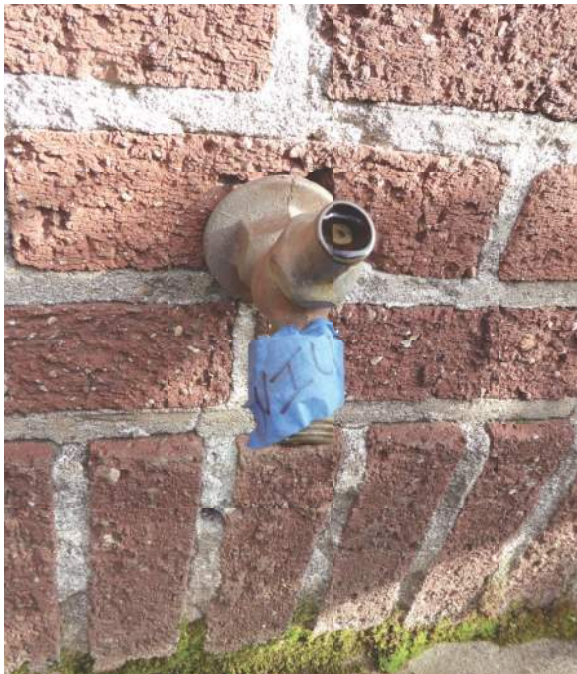
2.2.4/3 Dripping faucet.

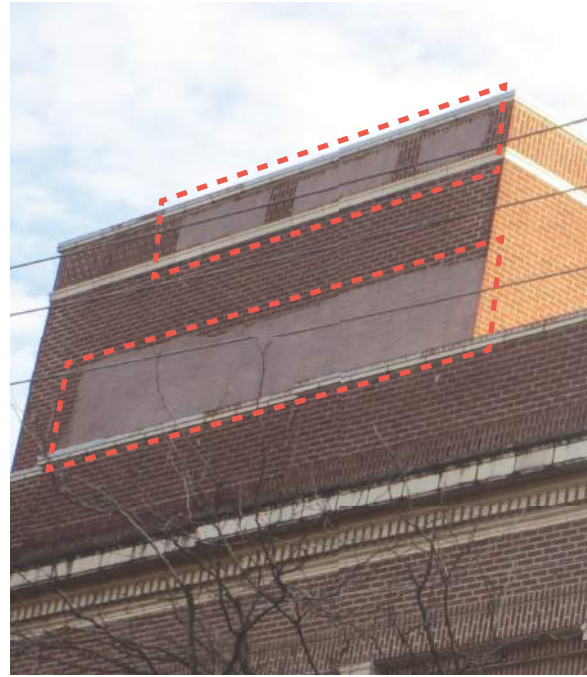
2.2.4/6 Painted over graffiti area at Building B - north elevation.

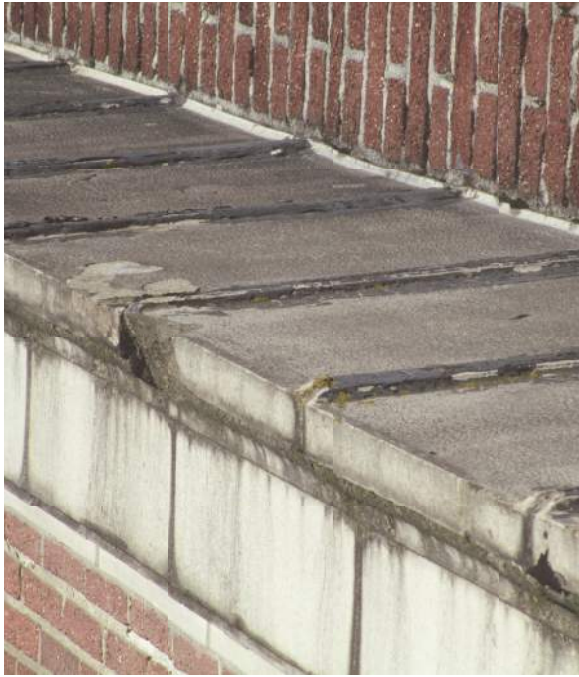
2.2.4/7: Deteriorated roofing mastic applied over upward-facing joints at terra cotta copings, Building A - south elevation.

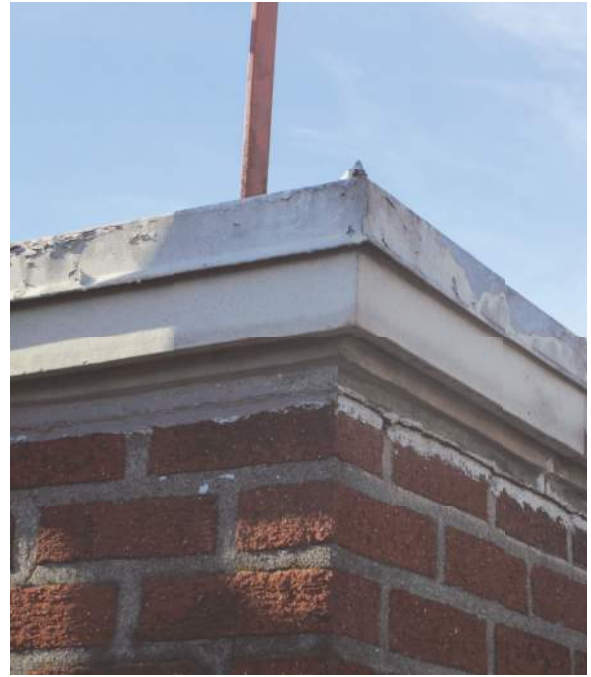
2.2.4/8: Painted sheet metal cap flashing installed over terra cotta copings at Building C. Note deteriorated coping joints and horizontal sealant joint between coping and brick parapet wall.

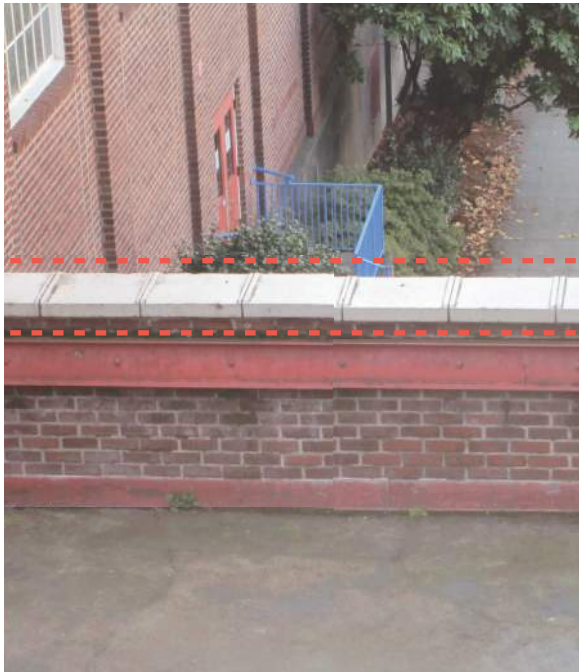
2.2.4/9: Section of original terra cotta coping at connection bridge between Buildings A & C. At most other locations, copings have been covered with sheet metal flashing.

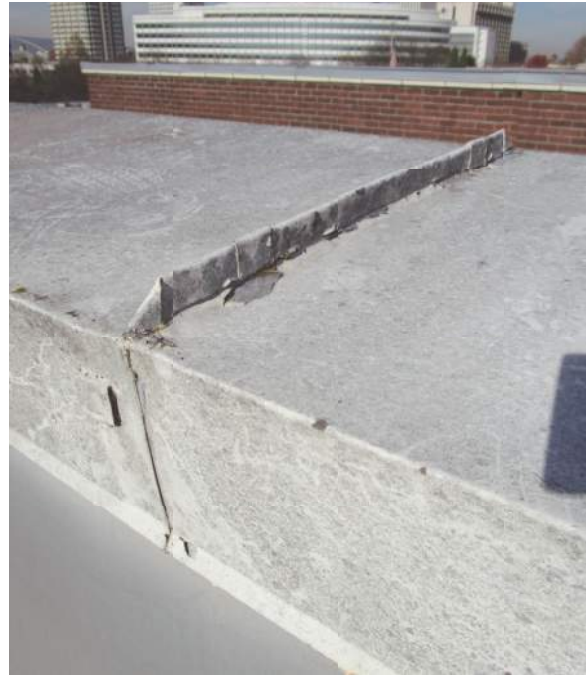
2.2.4/12: Damaged seams and peeling paint at galvanized sheet metal flashing, Building C - north elevation.

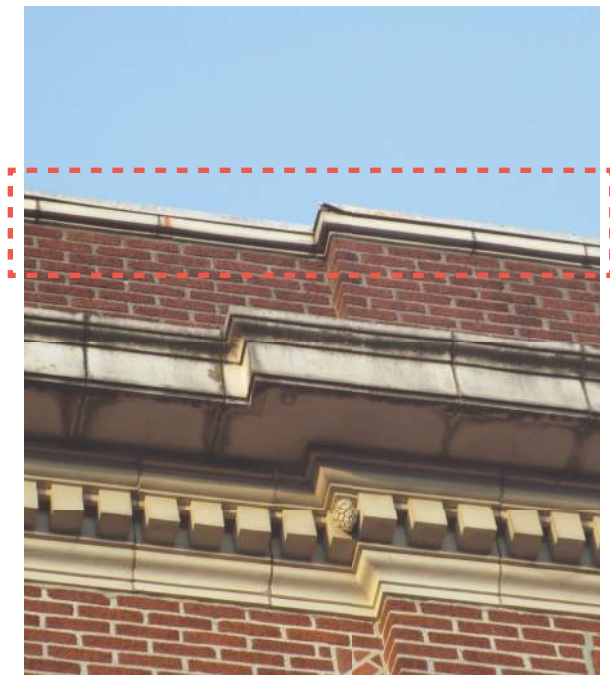
2.2.4/13: Damaged cap flashing at parapet, and rust stains at terra cotta copings, Building B - south elevation.

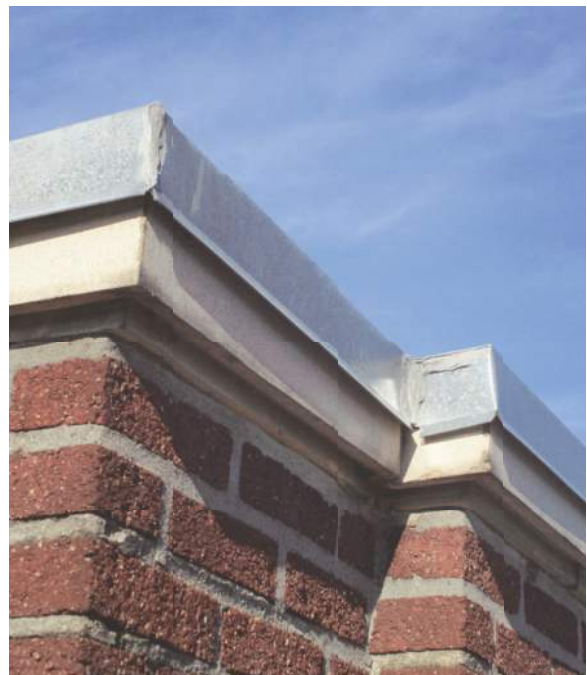
2.2.4/14: Galvanized sheet metal flashing installed at parapet coping, Building A - east elevation. Note open seams at corners covered with sealant.

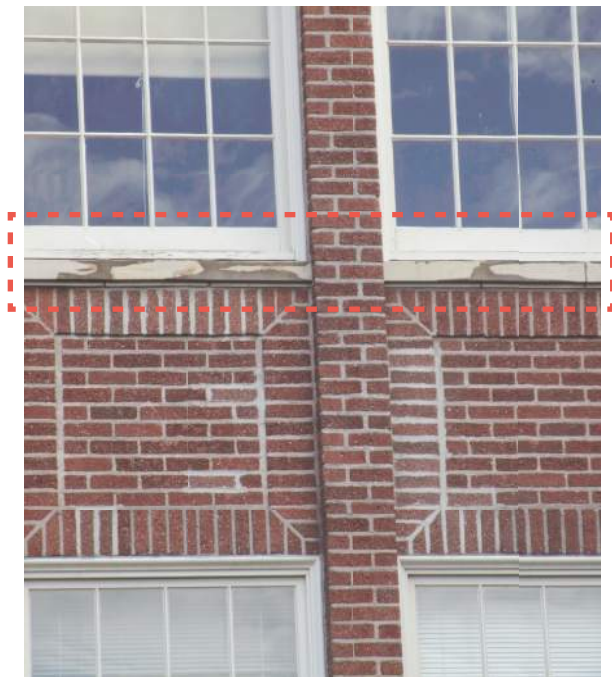
2.2.4/15: Previous cementitious patch repairs at terra cotta window sills, Building A - west elevation.

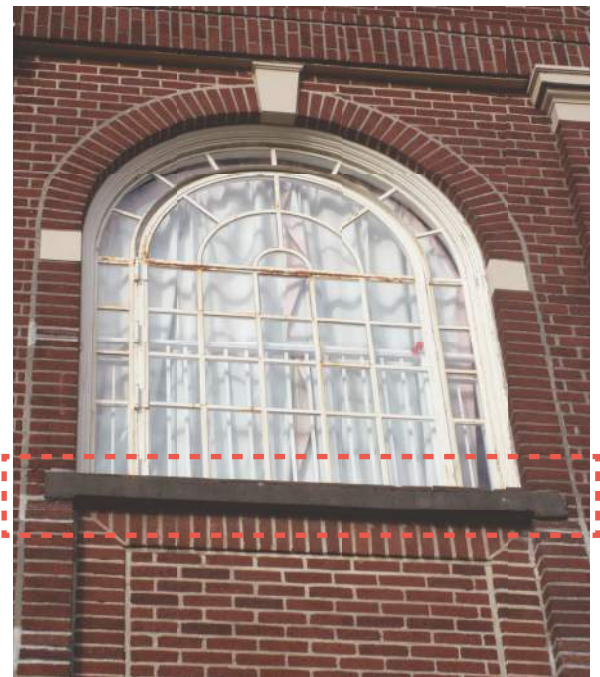
2.2.4/16: Cast concrete window sill at location of removed fire escape stair landing, Building B - south elevation.

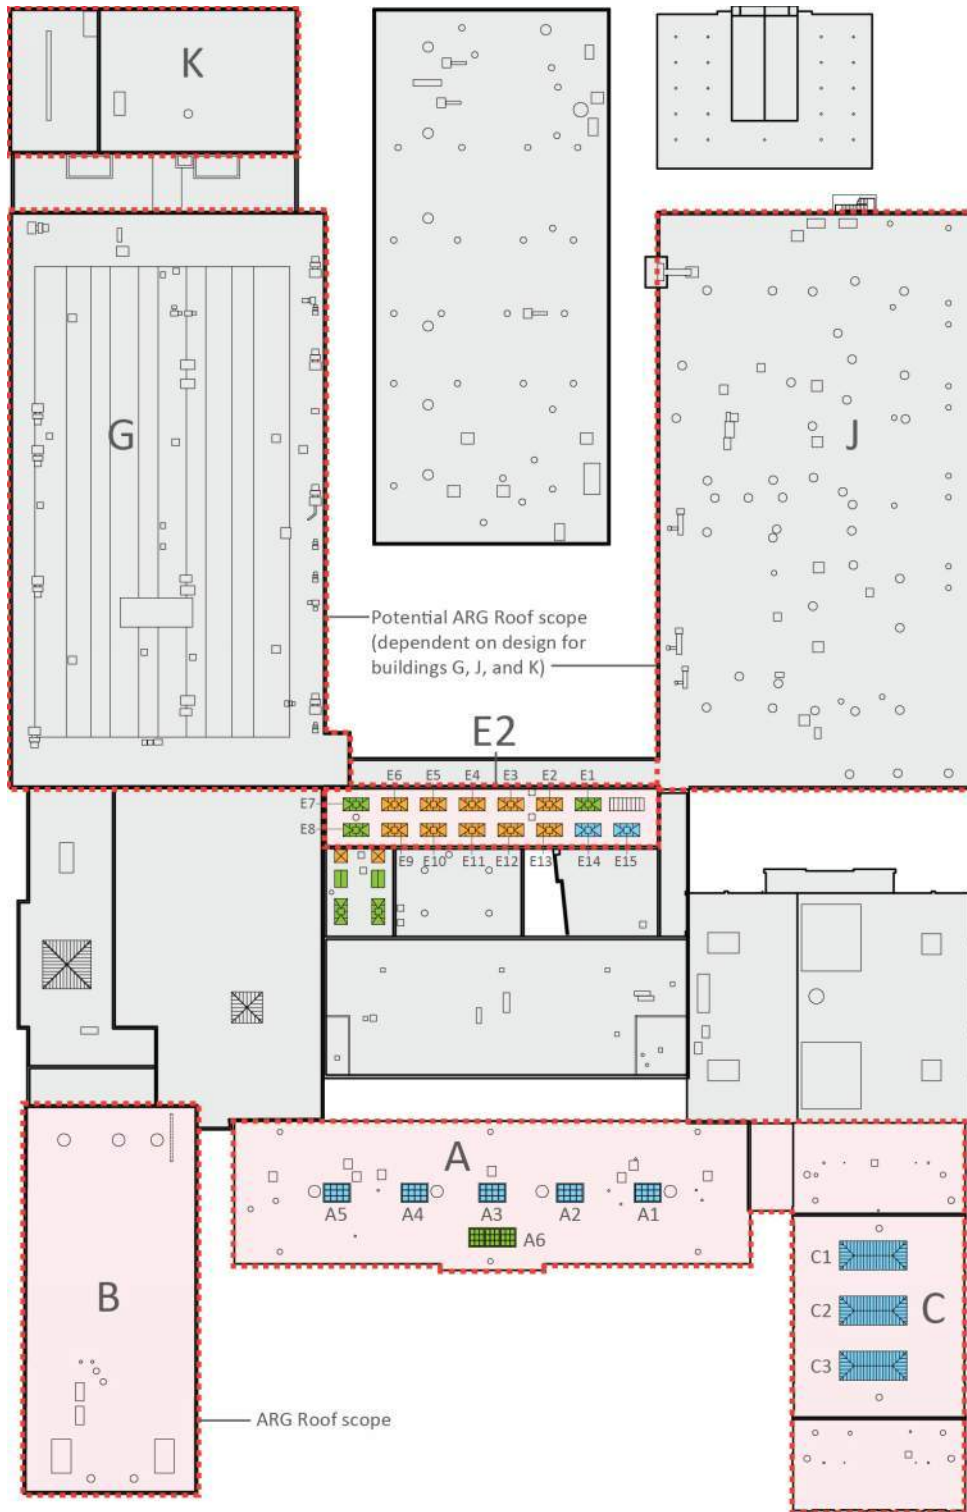
2.4.2 Roof Recommendations

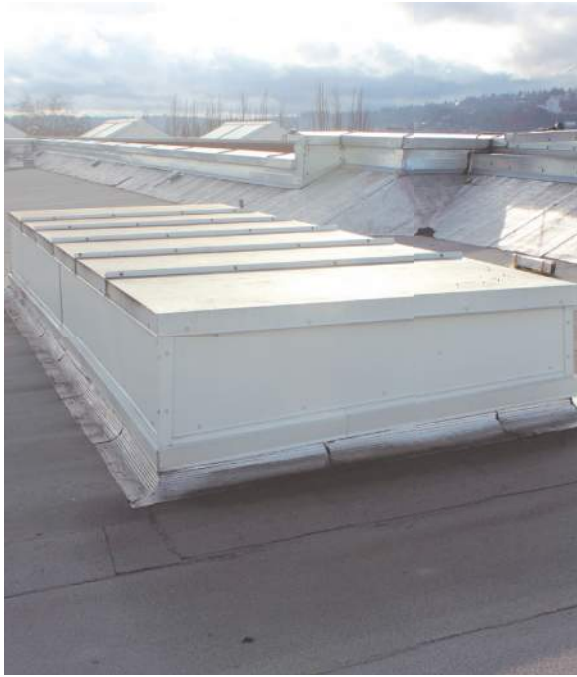
2.4.3/1 Skylight A6: Originally illuminated historic library no longer in function.

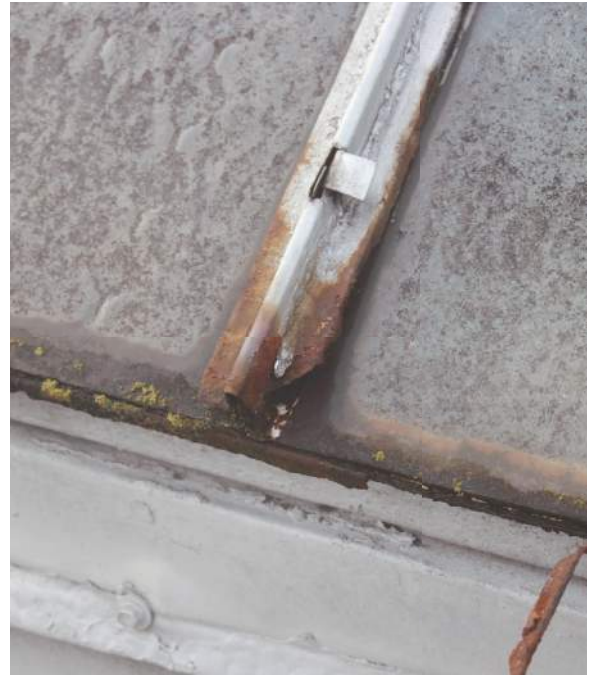
2.4.3/2 Skylight E11: Typical existing biogrowth, corroded metal components and deteriorated sealant on historic skylights.

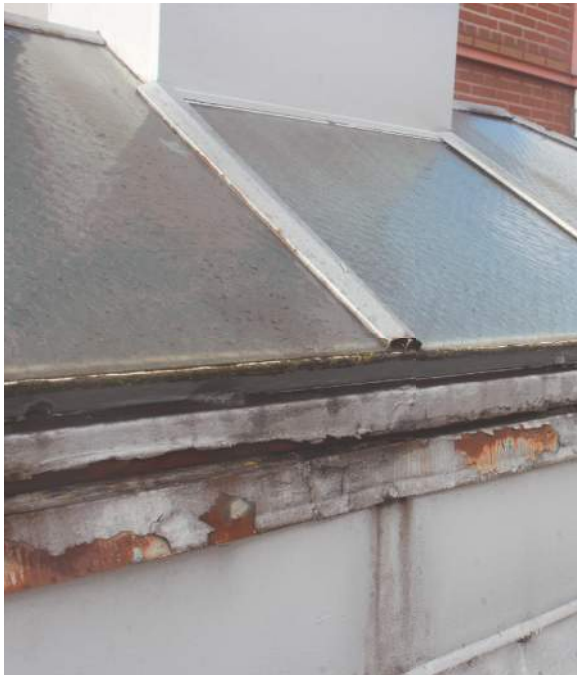
2.4.3/3 Skylight E13: Typical corroded metal flashing, biogrowth, and peeling paint on historic skylights.

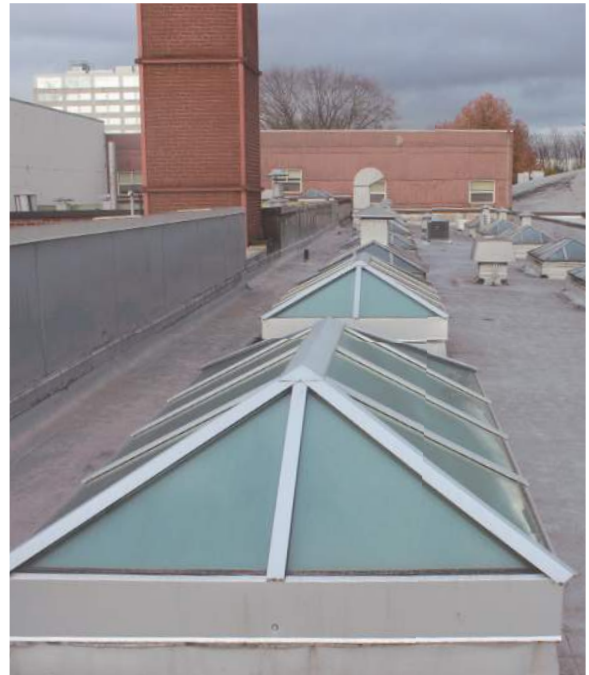
2.4.3/4 Skylights E14 and E15: Aluminum system skylight replacements.

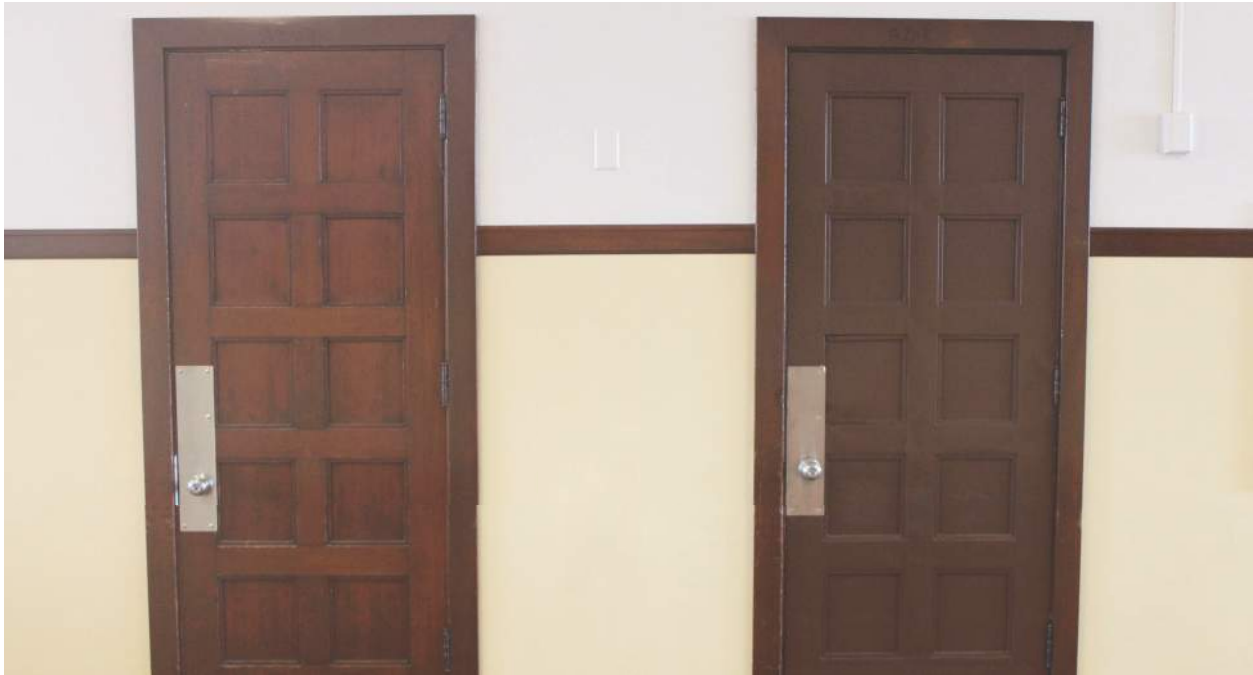
2.5.2/1 Two doors at the second-level lobby of Building B. The left one is wood and the right door is clad with sheet metal.

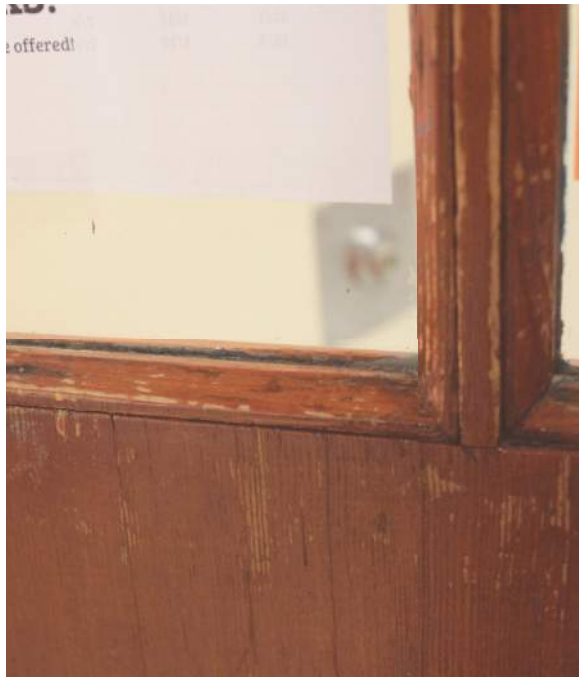
2.5.3/1 Typical door wood crack and split wood condition.

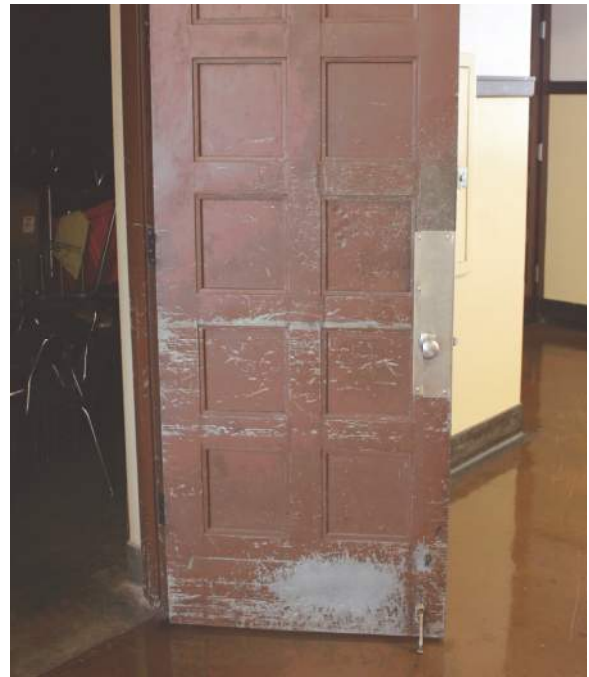
2.5.3/2 Dented and scratched kalamein door. Coating is severely abraded.

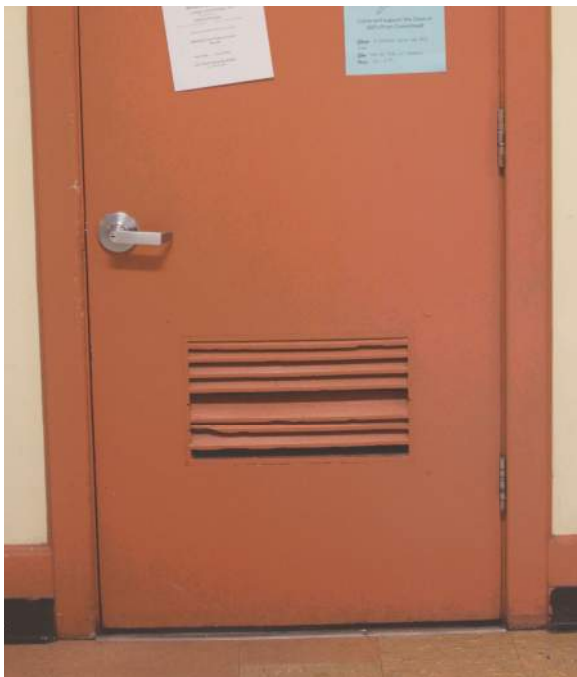
2.5.3/6 Typical broken slats at wood door grilles.

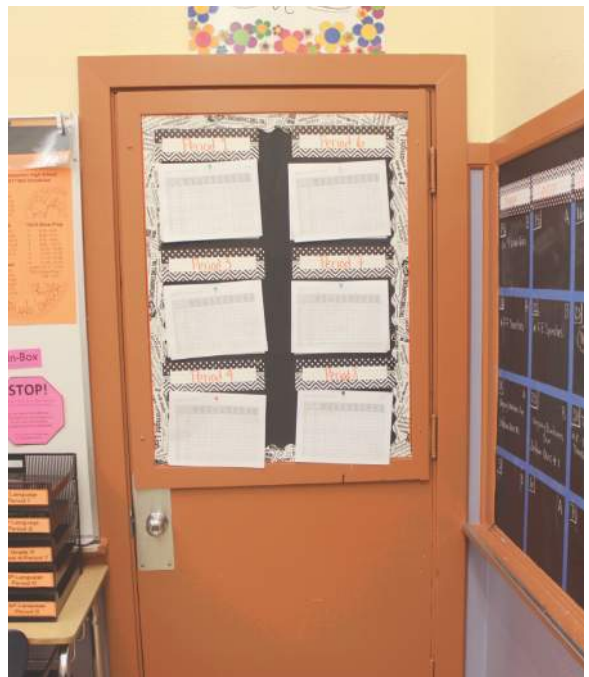
2.5.3/7 Typical door chalk board.

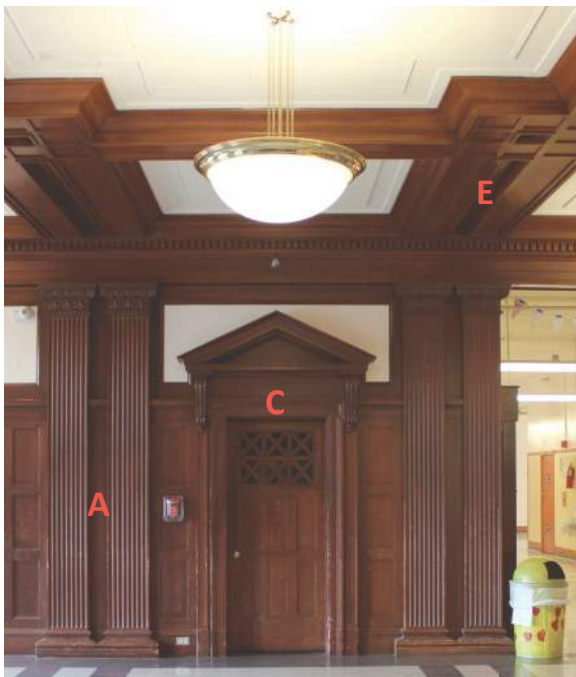
2.6.1/1 Interior door with wood pediment flanked by paired stained wood Doric pilasters and paneled wainscot.

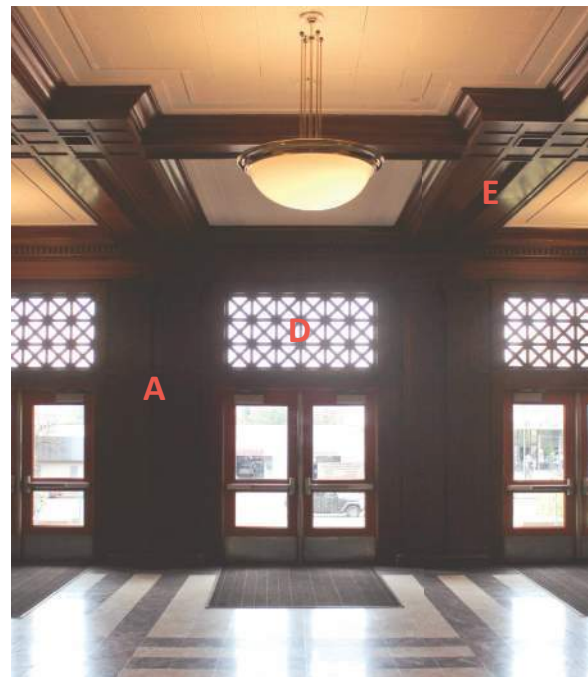
2.6.1/2 Multi-light transoms over main entry doors. Also note ceiling wood molding detailing.

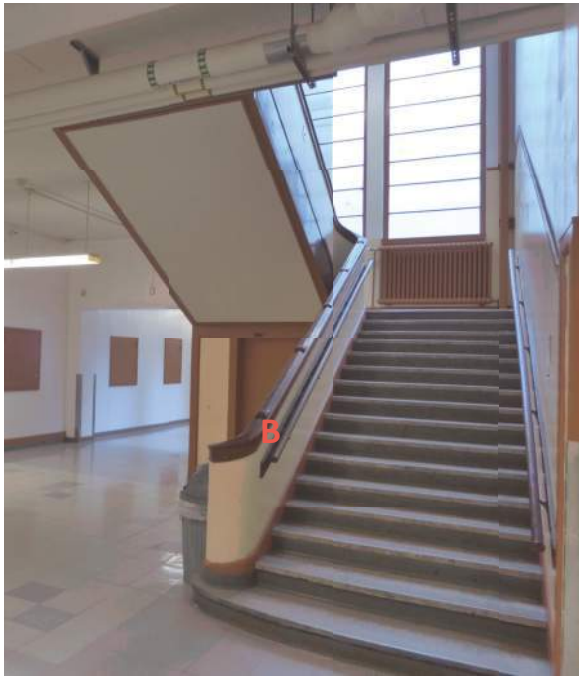
2.6.1/9 Northern staircase, view from first floor.

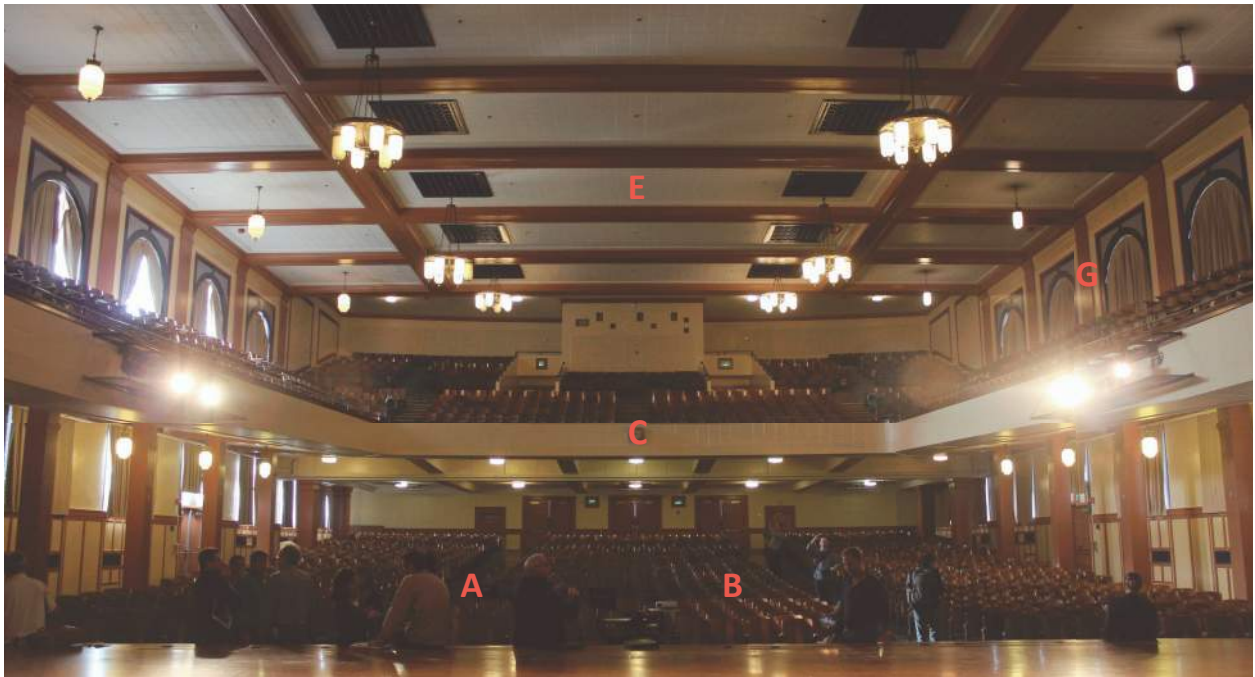
2.6.2/1 View of the auditorium from stage.

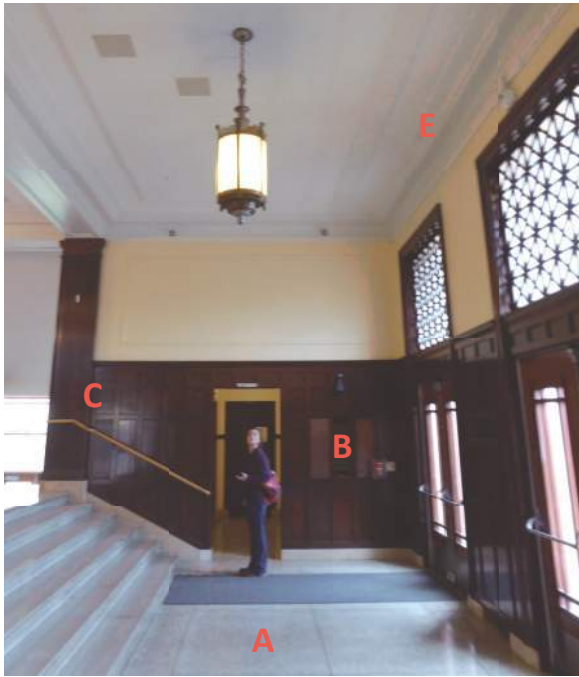
2.6.2/3 Auditorium lobby.

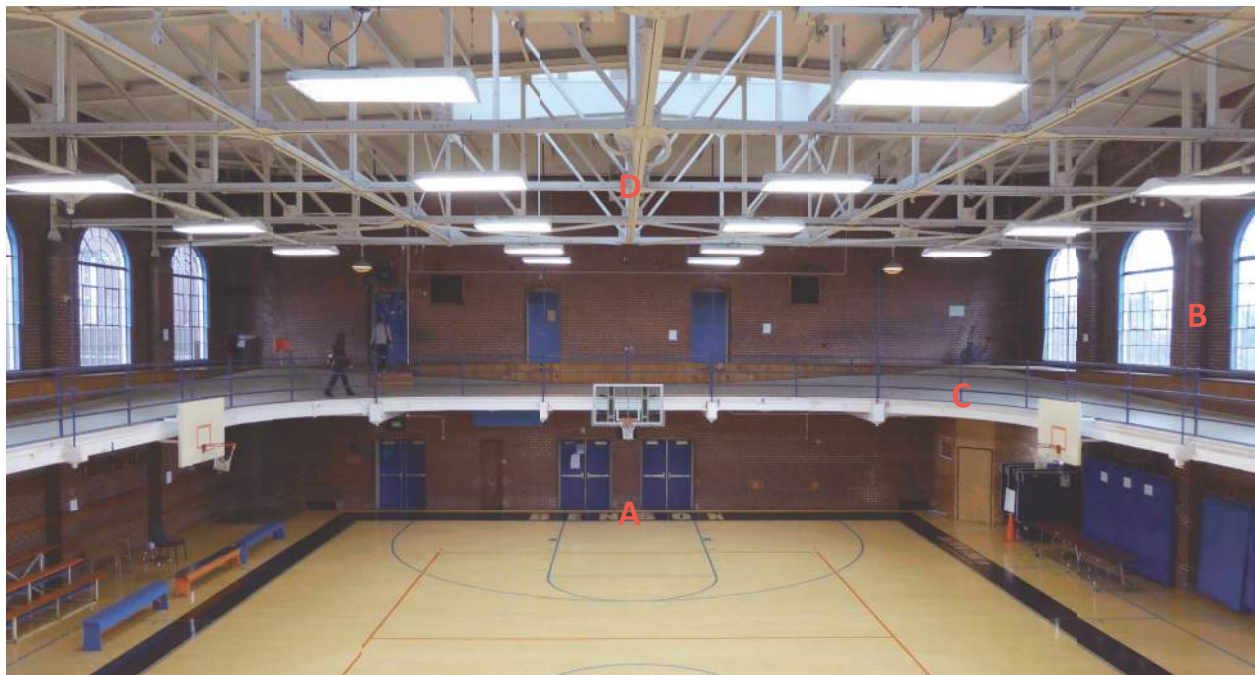
2.6.3/1 Old Gymnasium from mezzanine level.

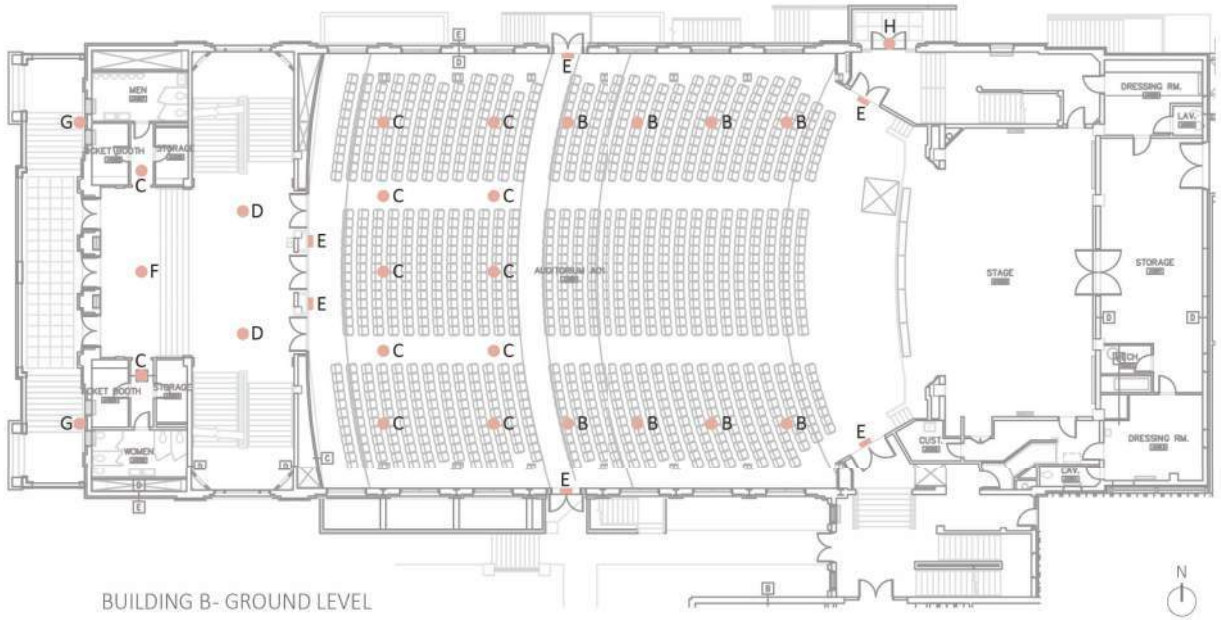
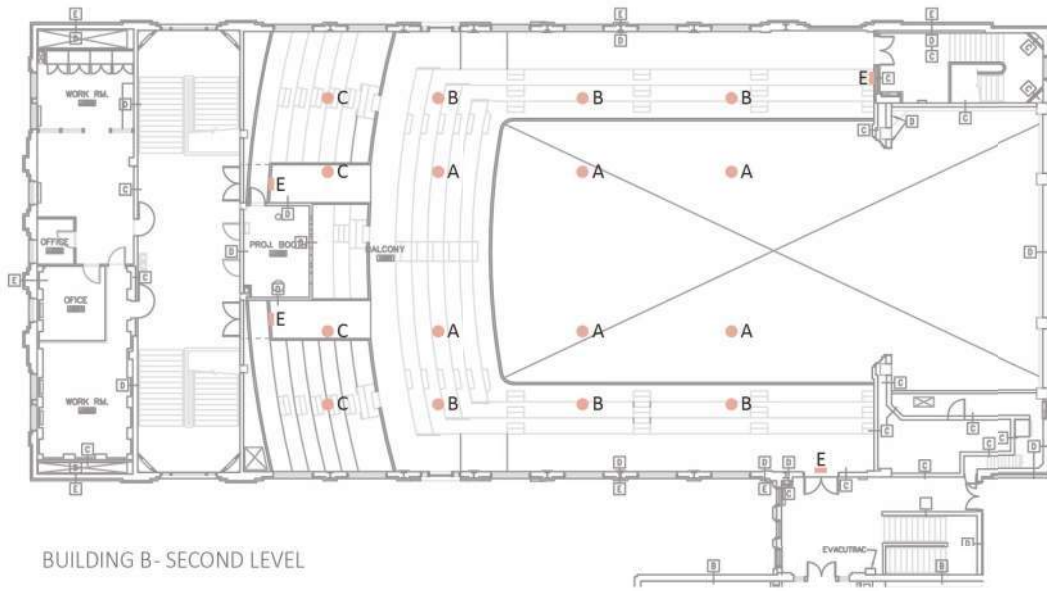
The historic light fixtures will require basic refurbishment and maintenance. Several of the pendant and pan light fixtures have canopies that need to be readjusted back into place. Besides that, the light fixtures are generally in good condition.

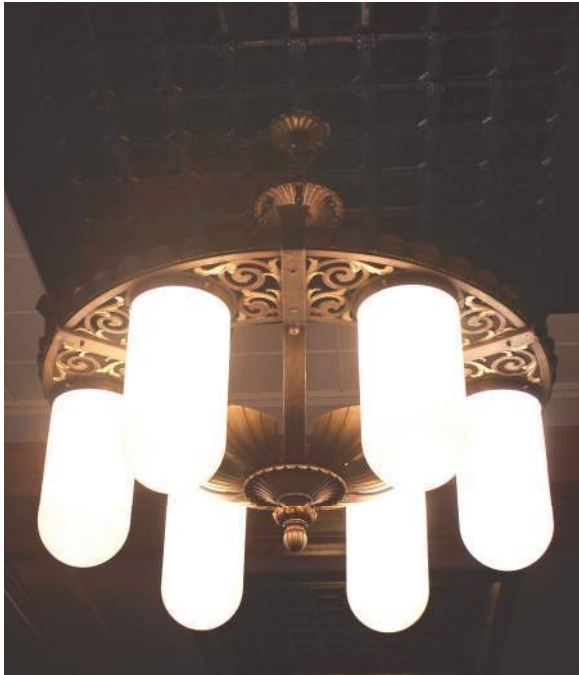
2.7.1/1 Fixture A: bronze pan light fixture.

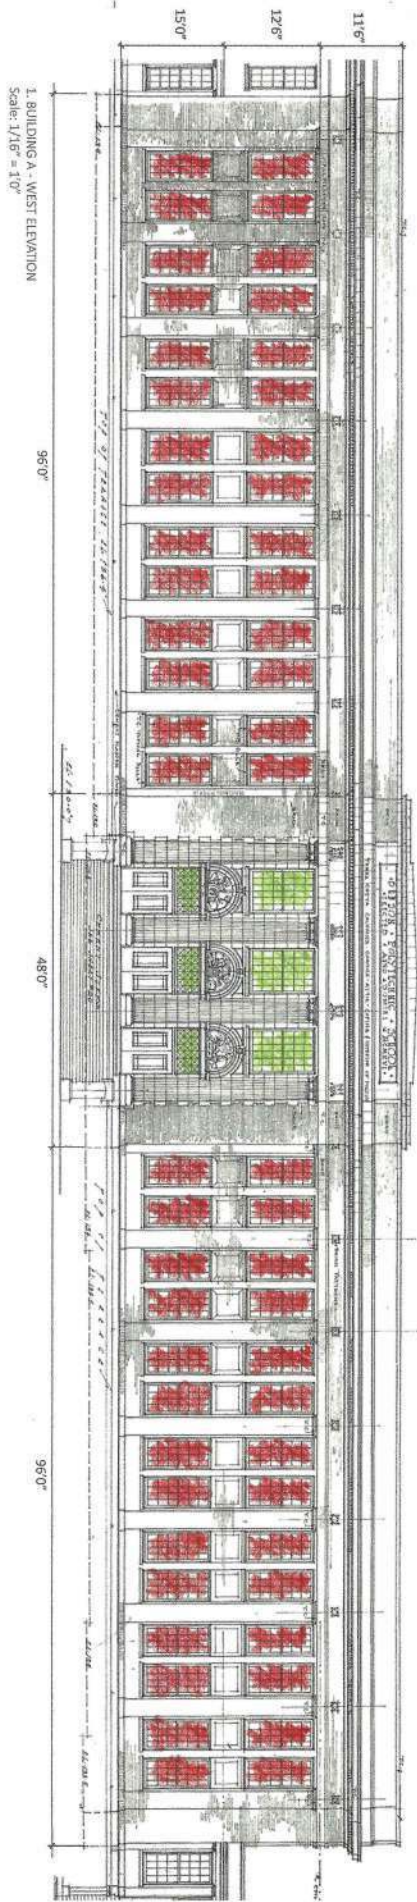
REPLACED WITH STEEL SASH

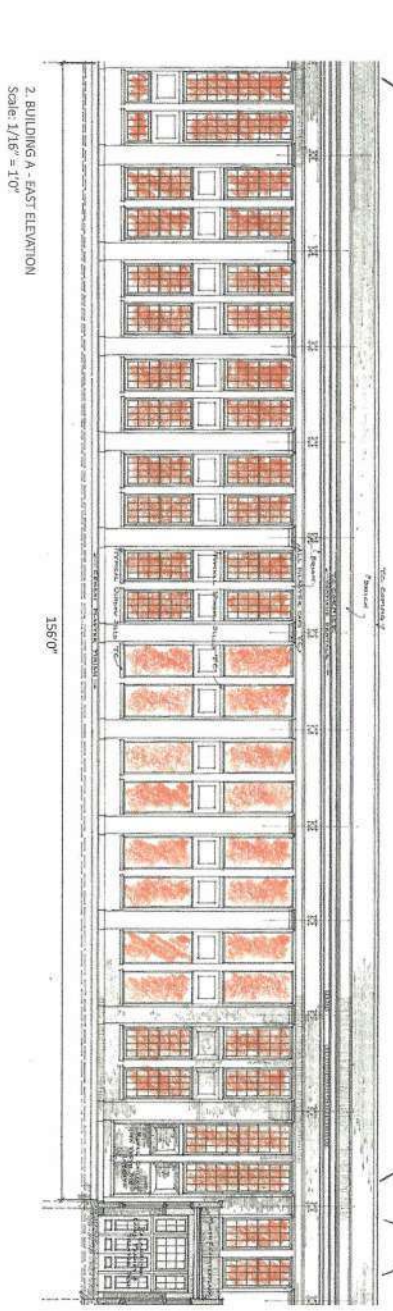
EXISTING CONDITIONS SURVEY
 Benson Polytechnical High School
 Portland OR

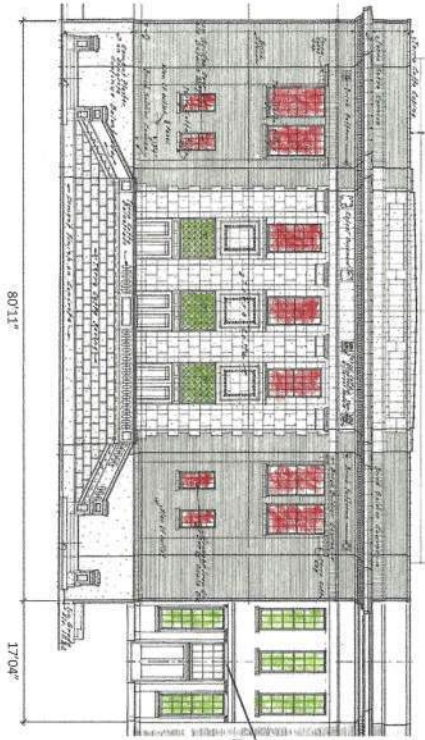
3. BUILDING B - WEST ELEVATION
Scale: 1/16" = 1'-0"

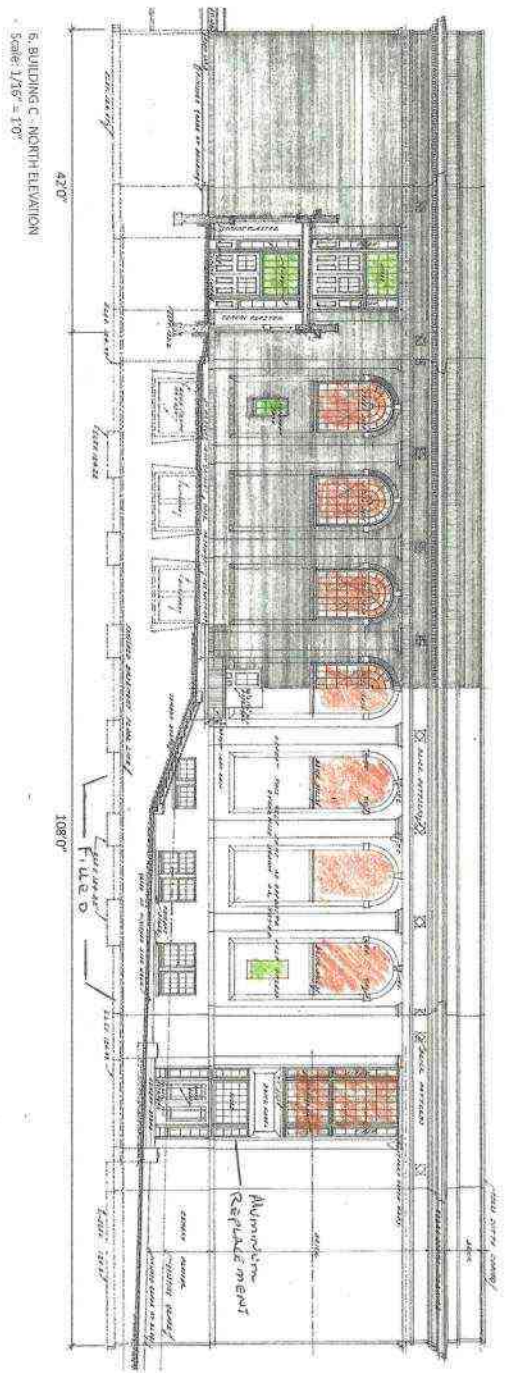
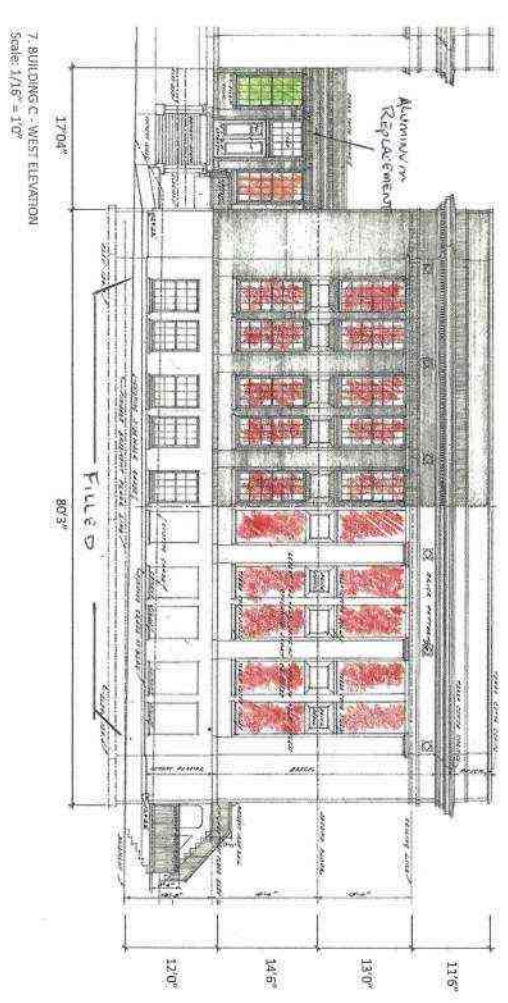
EXISTING CONDITIONS SURVEY
 Benson Polytechnical High School
 Portland, OR

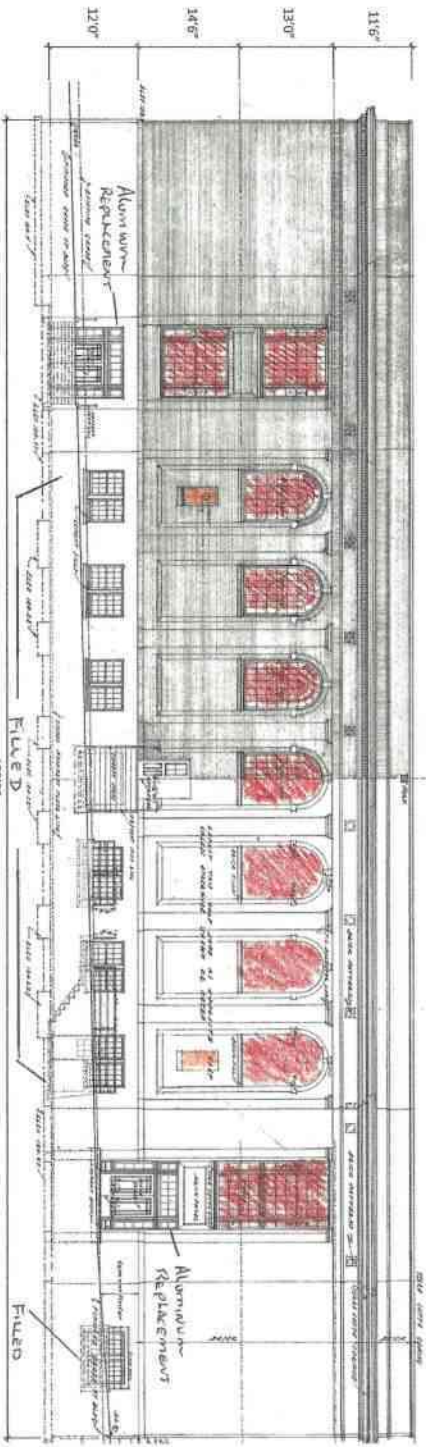
8 BUILDING C - SOUTH ELEVATION
 Scale: 1/16" = 1'0"
