Pre-Design Diligence Report
Benson Polytechnic High School
June 12, 2017

TABLE OF CONTENTS

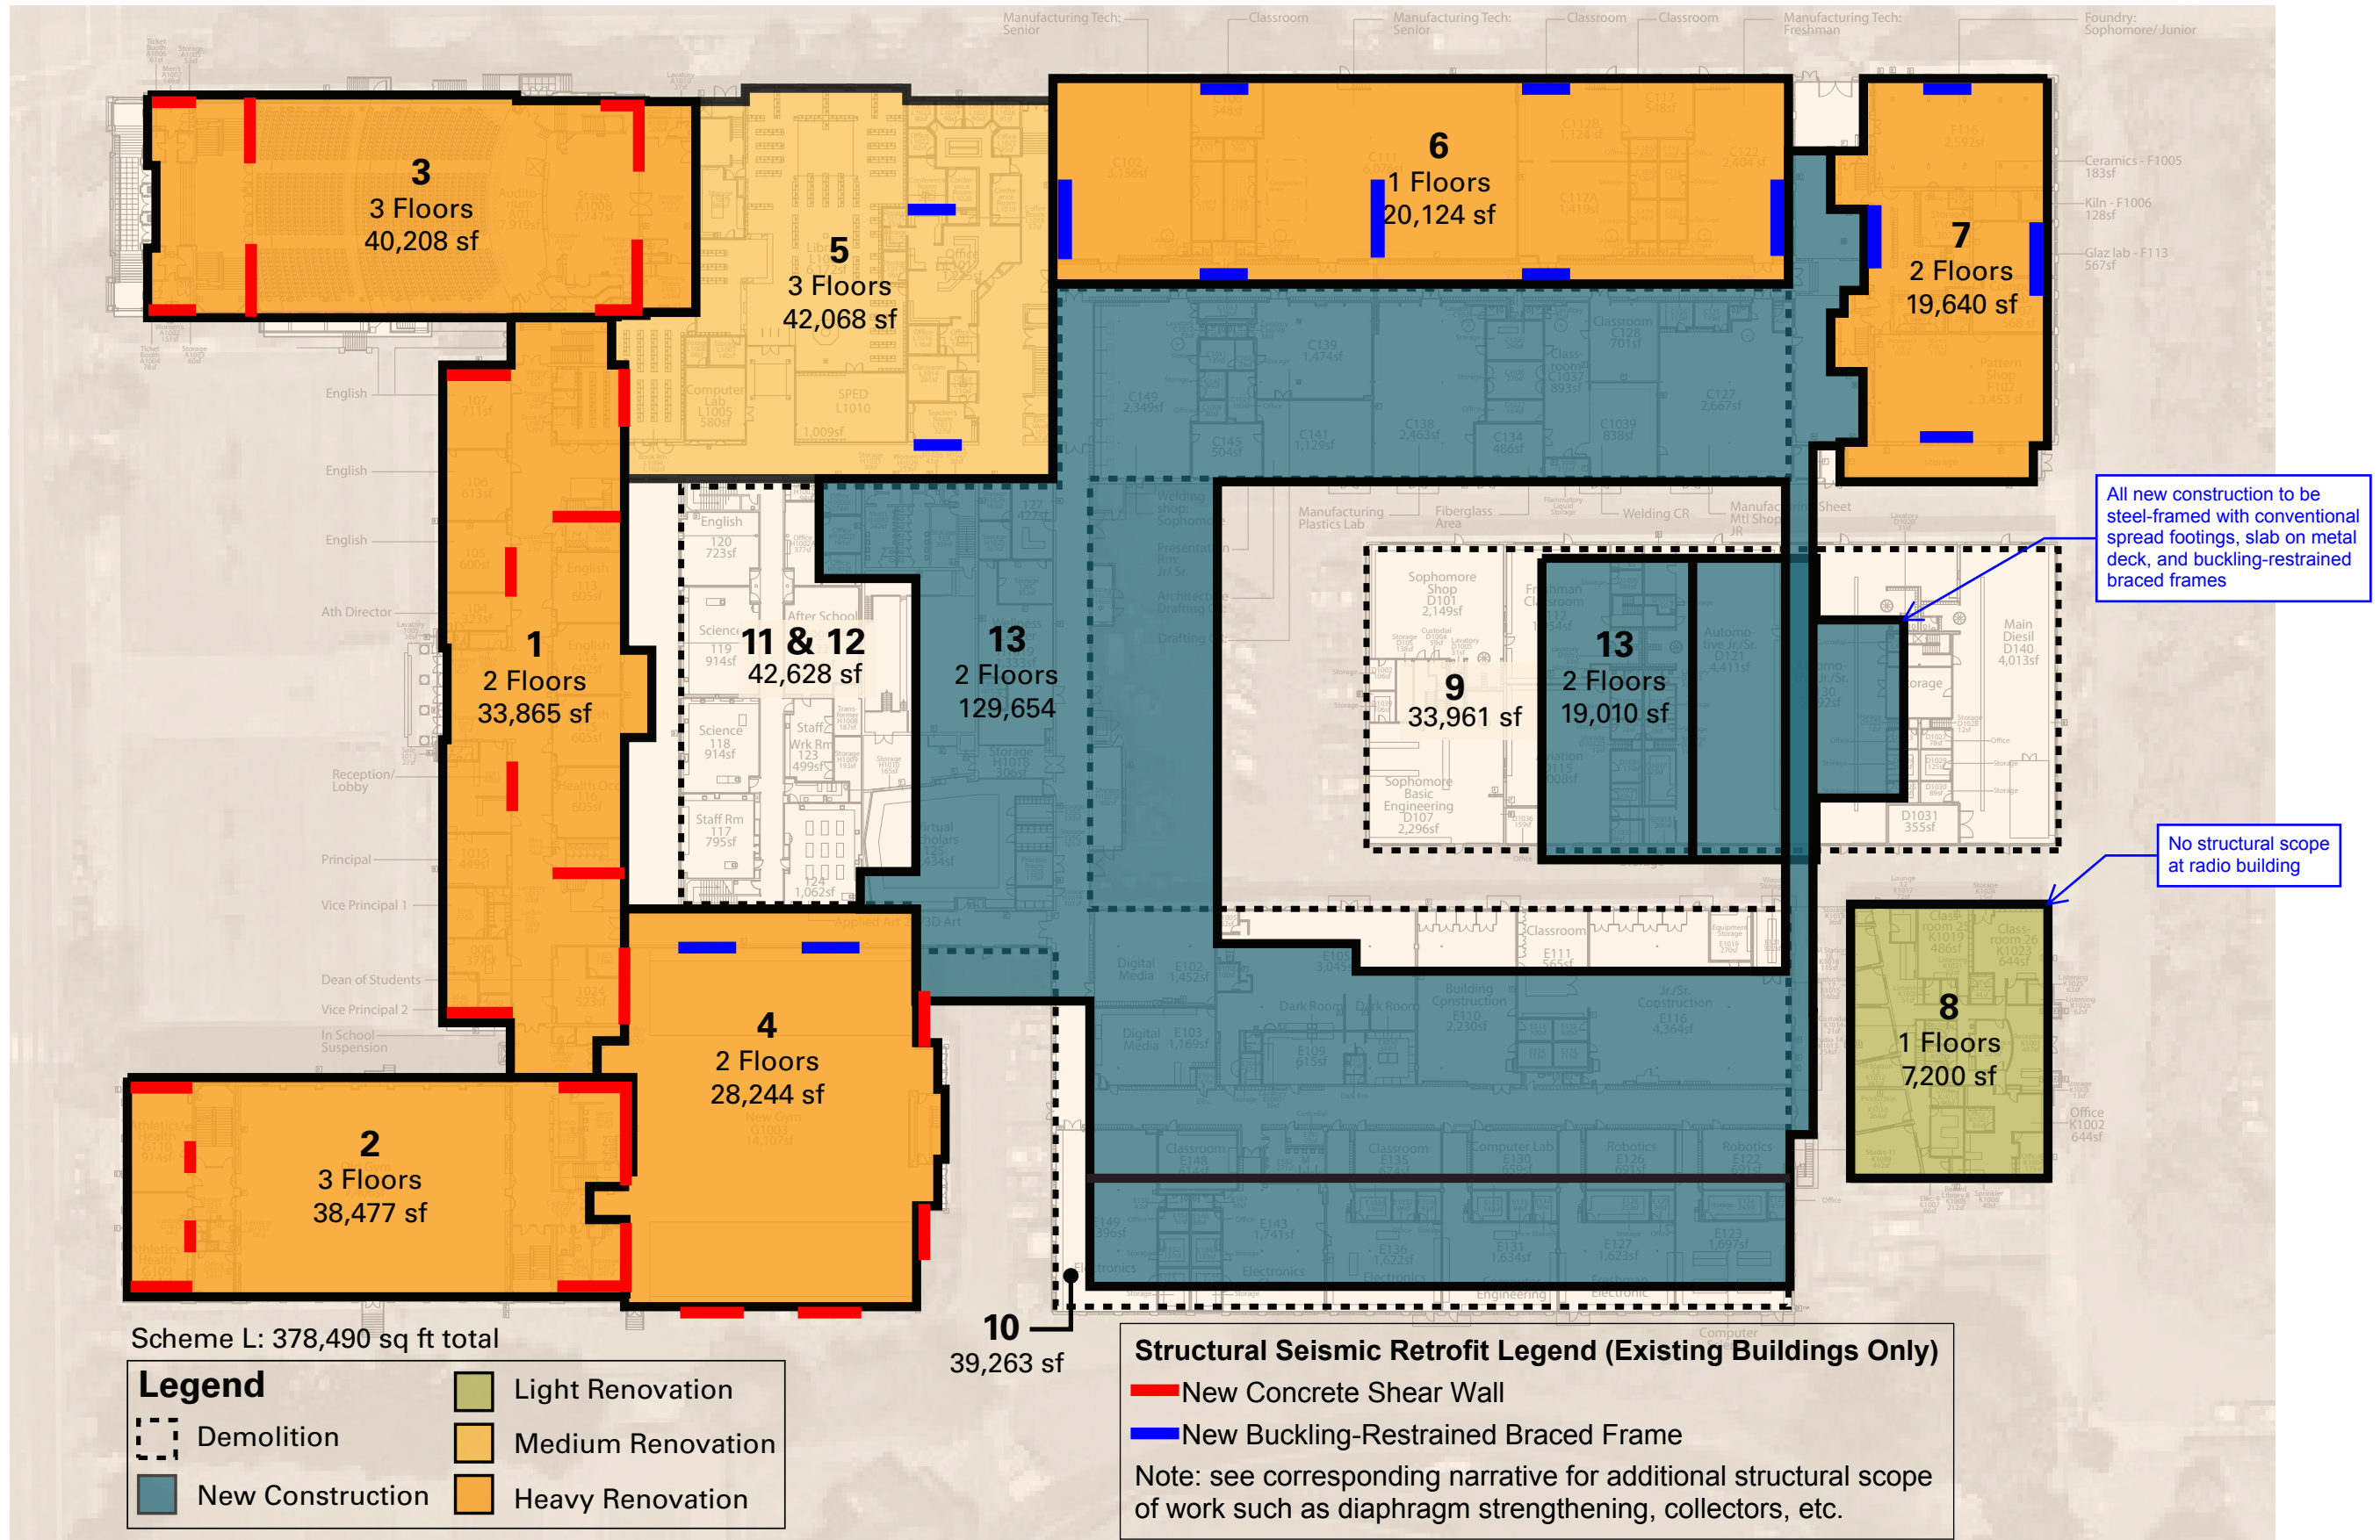
- Stairs (bidder-designed exist stairs and feature stairs)
- Seismic bracing for any remaining hollow clay tile partition walls
- Elevator guide rail supports and separator beams
- Elevator overruns
- Mechanical screens
- Mechanical equipment support
- Curbs
- Additional slab thickness or concrete toppings to accommodate radiant floor heating
- Slab reinforcing steel for exposed finishes
- Parapets
- Roof tie-off systems
- Backup steel for cladding systems
- Fire water tanks
- Site structures (canopies, trellis structures, site retaining walls, elevated walkways, etc.)
- Excavation shoring (by others)
- Construction means and methods items (e.g. tower crane support, material hoist supports)

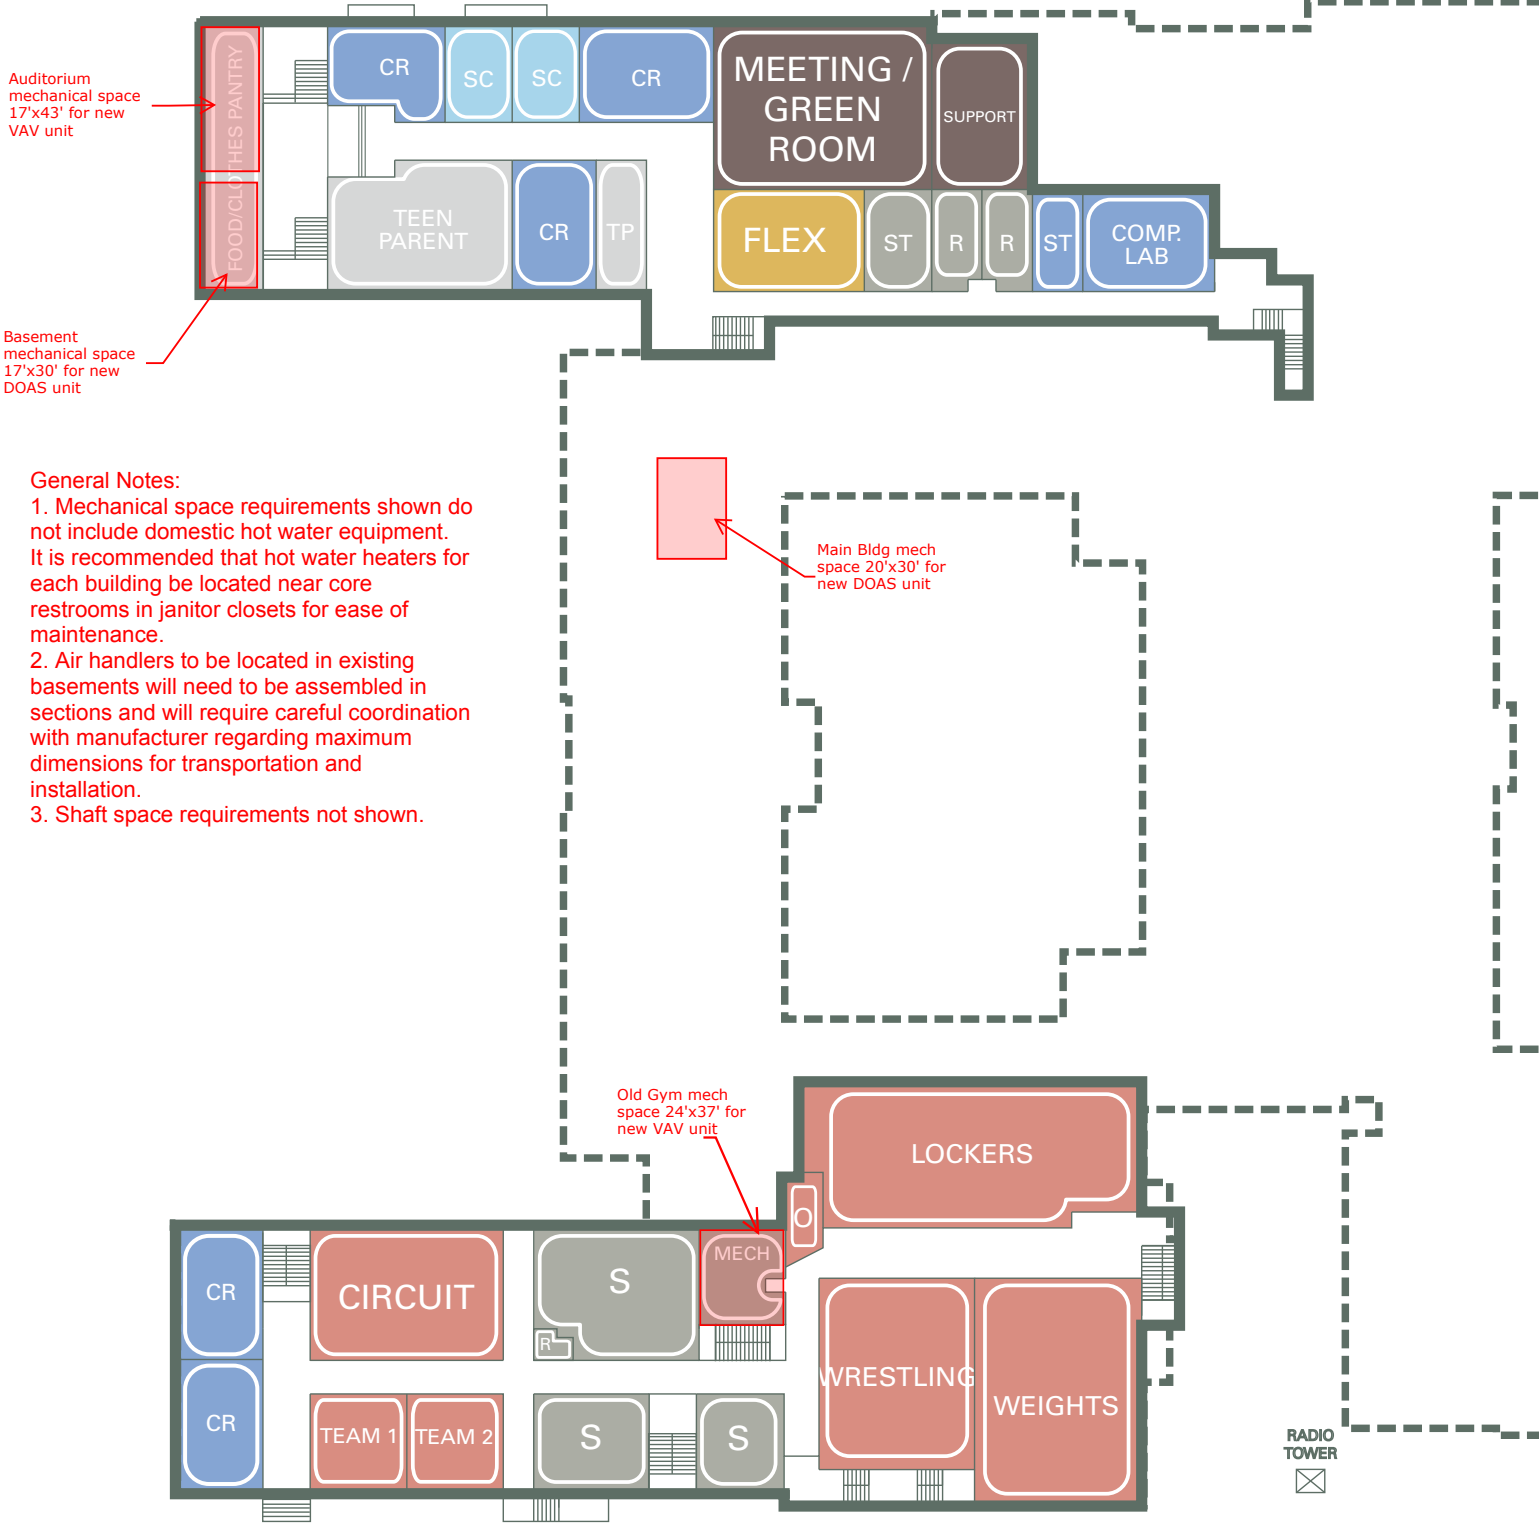
With new construction being proposed in several locations, multiple radon mitigation systems will be required. Radon mitigation systems are not required to be retroactively added to existing buildings. A radon mitigation system consists of a centralized exhaust fan with distributed sub grade perforated pipe.

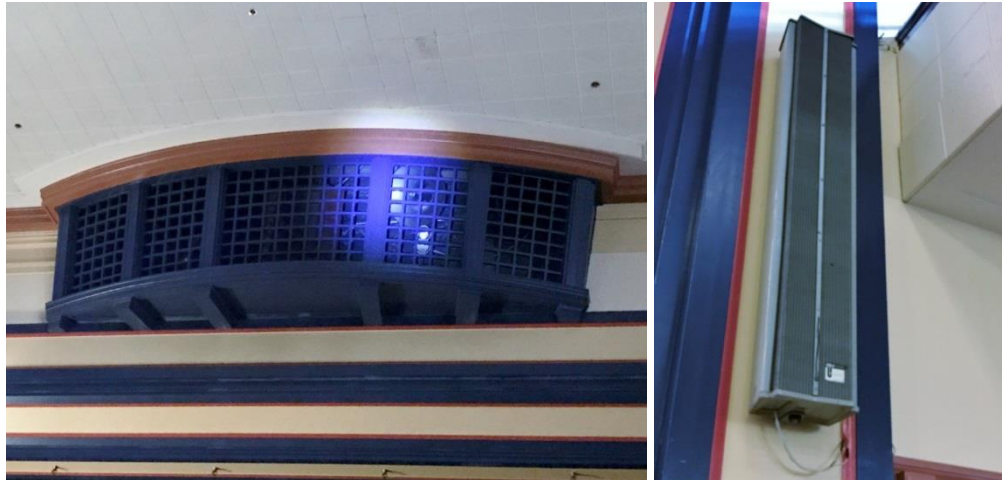
- Portable Speakers - Kustom brand speaker cabinets were found in storage behind the stage. These are not appropriate for permanent installations, but may be useful in portable applications.

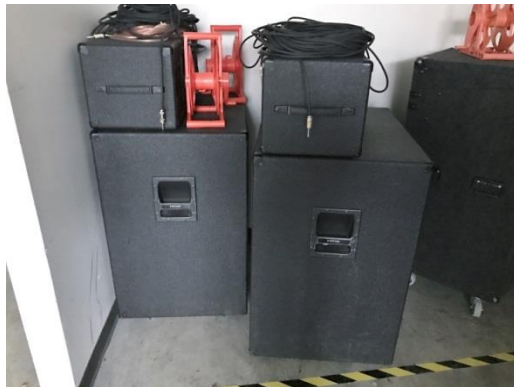
- Mackie 1402VLZ Mixer - This is a relative low-quality analog mixer unsuitable for a large space such as this. However, it may be repurposed for the Music Classroom, or for use as portable equipment.

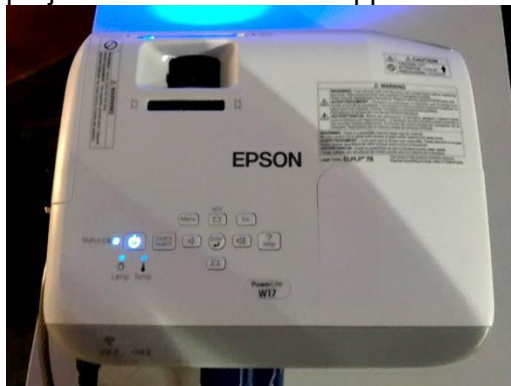
Performance of existing conditions

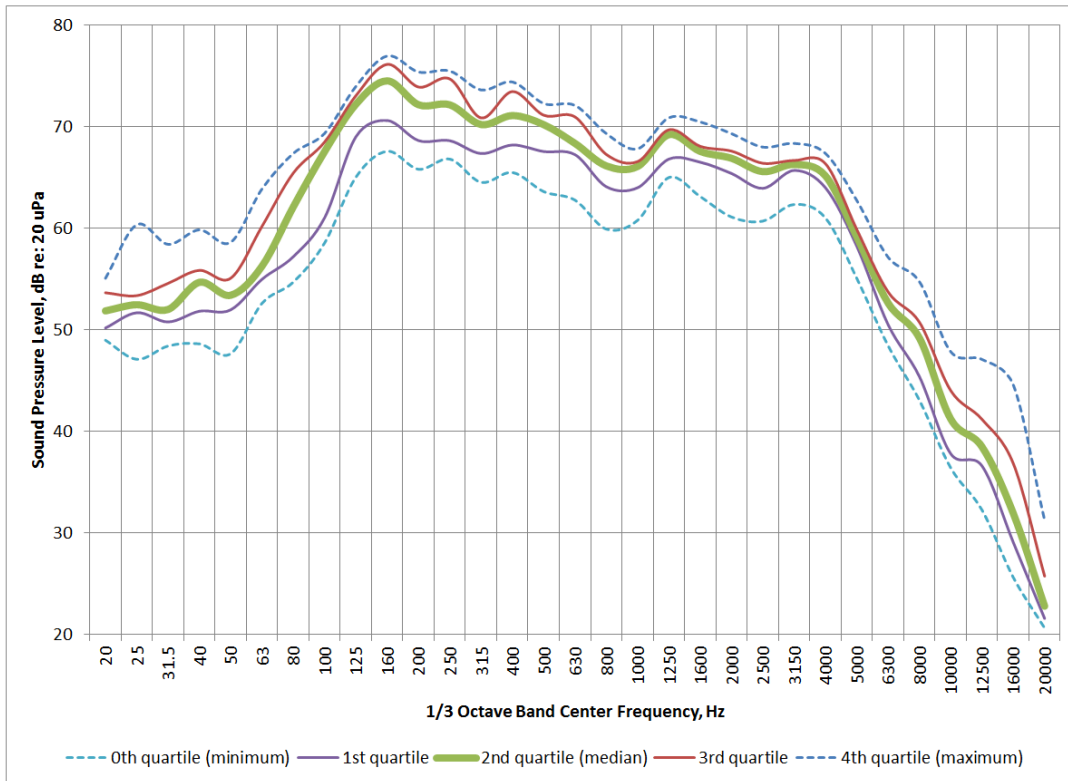
- The existing sound system was tested for speech intelligibility and coverage. The coverage was found to be poor (shown in the figure below), with high variability in sound levels at different seating locations, mostly due to a “split source” system (speakers flanking each side of the proscenium) resulting in severe phase cancellations along the centerline of the Auditorium. Speech intelligibility was also observed to be poor due to excessive reverberation at low frequencies.

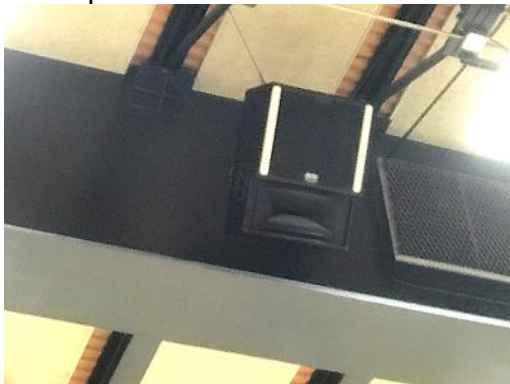
- Four speakers mounted in the rafters aimed at the bleachers.

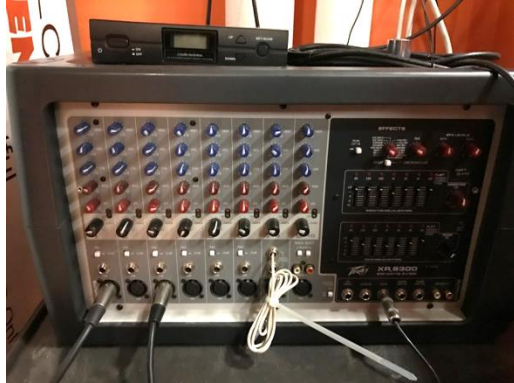
- Audio Technica ATW-R2100a1 with ATW-T702 handheld wireless microphones are antiquated and likely no longer compliant with FCC code.

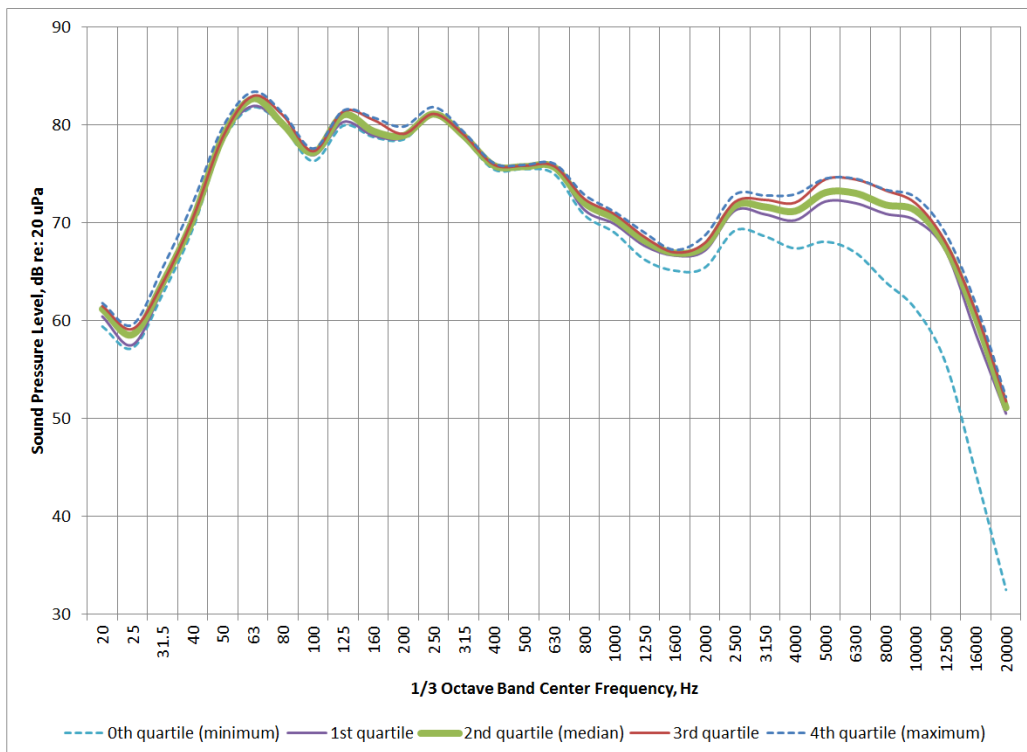
- The exiting sound system was tested for speech intelligibility and coverage. While the coverage was excellent (shown by consistent sound levels throughout the space in the figure below), the speech intelligibility rating was very poor due to excessive reverberation and low and mid frequencies.

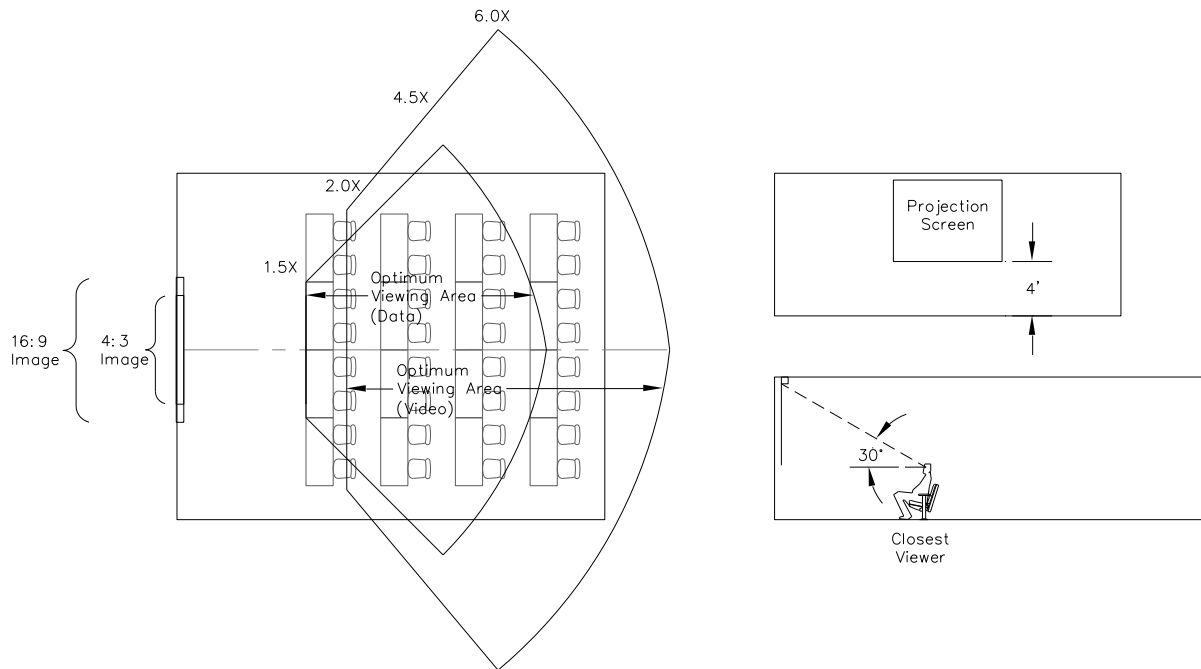
In some larger rooms, the screen size may be limited by the ceiling heights, resulting in the screen being somewhat smaller than it should be. However, viewing conditions should be optimized as much as practical within architectural limitations.

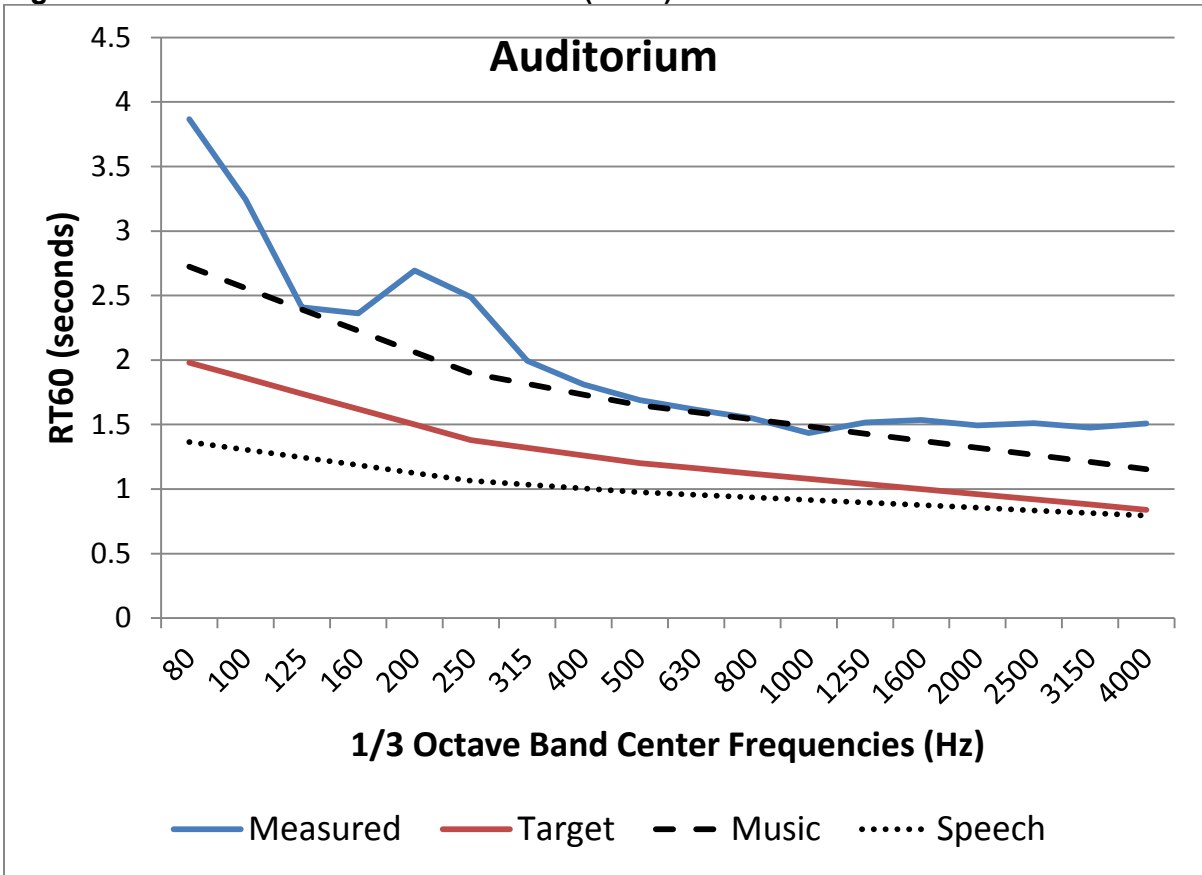
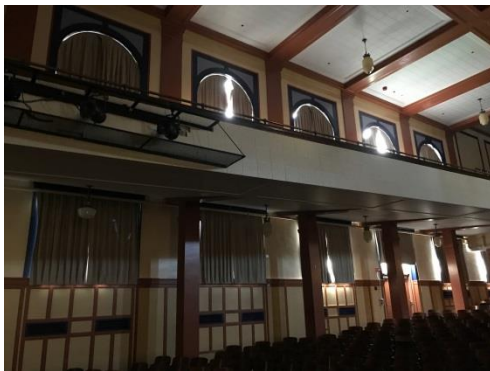
Wall and Window Treatments

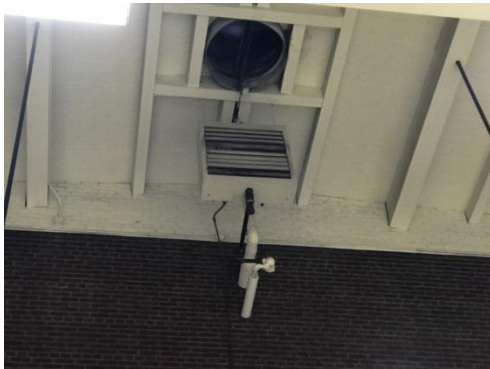
Noisy Mechanical Equipment

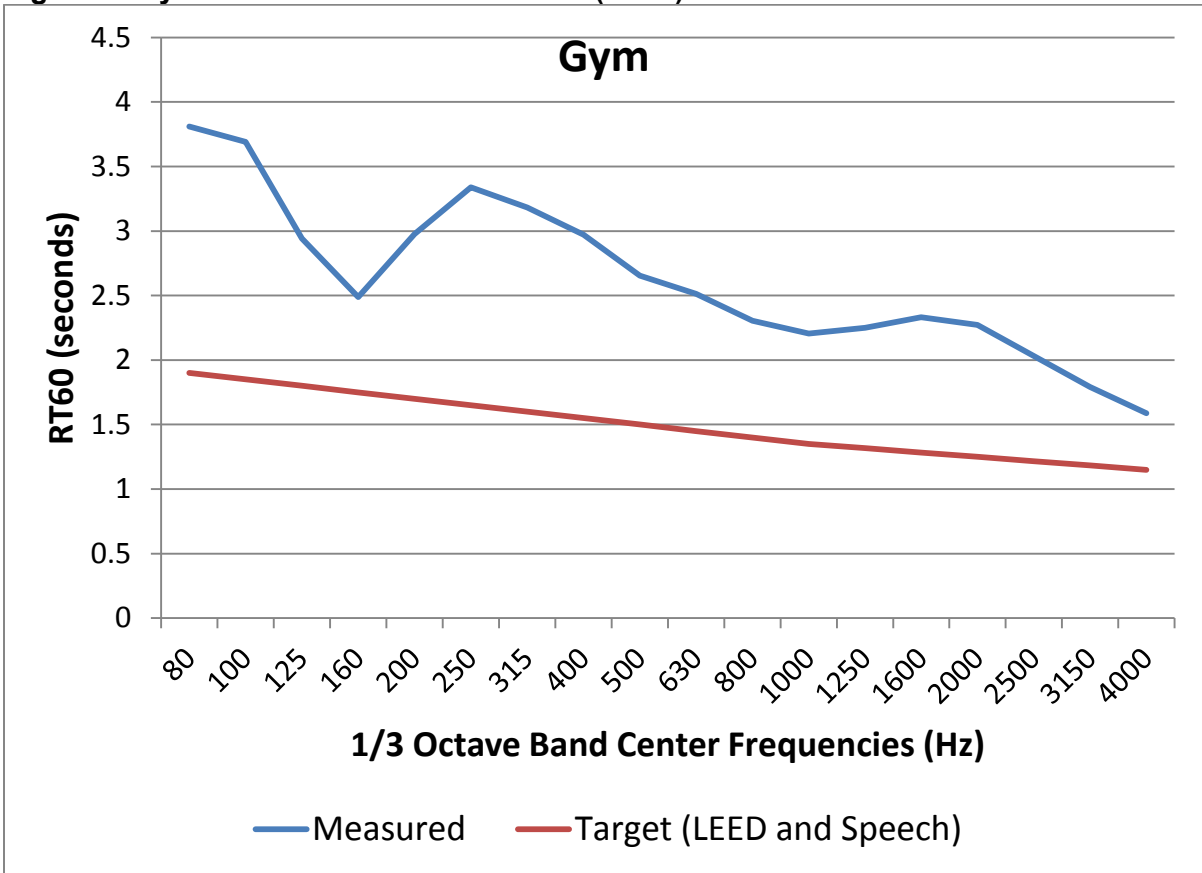
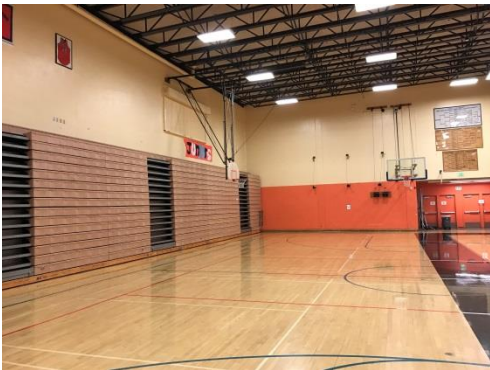
Figure 2: Gymnasium Reverberation Time (RT60)

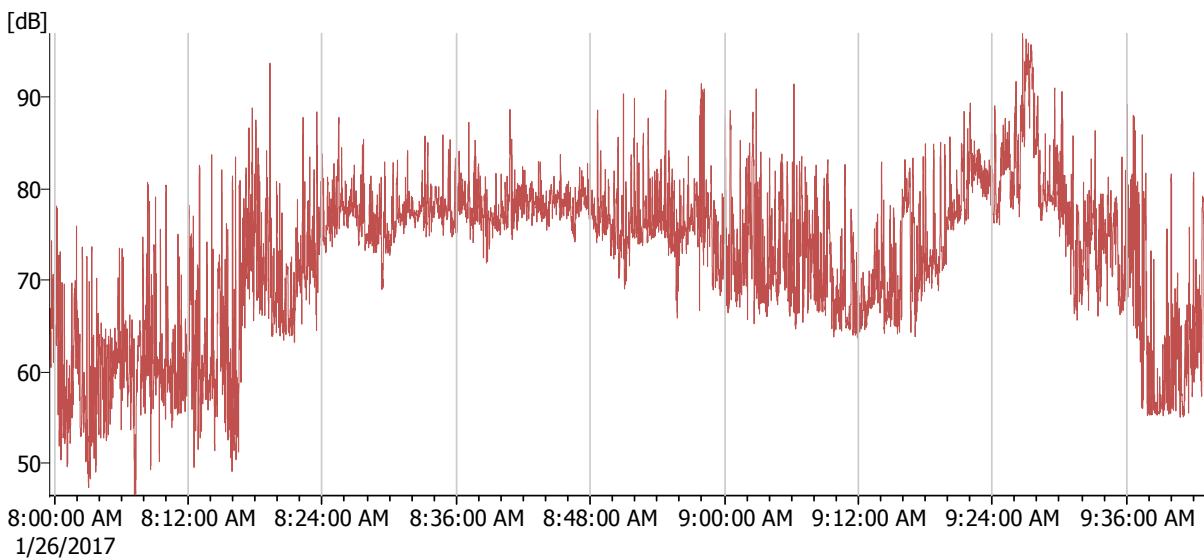
Sound isolation for other areas adjacent to shops will depend on the sound sensitivity of the area. Spaces with sensitivity similar to classrooms would need a similar level of sound isolation, double stud walls with 2 layers of gypsum board on each side, STC 65. Buffer spaces such as corridors, storage or utility rooms are very effective to isolate sound from noisy shop spaces. Doors into corridors should be acoustically rated, at least STC 45. Budget **\$5,000** for each acoustically rated door. Roll up doors at the Auto Shop should be located away from sound sensitive areas or spaces as roll up doors do not provide much acoustical isolation. If sound sensitive spaces cannot be located away from these doors consider large acoustically rated sliding doors, or a pair of roll up doors.

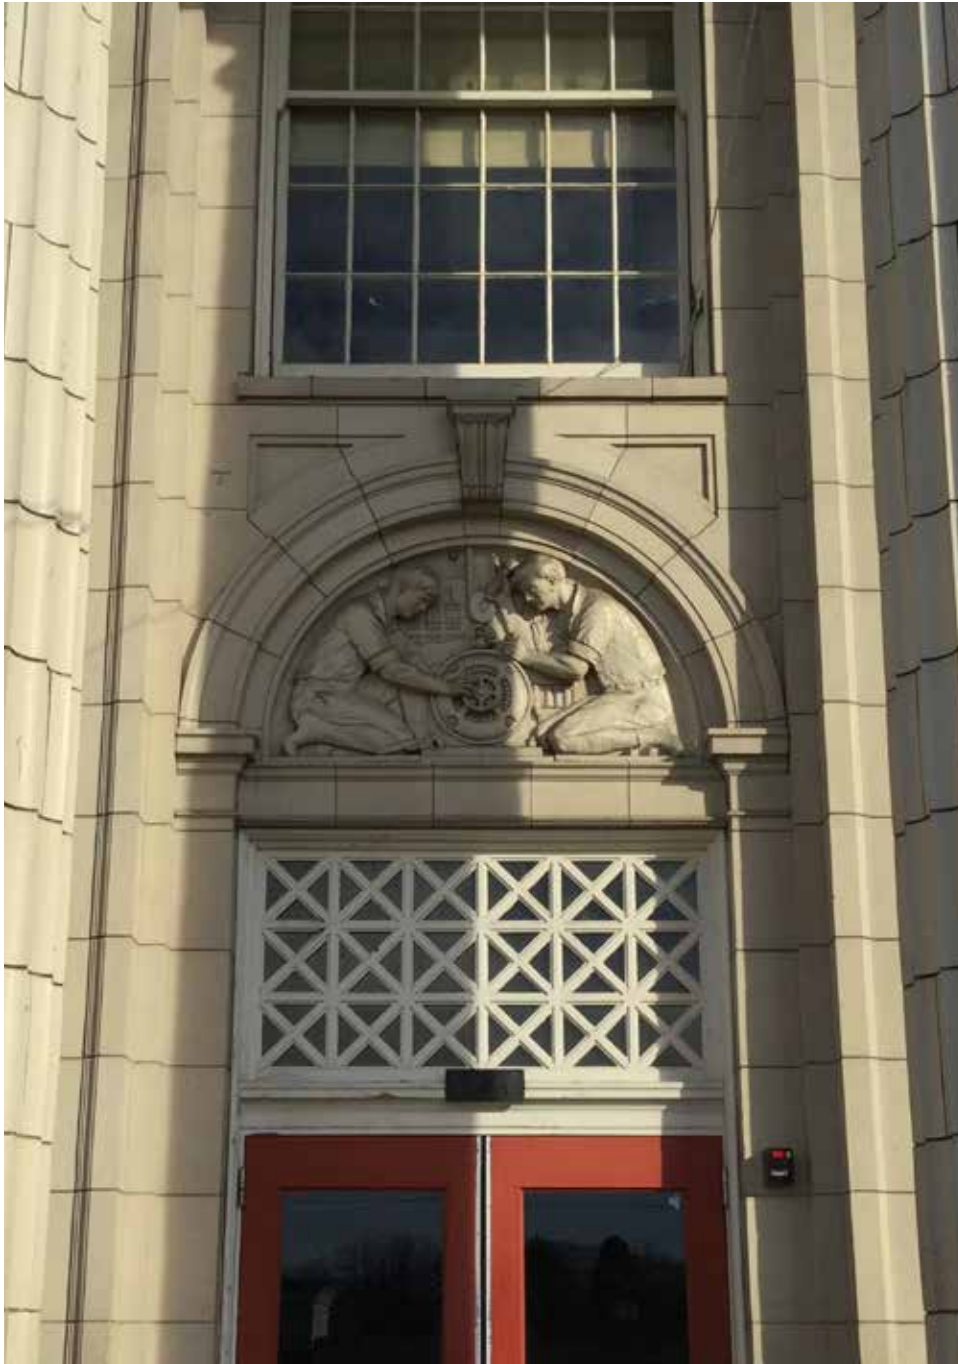
CATEGORIES (...continued)

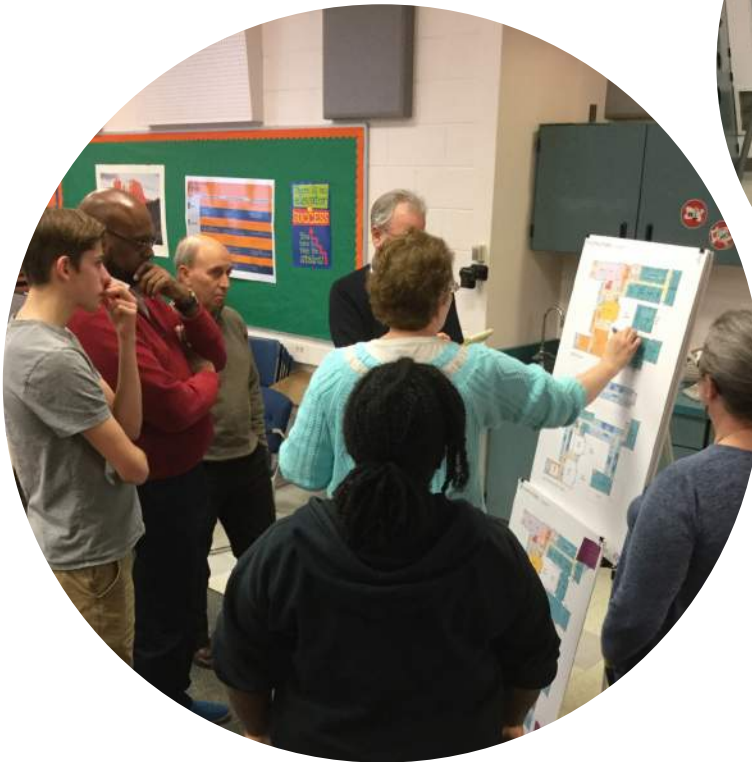
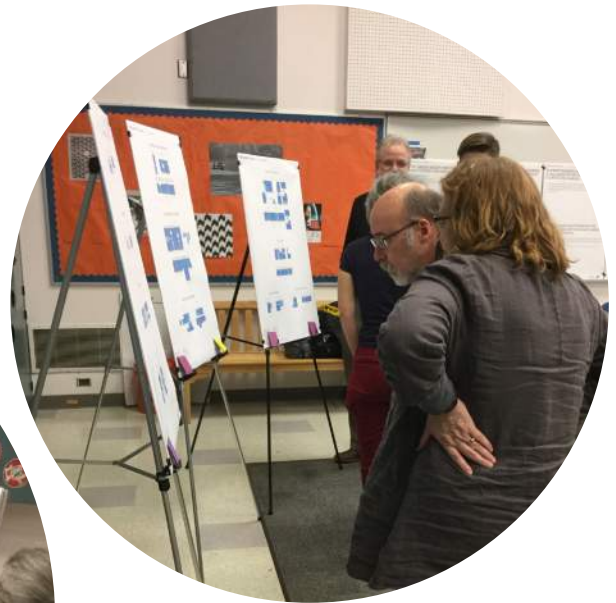
GUIDING PRINCIPLES SUMMARY

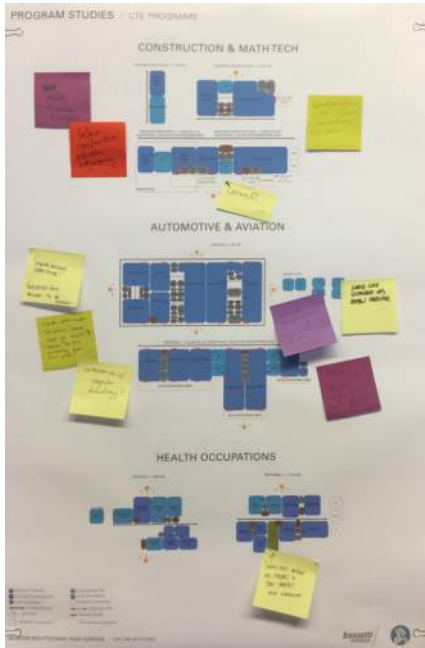
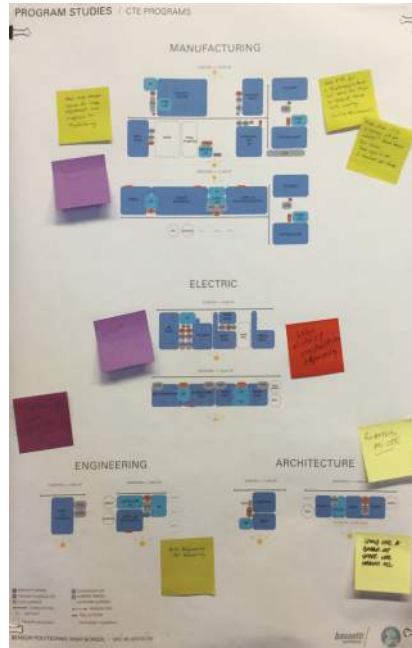
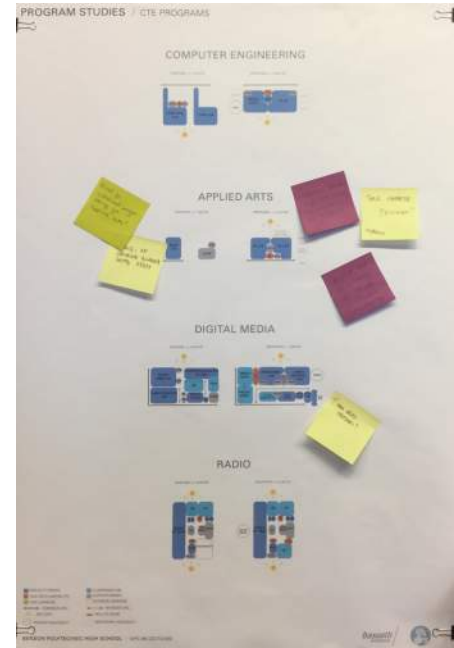
Construction & Math Tech

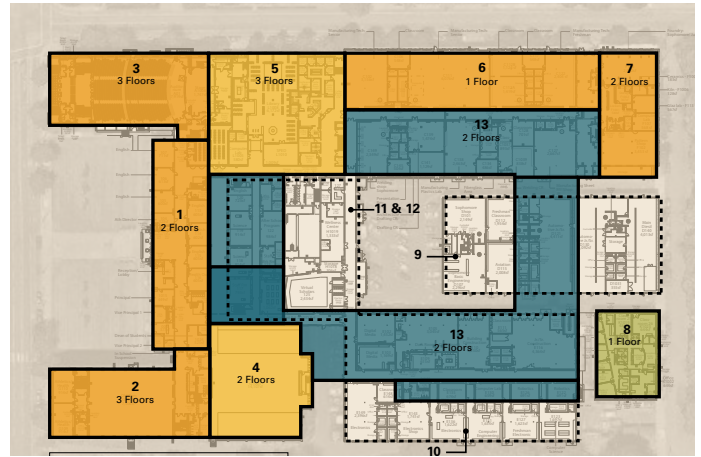
- + Variation on option "D" from masterplan
- + Commons to the west off of the historic entry
- + Central courtyard opens to the south
- + Service from the courtyard and east side
- + Two story U-addition above shops
- + Preserve North shops, demo South shops
- + Preserve Foundry and Radio buildings

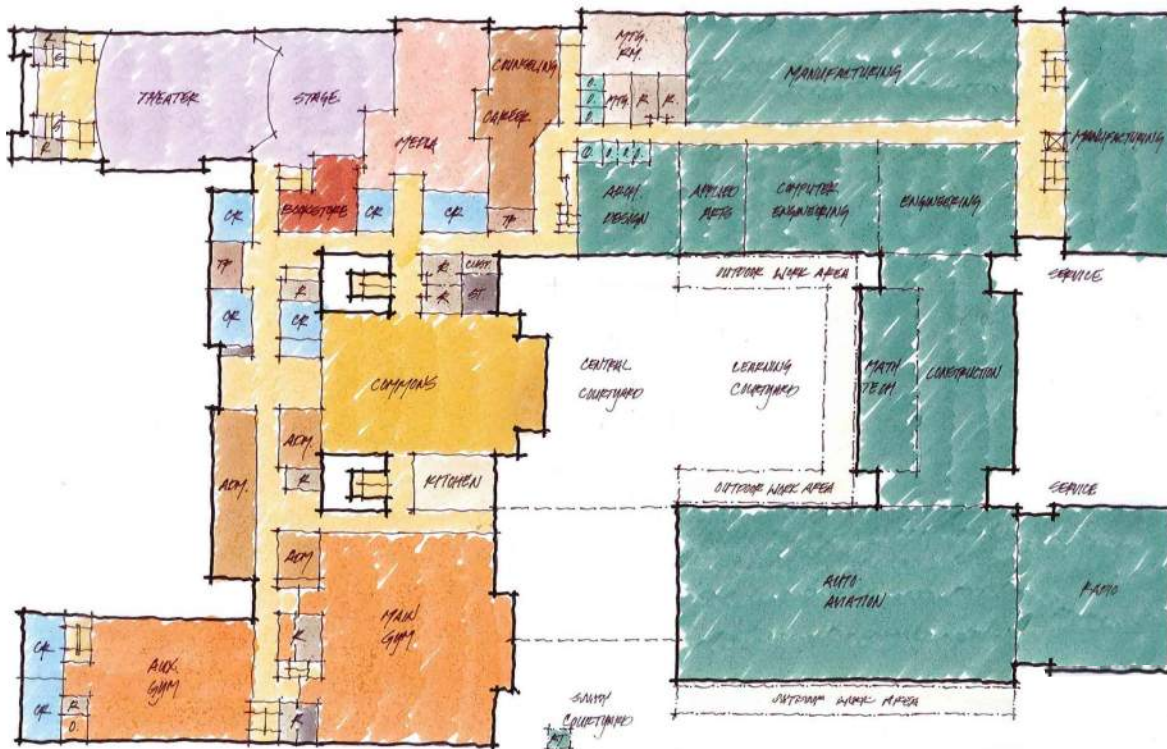
- + Engineering has no access to daylight
- + Welding/manufacturing needs direct access for big projects
- + Maintain integrity of lobby
- + Being able to have internal circulation continue as a full loop, through electrical, would be preferred, if able to also accommodate Electrical's CTE program needs
- + Digital Media should be by Radio, not above the foundry, too loud
- + Digital Media and Radio should be adjacent to Applied Arts
- + Architecture wants to be directly adjacent to construction
- + Electric on the second floor could be challenging with material deliveries and supplies
- + Go around historic lobby to enter commons.

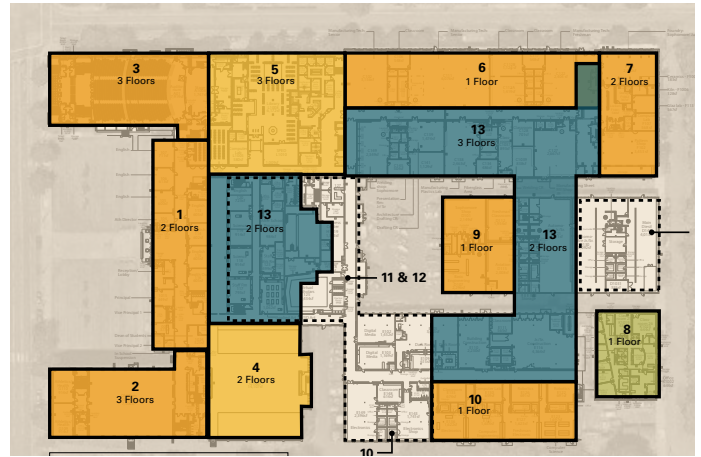
- + Variation on option "A" from masterplan
- + Commons to the west off of the historic entry
- + Central courtyard opens to the south
- + Service from the courtyard and east side
- + Preserve North shops, Foundry, Radio, portion of Automotive, and South shops
- + Three story addition over North shops
- + Two story addition over Automotive and South shops

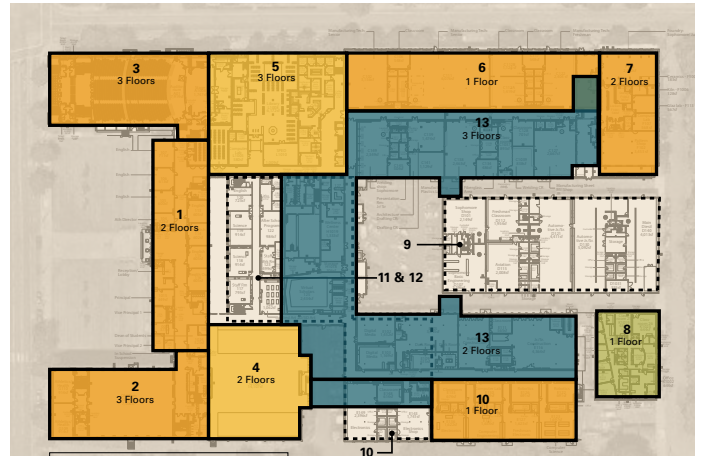
- + New variation
- + Restores East side of 1916 building, adding more daylight
- + Commons facing south courtyard and east courtyard
- + Multiple courtyards
- + Preserve North and South shops, Foundry, and Radio. Demolish Automotive building
- + Two story addition over South shops
- + Three story addition over North shops

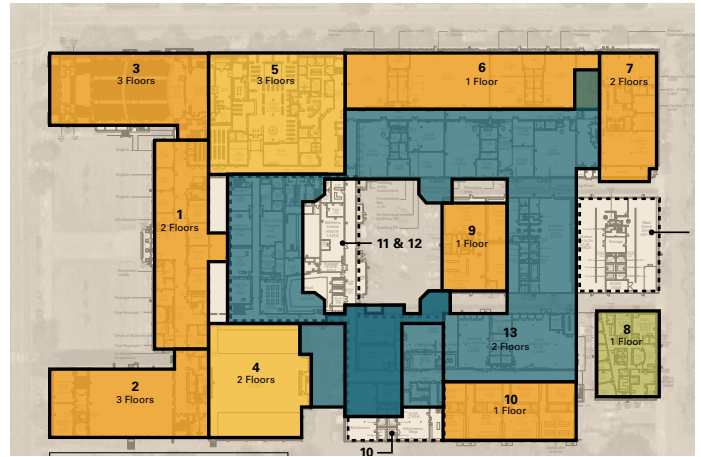
- + Variation on option "D" from masterplan
- + Commons face North and South
- + Central courtyard
- + Preserve North wing, portion of South wing and Automotive, Foundry, and Radio
- + Two story square-shape addition

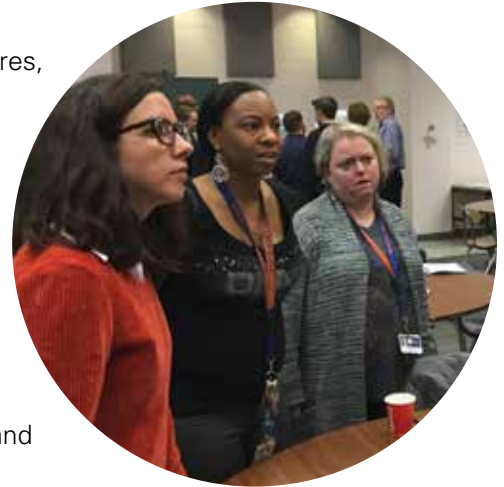
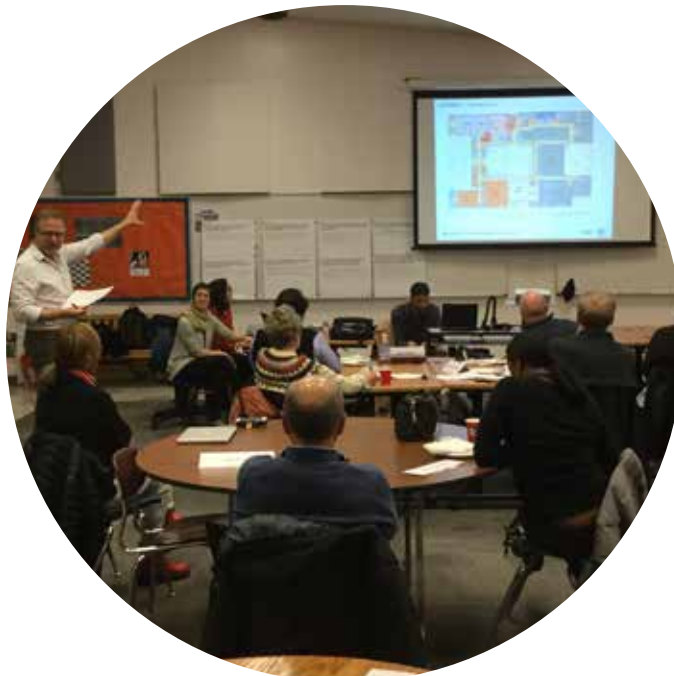
Jen met with Portland Parks and Rec staff to review master plan, survey, parking lot & field use and school connection to field. Part of the parking along the south driveway is not on PPS property.

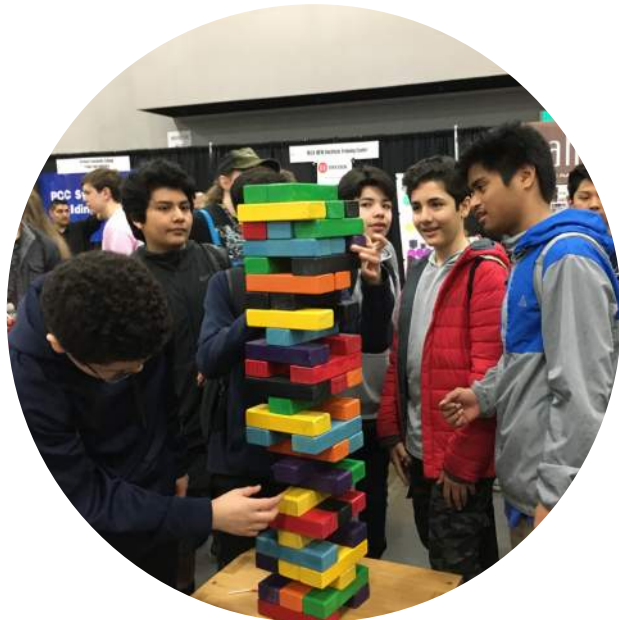
- + Key Meetings:
 - + Portland Bureau of Transportation (PBOT)
 - + Portland Landmarks Commission
 - + Portland Bureau of Development Services
- + Existing Conditions Investigation
 - + Phase II Environmental Report
 - + Geotechnical Testing
 - + Structural Testing
 - + Traffic Impact Report
- + Educational Specification Refinement
- + Student Facebook Survey

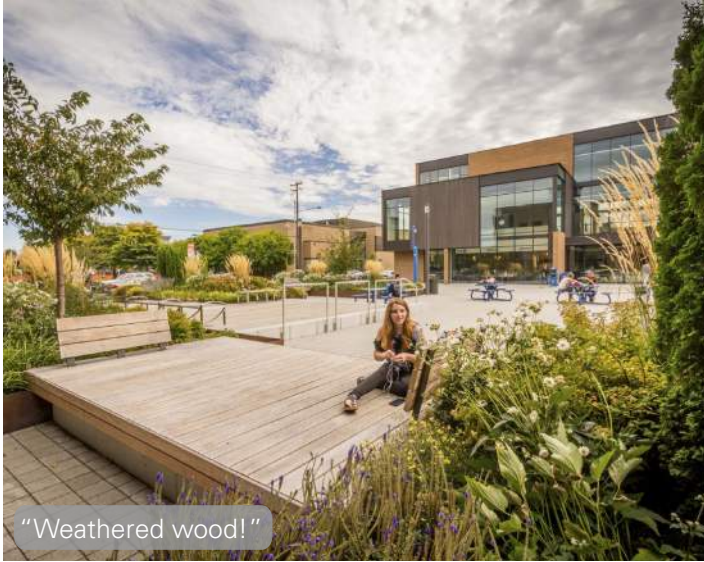
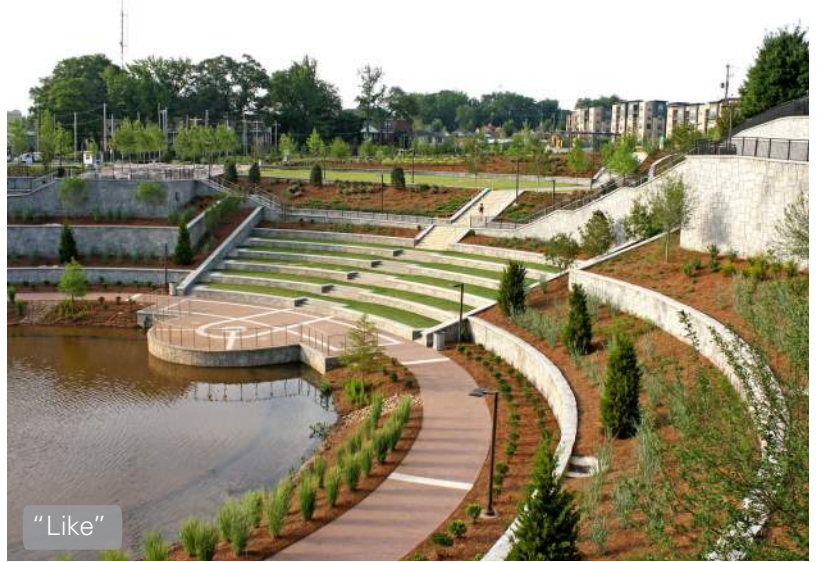
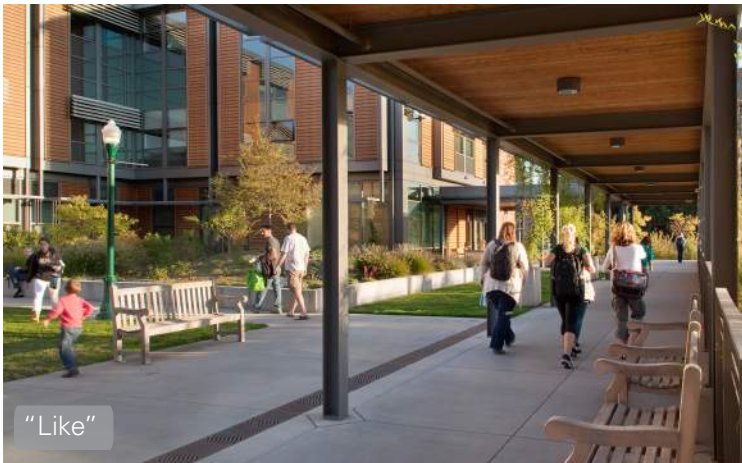
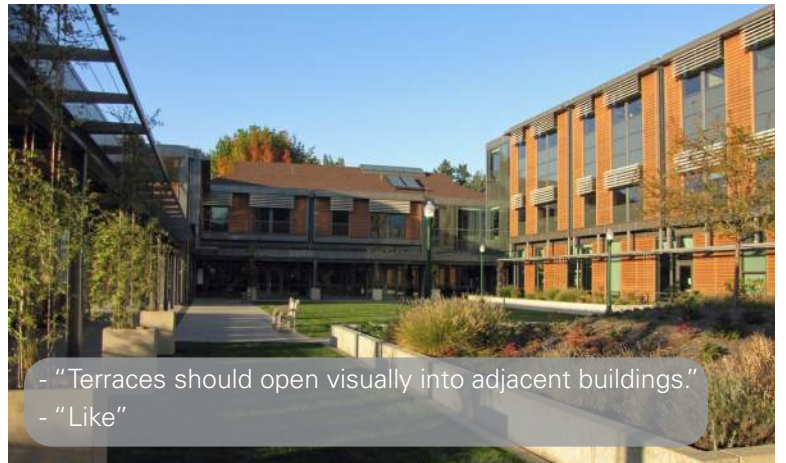
- + Incorporate water and plant life into the landscape and integrate it with the building
- + The building should reflect a strong image of sustainability and act as a billboard for a new way of thinking
