Pre-Design Diligence Report
Benson Polytechnic High School
June 12, 2017

TABLE OF CONTENTS

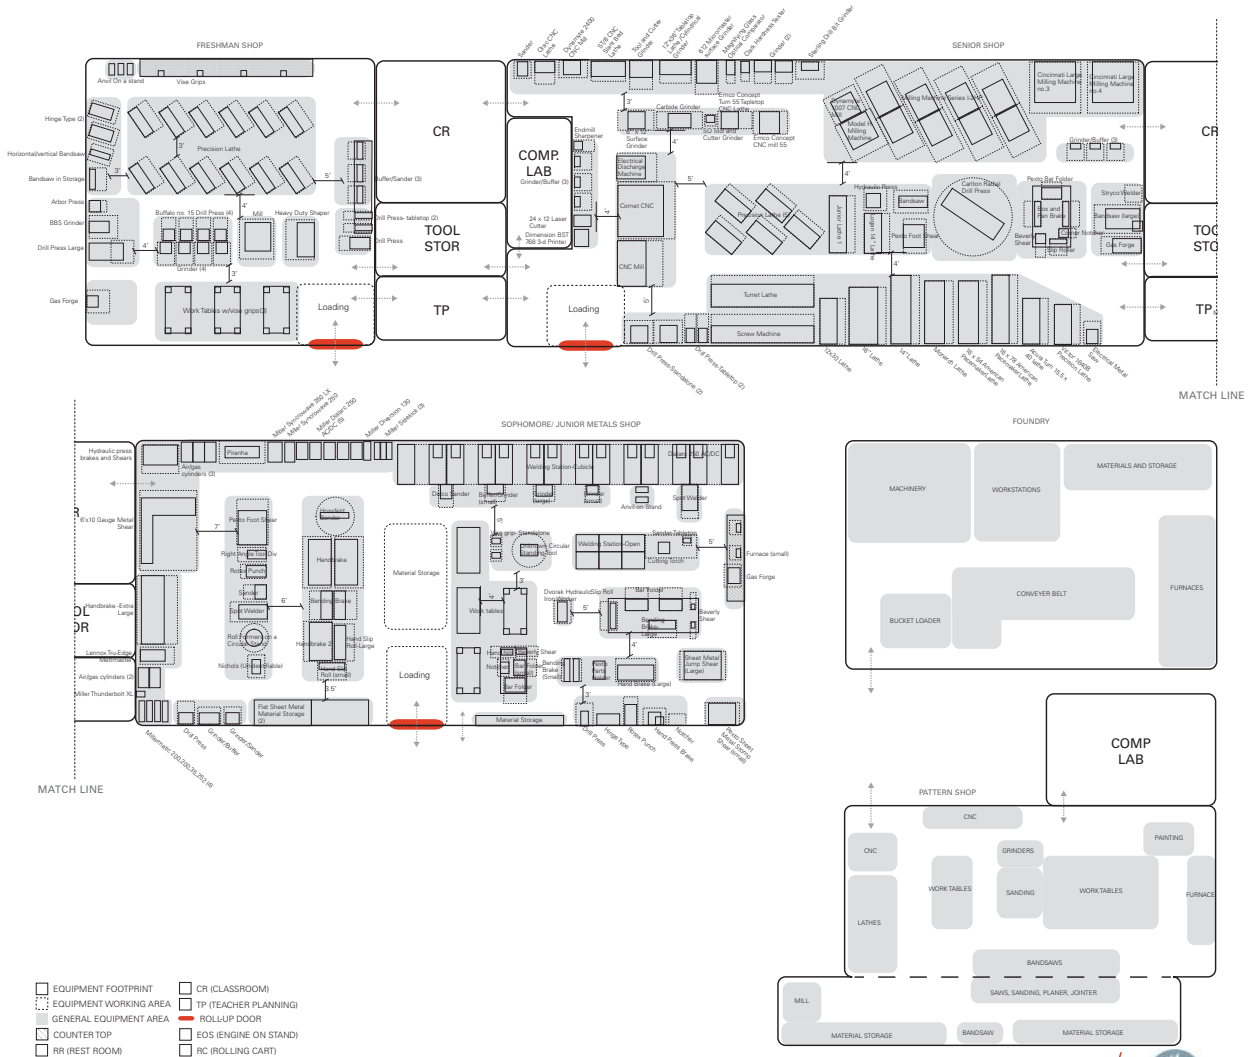
- + 3D Printing
- + Prosthetic Limbs
- +
