Regarding: Lead Paint Condition Assessment
Irvington Elementary School
1320 NE Brazee Street
Portland, Oregon 97212
PBS Project: 6500.721 Phase 0025

Irvington Elementary School
Assessment of Paint/Varnish in Deteriorated Condition

Irvington Elementary School 1320 NE Brazee 97212 Facility Plan

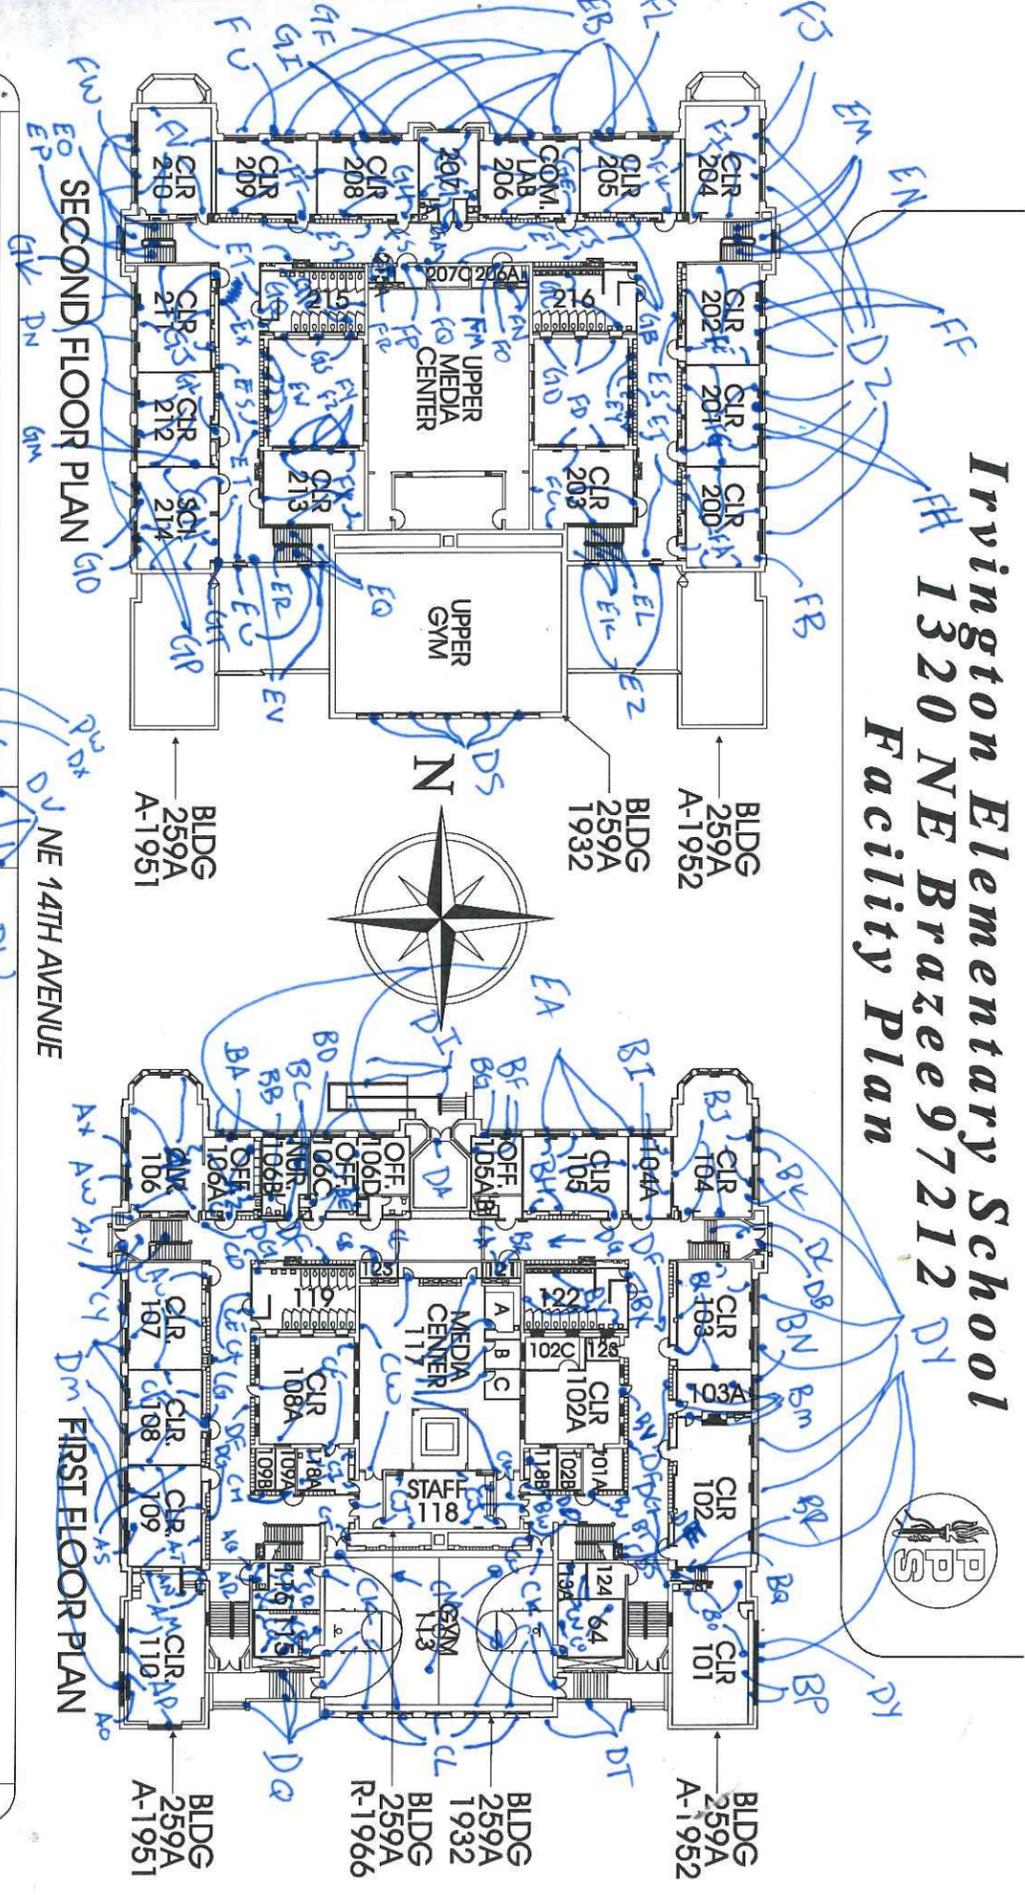
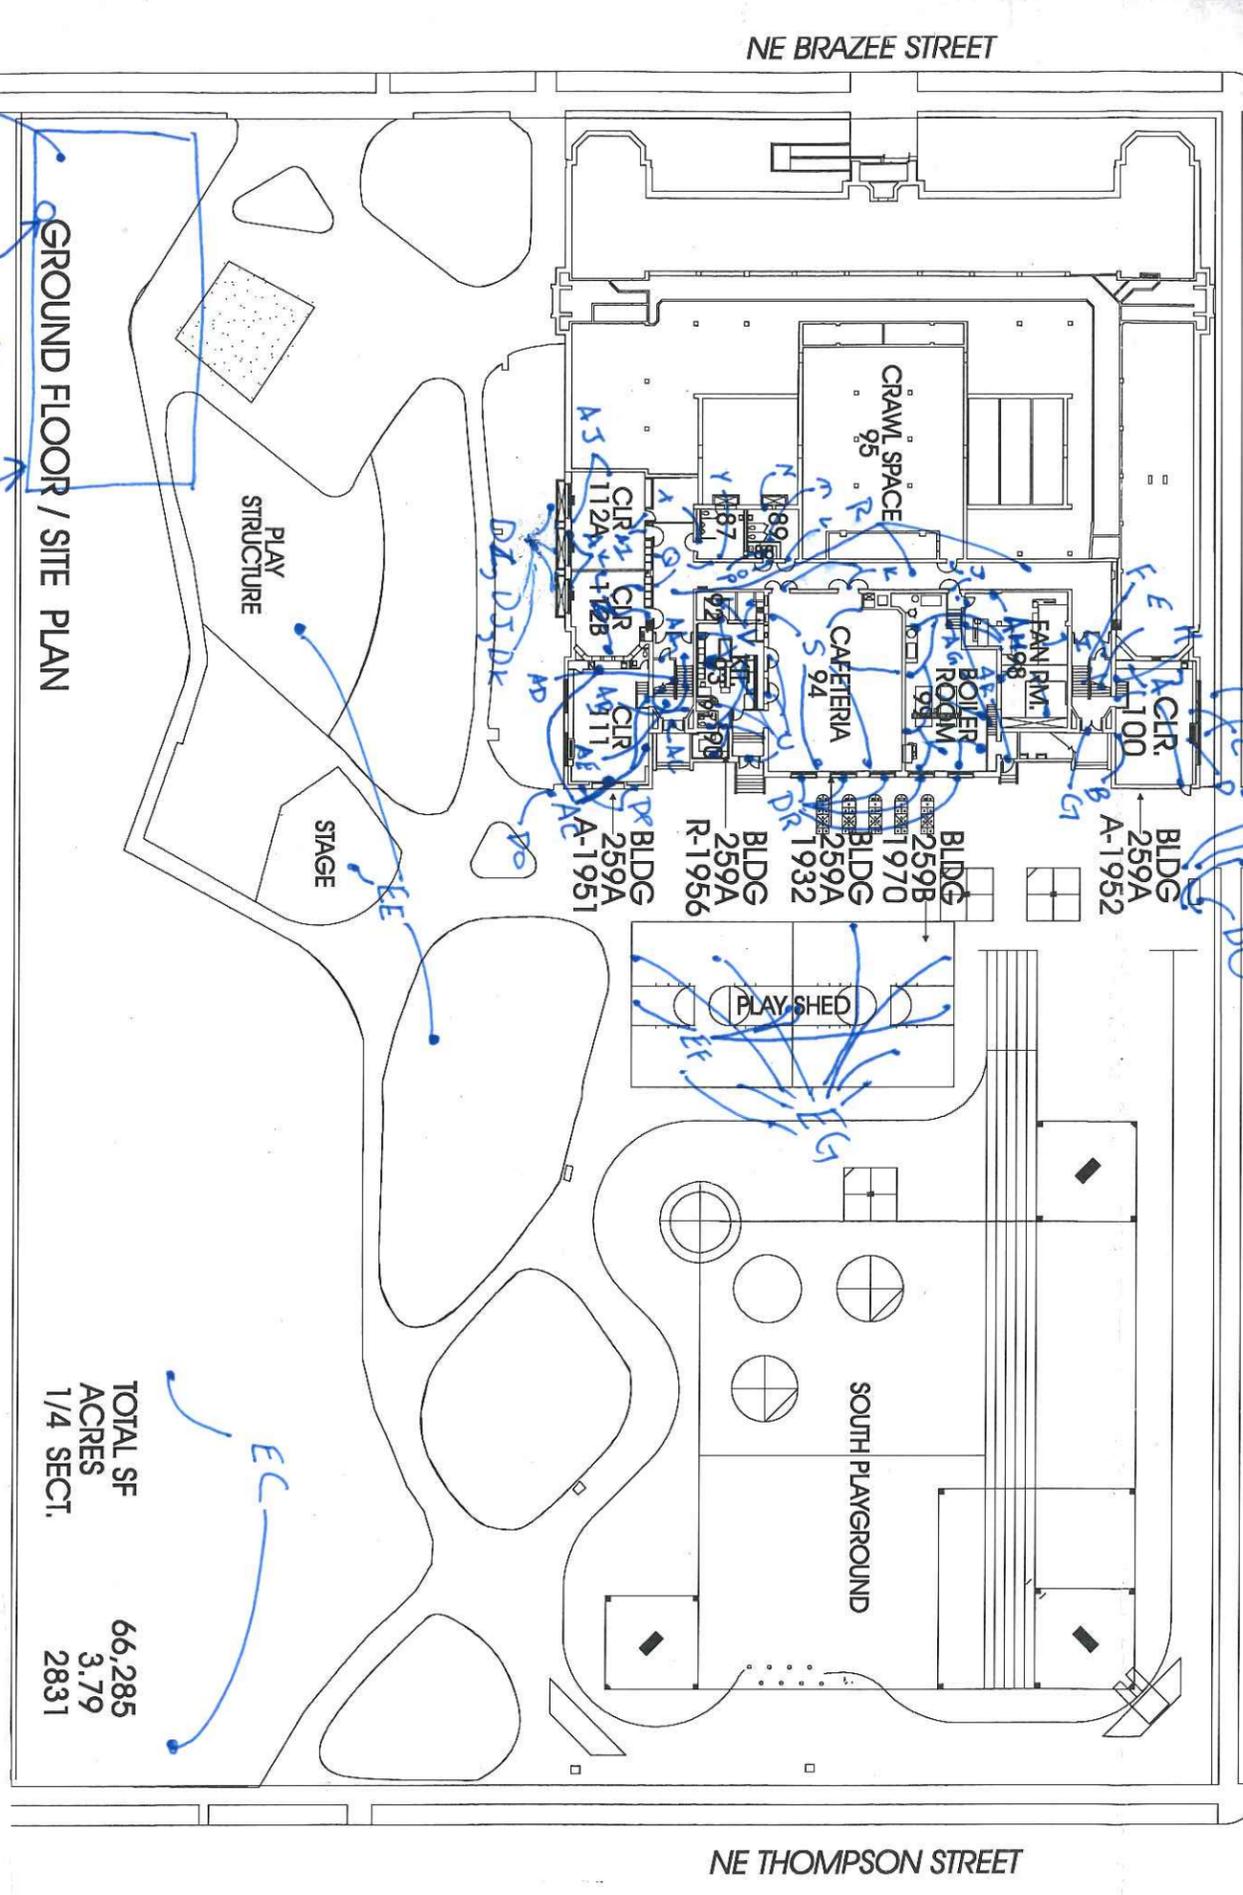
EH
EI
EJ
E3 } Third Floor Loft,
Fan Tower
(Not on Drawing)
