February 8, 2017

Regarding: Lead Paint Condition Assessment
Lewis Elementary School
4401 SE Evergreen Street
Portland, Oregon 97206
PBS Project: 6500.721 Phase 0032

Lewis Elementary School
Assessment of Paint/Varnish in Deteriorated Condition

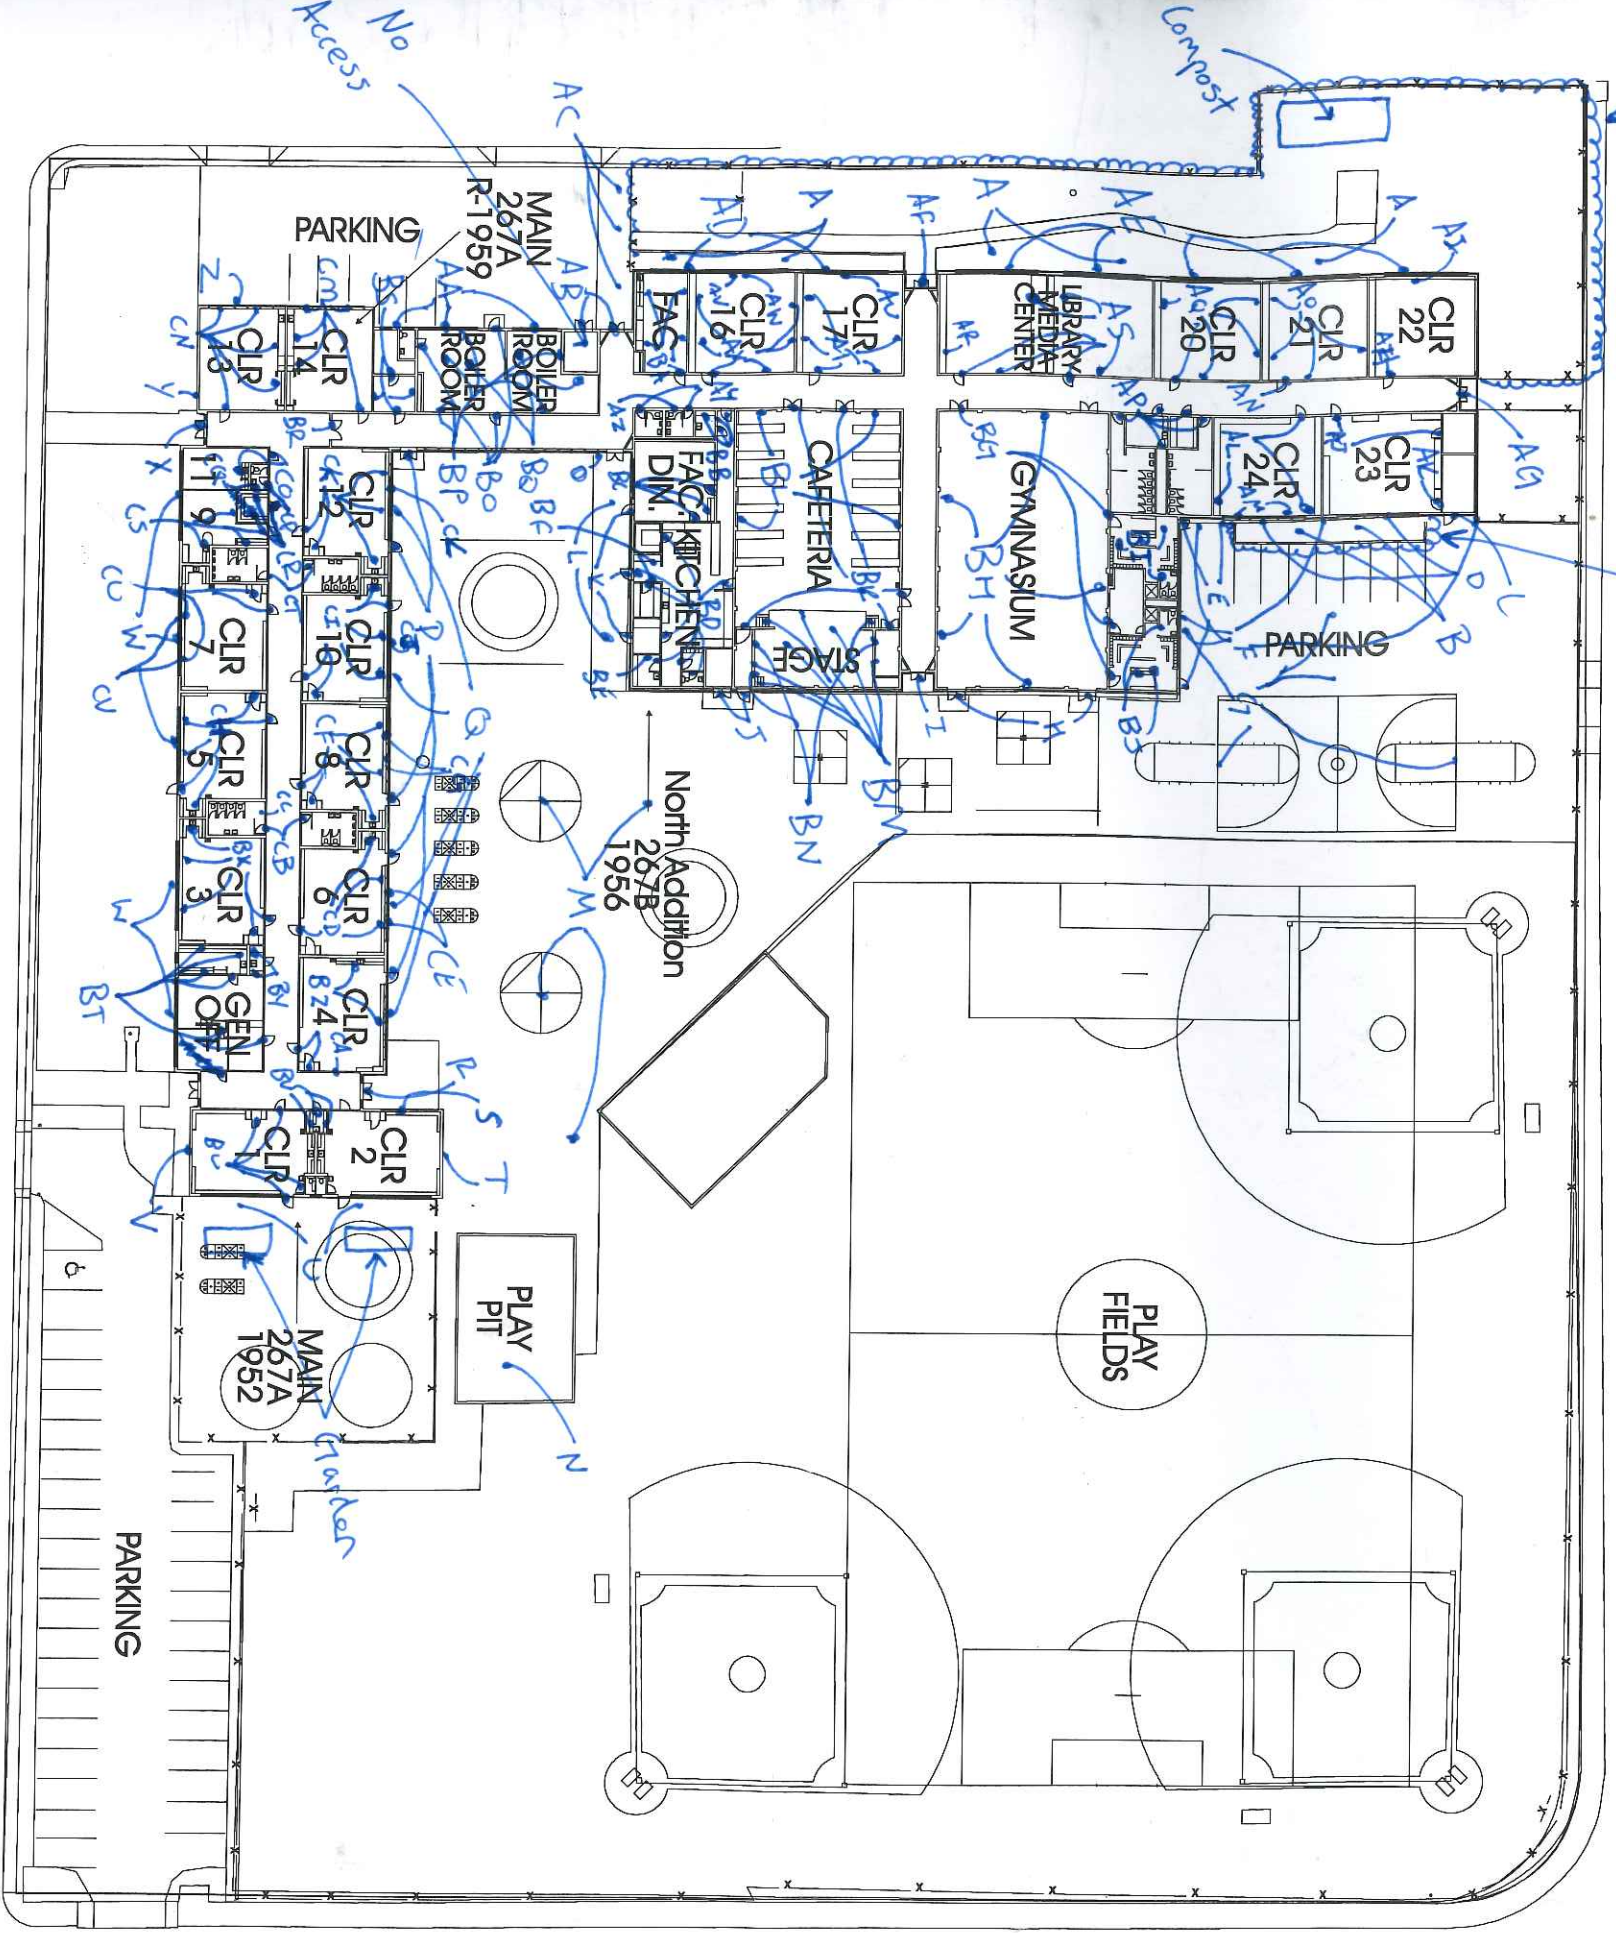
Lewis Elementary School
4401 SE Evergreen 97206
Facility Plan

Overall, the building's interior painted and varnished surfaces were found to be in intact condition, with exterior surfaces in deteriorated condition. A table listing the locations and quantity of surfaces in deteriorated condition is attached to this report.

PBS recommends that all painted or varnished surfaces in deteriorated condition noted on the attached table be stabilized. All paint chips should be removed. Paint chips and dust should be removed from the wood window troughs.
