Regarding: Lead Paint Condition Assessment
Marshall High School
3905 SE 91st Avenue
Portland, Oregon 97266
PBS Project: 6500.721 Phase 0074

Marshall High School
Assessment of Paint/Varnish in Deteriorated Condition

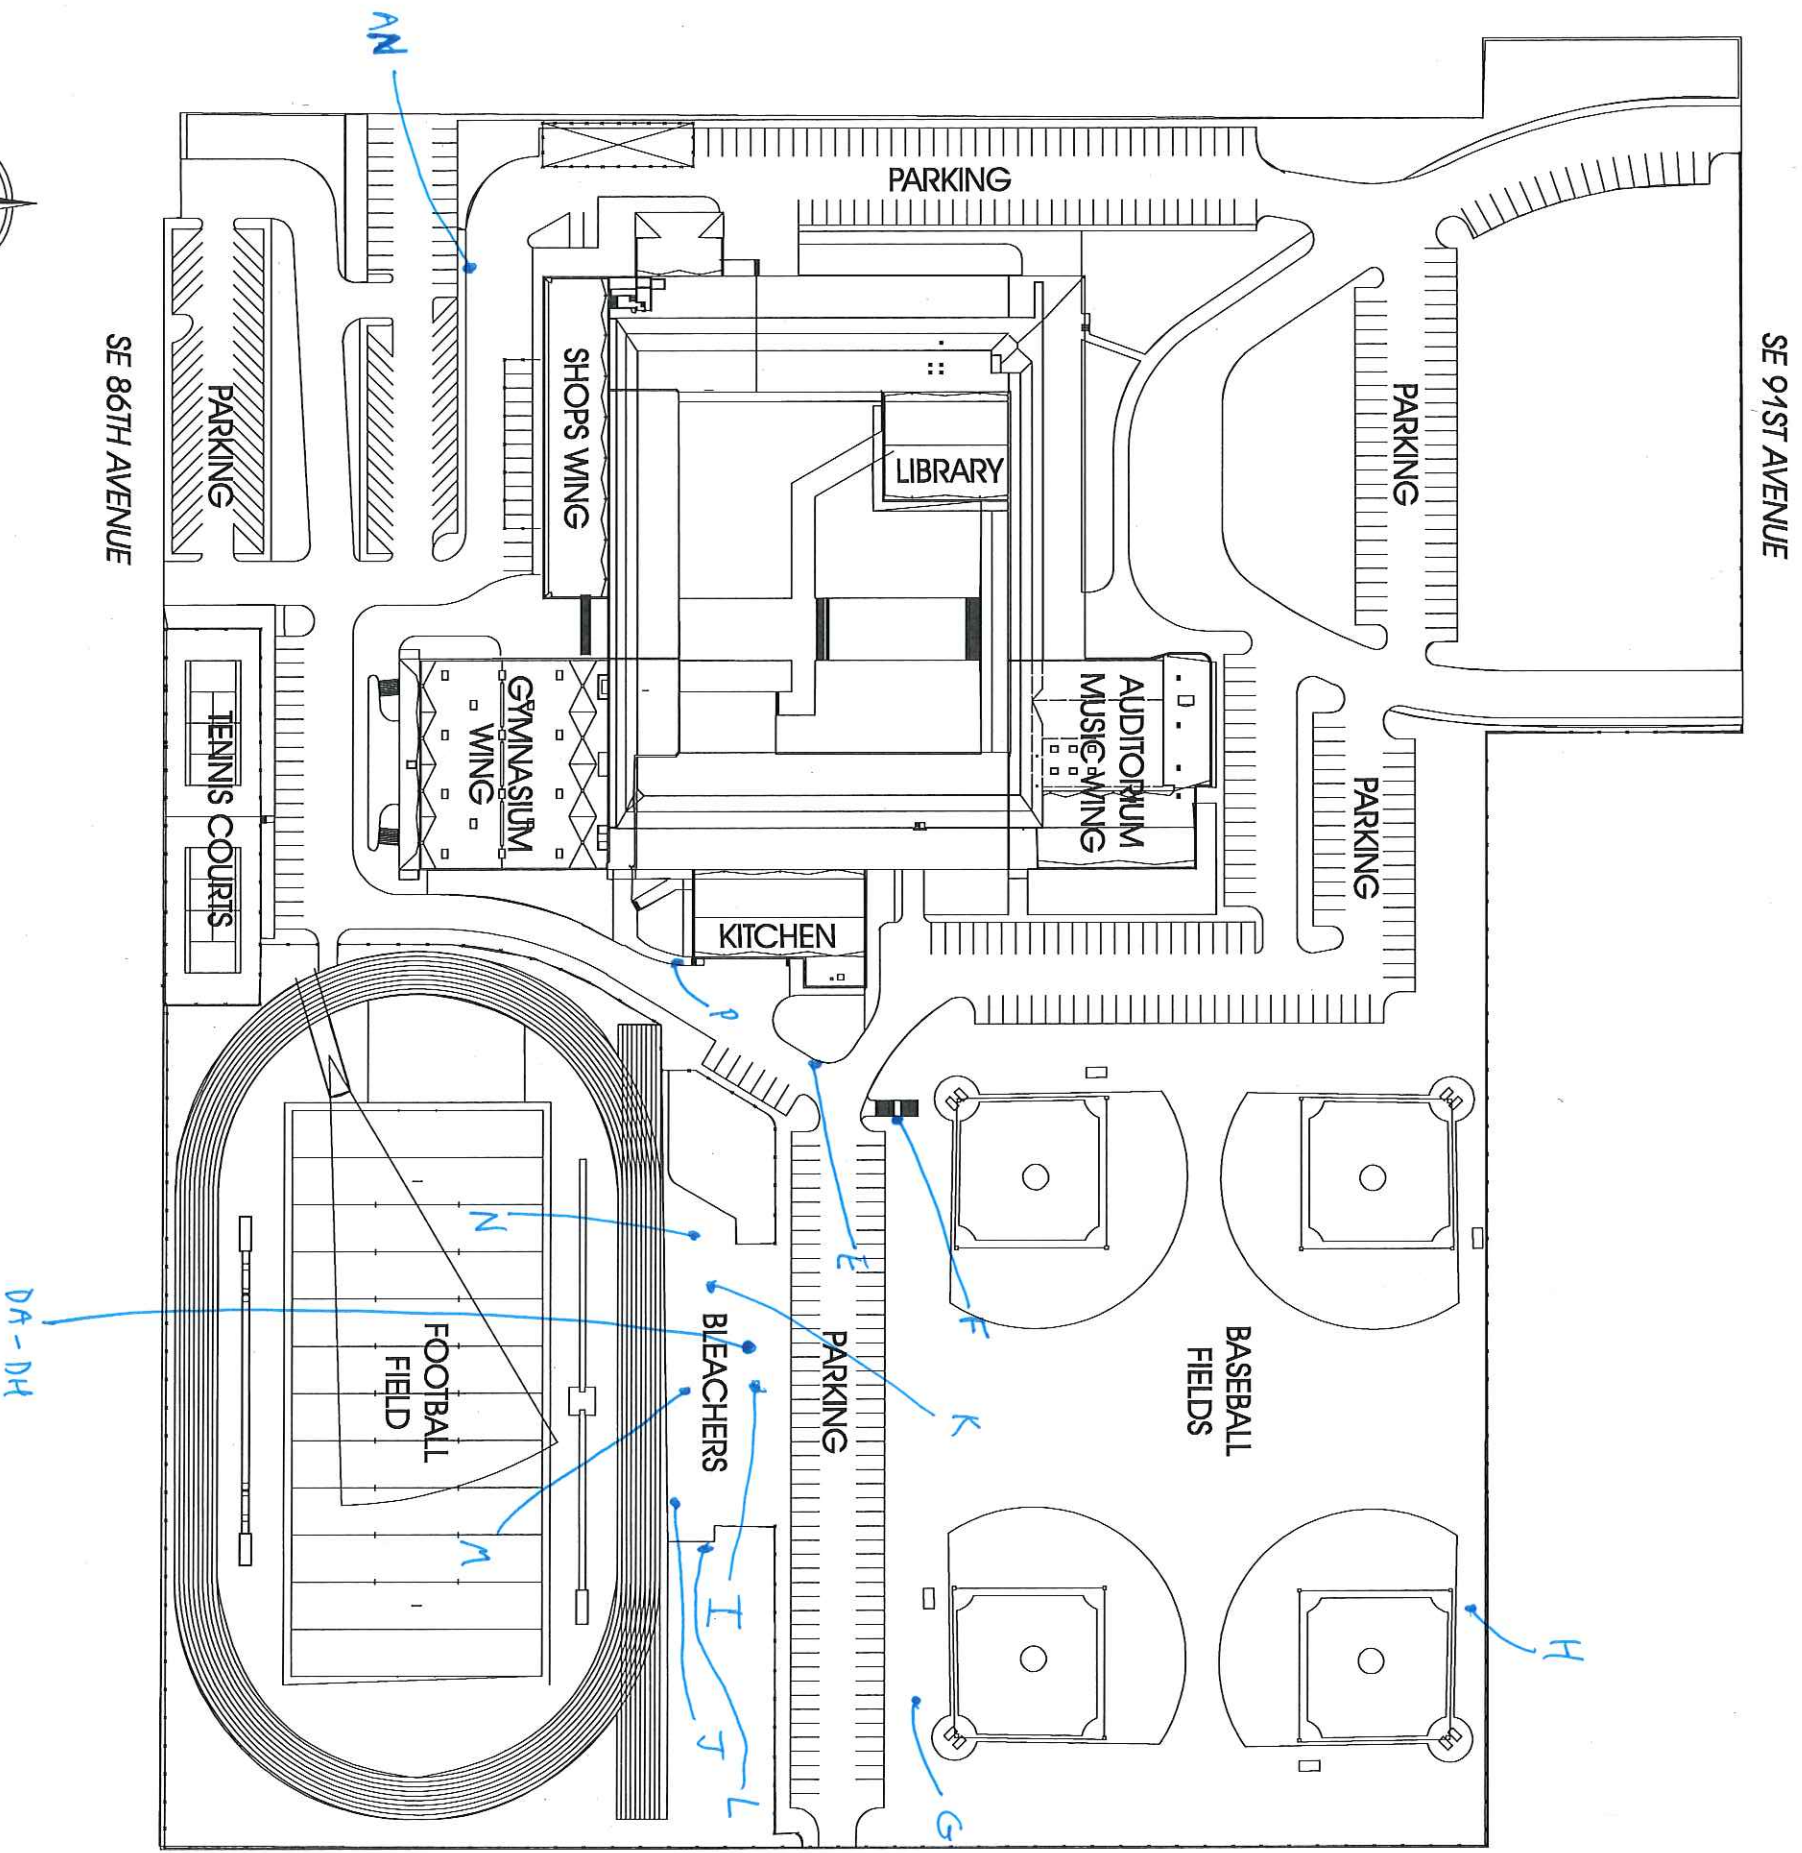
SITE / FIRST FLOOR PLAN

No paint chips were observed in the school's garden spaces; however, paint chips were observed on concrete at the southwest and northwest gym doors and on asphalt by the west shop wing walls.

PBS recommends that all painted or varnished surfaces in deteriorated condition noted on the attached table be stabilized. All paint chips noted in this report should be removed.
