Regarding: Lead Paint Condition Assessment
Mt. Tabor Middle School
5800 SE Ash Street
Portland, Oregon 97215
PBS Project: 6500.721 Phase 0064

**Mt. Tabor Middle School
Assessment of Paint/Varnish in Deteriorated Condition**

Mount Tabor Middle School
5800 SE Ash 97215
Facility Plan

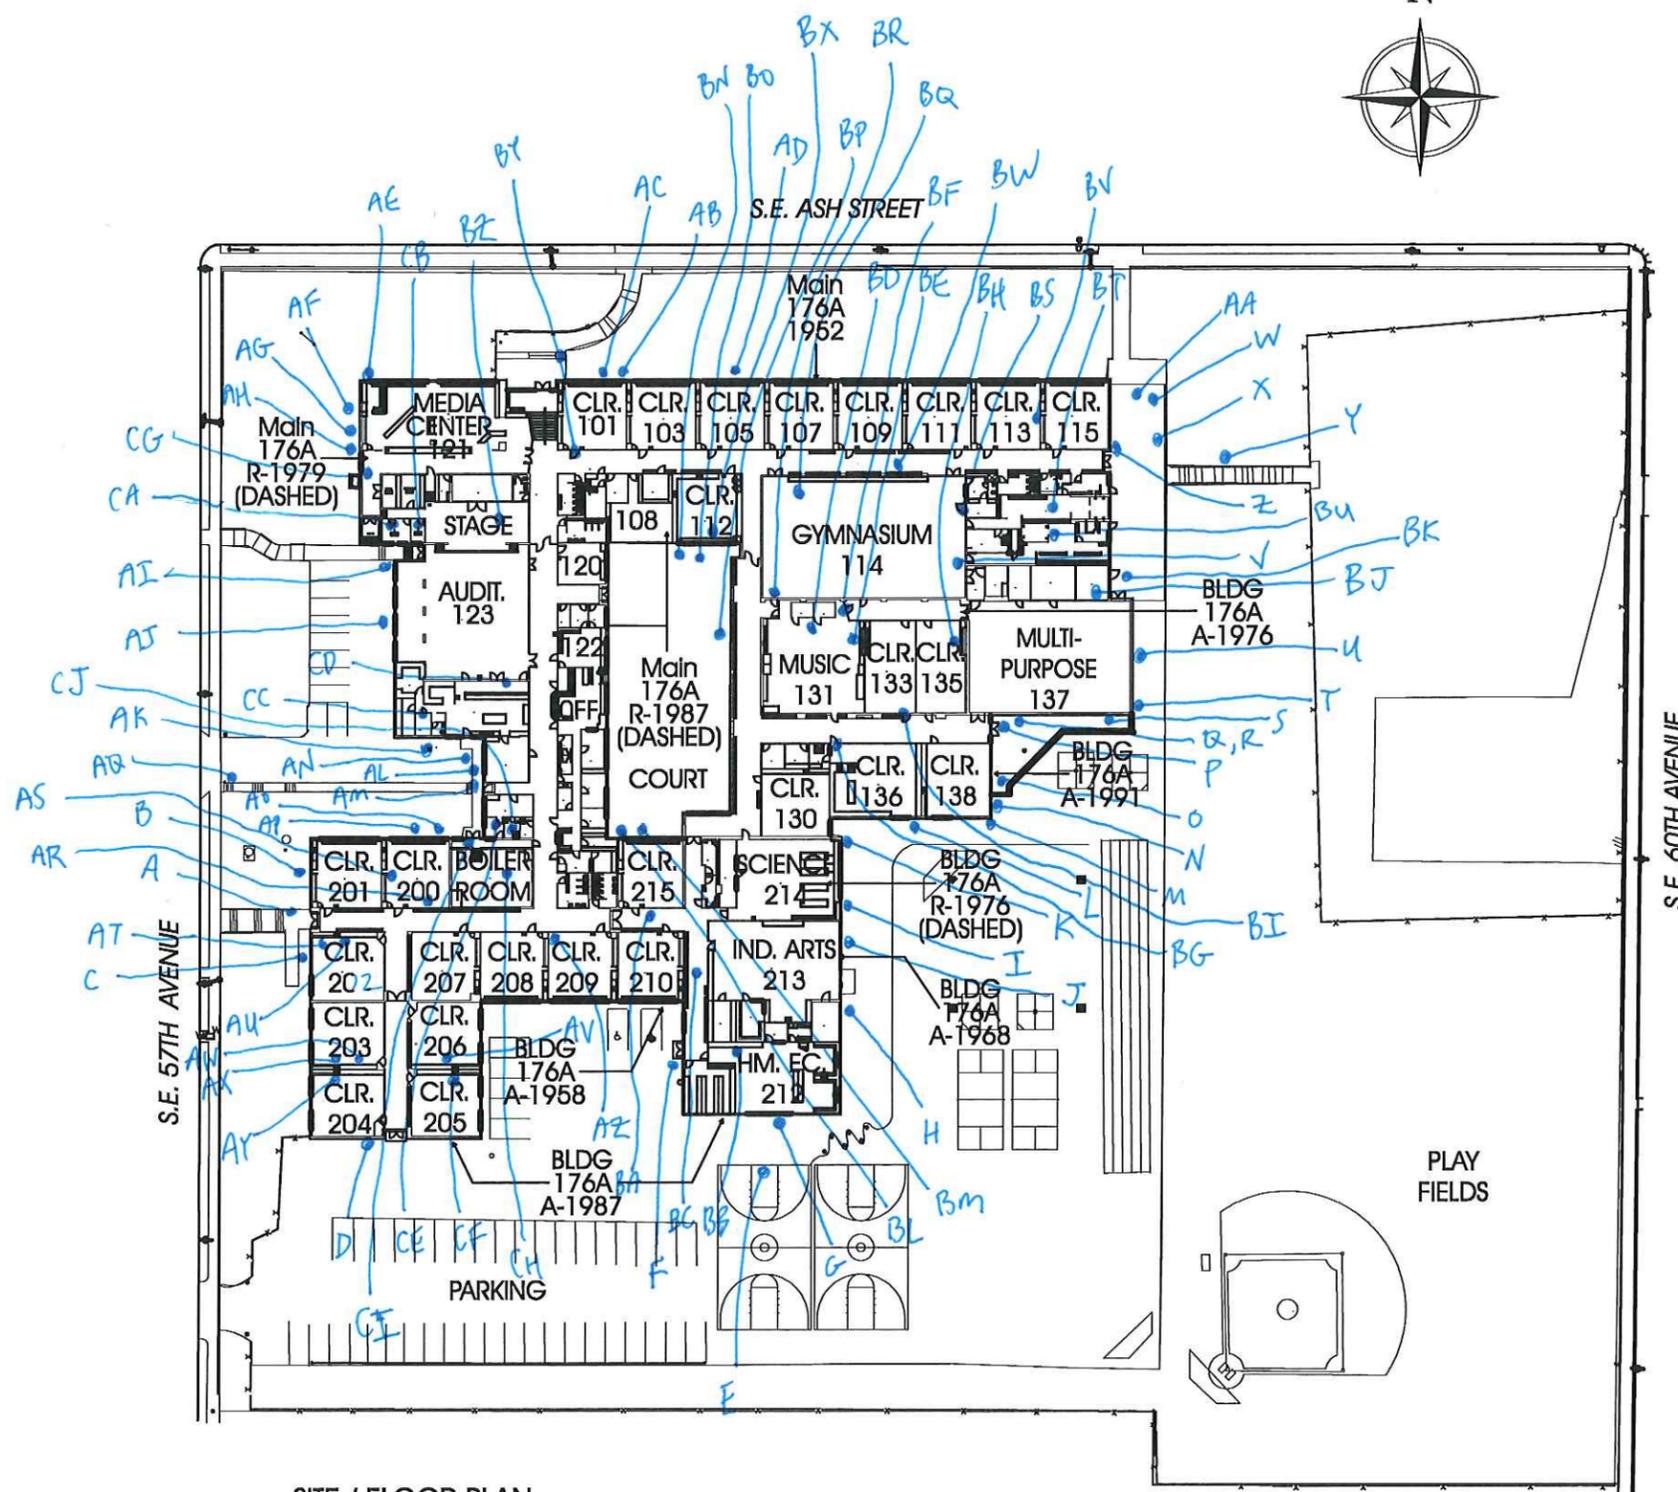
SITE / FLOOR PLAN

Paint chips were observed on asphalt outside the loading dock, on soil outside classrooms 200 and 201, in multiple locations in the courtyard, and in soil on the west exterior of the media center.

PBS recommends that all painted or varnished surfaces in deteriorated condition noted on the attached table be stabilized. All paint chips noted in this report should be removed.
