March 10, 2017

Regarding: Lead Paint Condition Assessment
Skyline School
11536 NW Skyline Boulevard
Portland, Oregon 97231
PBS Project: 6500.721 Phase 0049

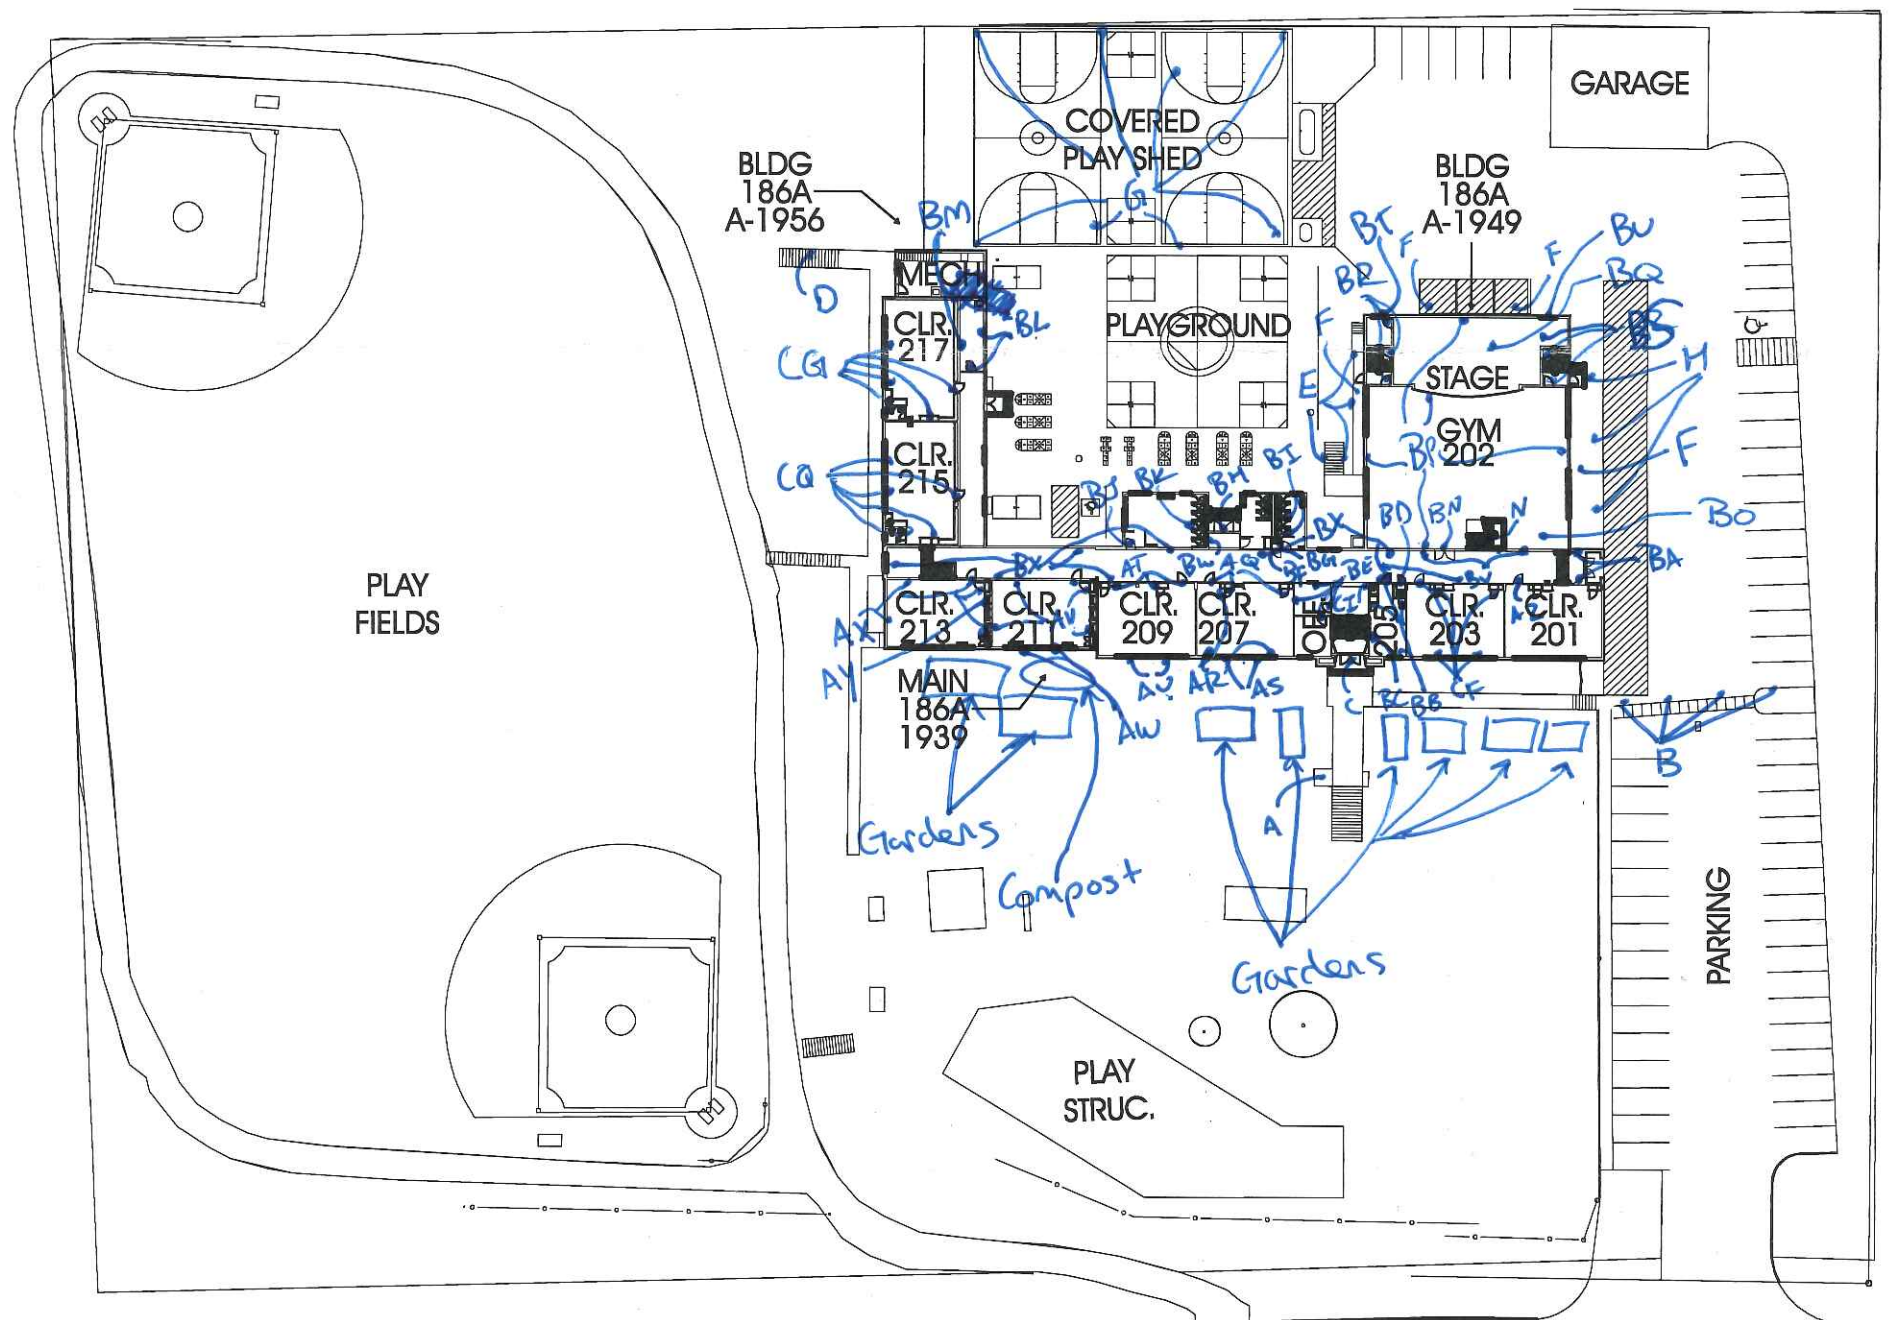
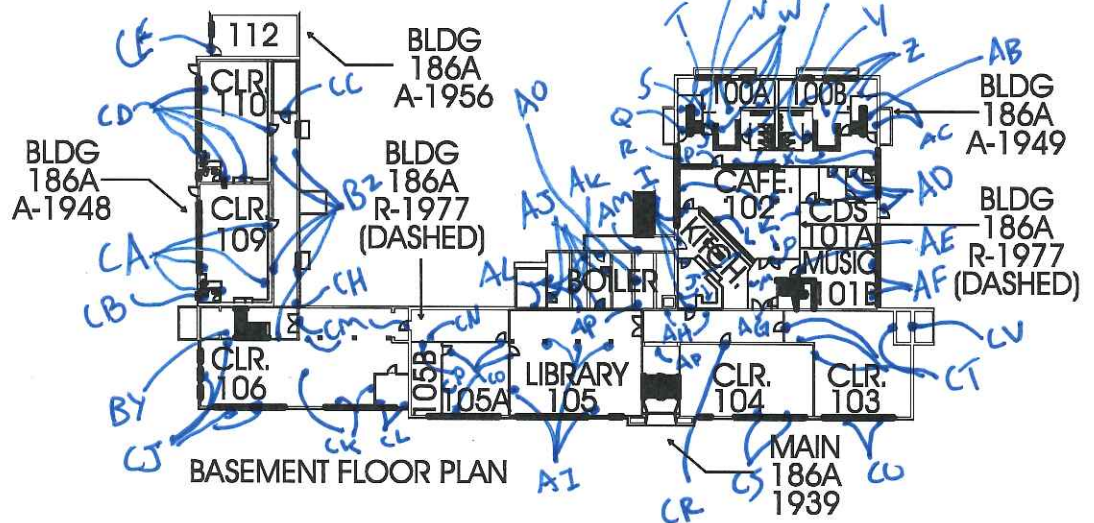
SITE / GROUND FLOOR PLAN

- Deteriorated paint below 5 feet and paint chips on the main hallway floor at the south end, and by the east playground door.
- Flaking paint and paint chips on the floor in classroom 109's bathroom.

PBS recommends that all painted or varnished surfaces in deteriorated condition noted on the attached table be stabilized.
