Regarding: Continuous Radon Monitor Measurement Report
Lane Middle School
Portland, Oregon
PBS Project No. 06500.618, Phase 0005

Radon Inspection Report

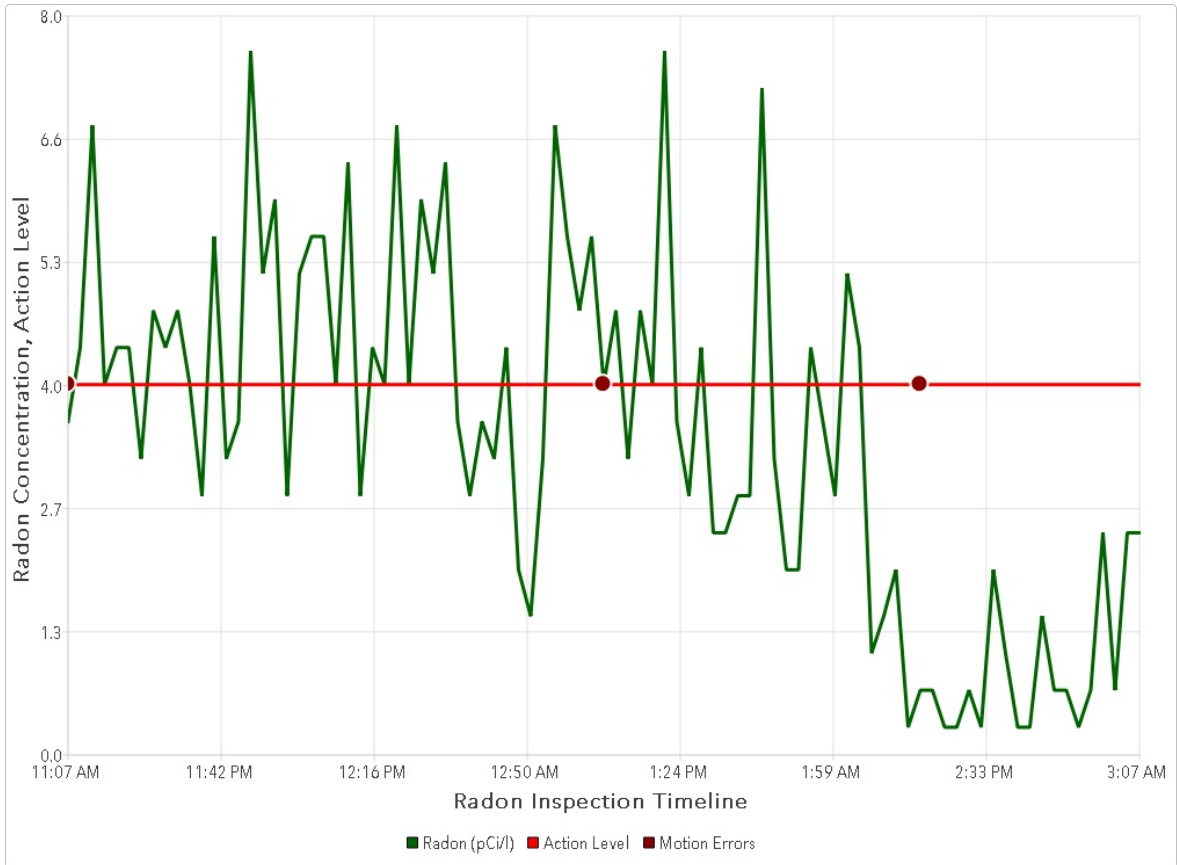
Radon Inspection Chart

<u>CRM Location:</u>	<u>Start:</u>	<u>Stop:</u>	<u>Interval:</u>	<u>Duration:</u>	<u>Overall Avg:</u>	<u>EPA Average:</u>
Room 131	01/14/2019 10:07 AM	01/18/2019 03:07 AM	1 hr	89 hr	3.4 pCi/l	3.4 pCi/l

<u>Measurement Units</u>	<u>Min</u>	<u>Max</u>	<u>Average</u>
Radon Concentration:	(pCi/l)	0.3	7.6	3.4

Test Result: No Mitigation Recommended

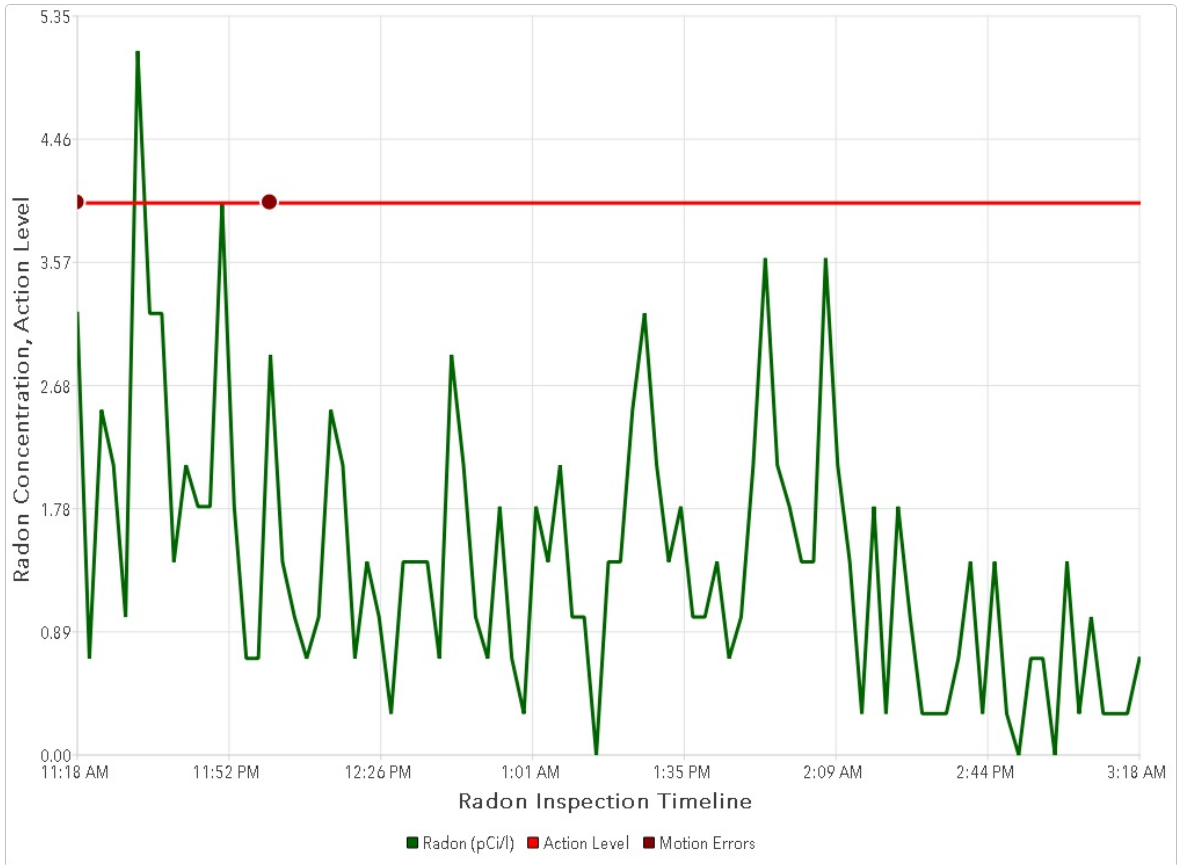
Radon Inspection Chart

<u>CRM Location:</u>	<u>Start:</u>	<u>Stop:</u>	<u>Interval:</u>	<u>Duration:</u>	<u>Overall Avg:</u>	<u>EPA Average:</u>
Room 180	01/14/2019 10:18 AM	01/18/2019 03:18 AM	1 hr	89 hr	1.4 pCi/l	1.4 pCi/l

<u>Measurement Units</u>	<u>Min</u>	<u>Max</u>	<u>Average</u>
Radon Concentration:	(pCi/l)	0.0	5.1	1.4

Test Result: No Mitigation Recommended

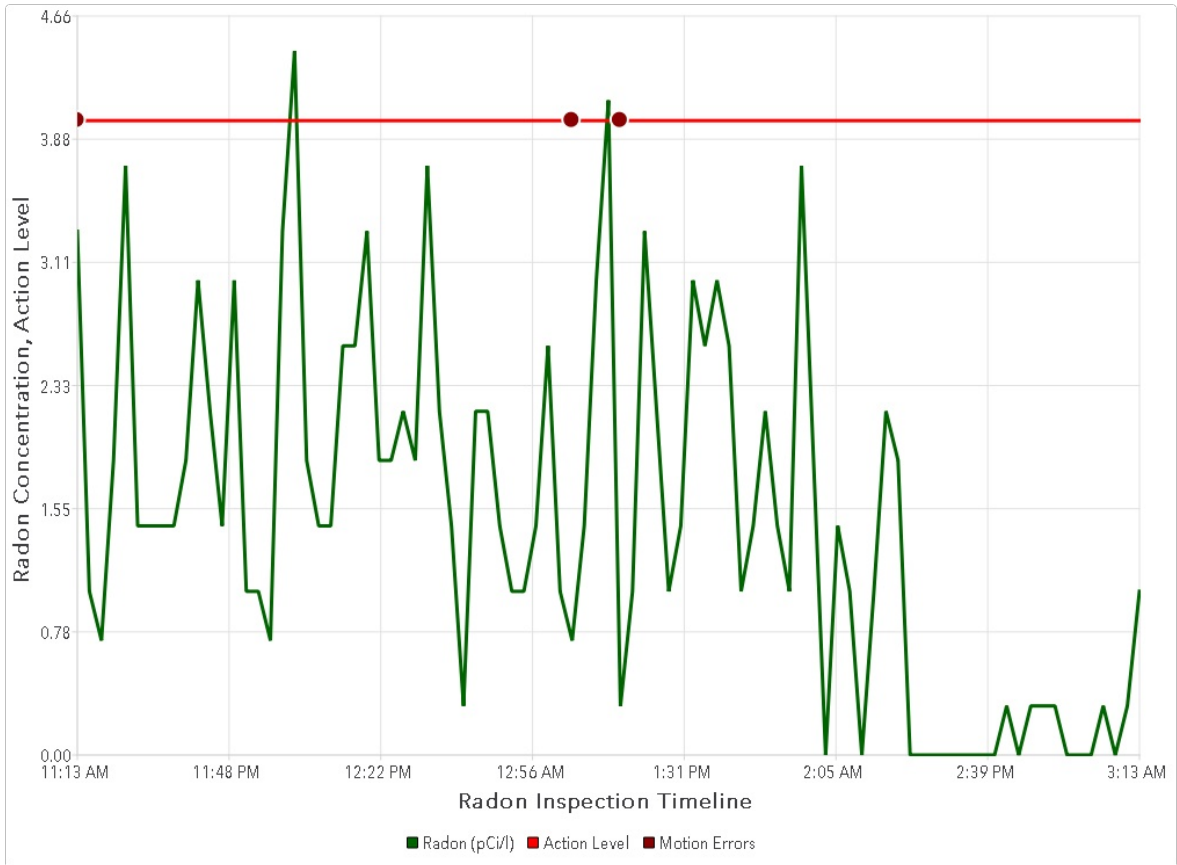
Radon Inspection Chart

<u>CRM Location:</u>	<u>Start:</u>	<u>Stop:</u>	<u>Interval:</u>	<u>Duration:</u>	<u>Overall Avg:</u>	<u>EPA Average:</u>
Room 184	01/14/2019 10:13 AM	01/18/2019 03:13 AM	1 hr	89 hr	1.5 pCi/l	1.5 pCi/l

<u>Measurement Units</u>	<u>Min</u>	<u>Max</u>	<u>Average</u>
Radon Concentration:	(pCi/l)	0.0	4.4	1.5

Test Result: No Mitigation Recommended

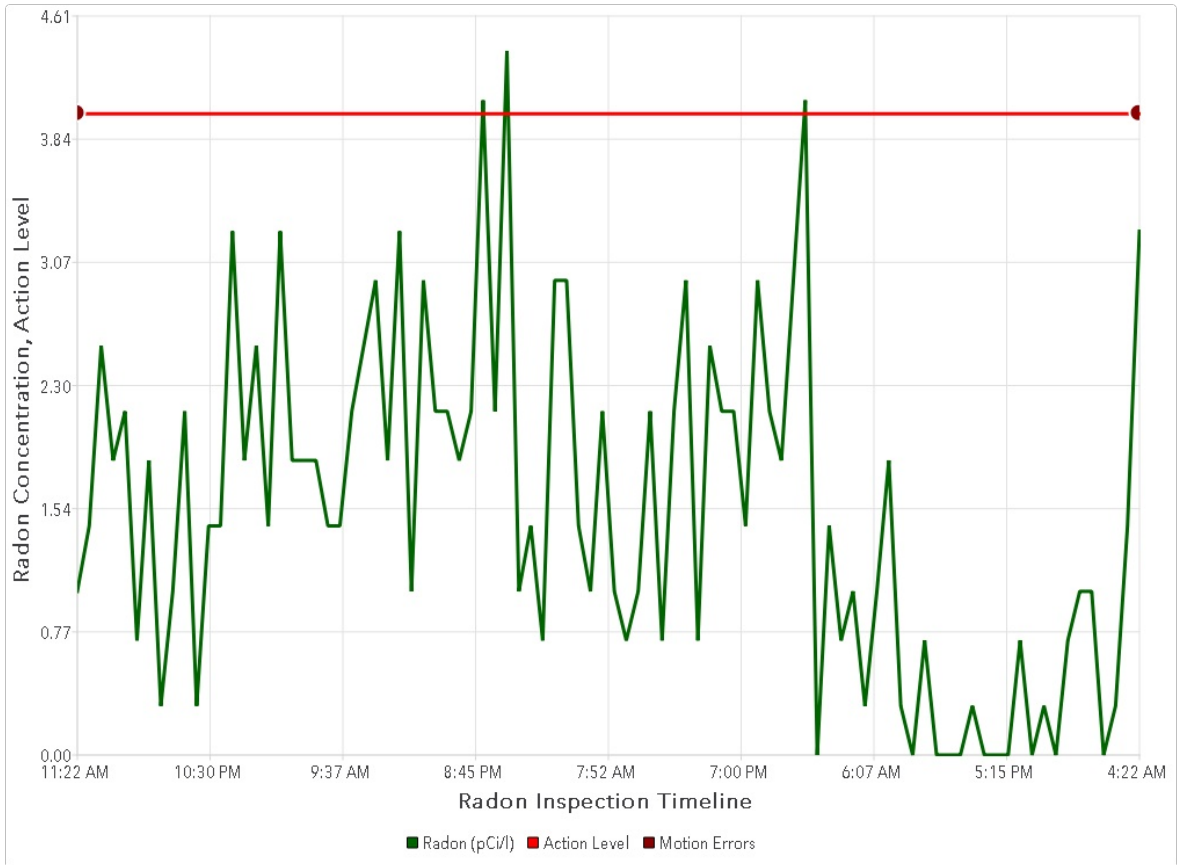
Radon Inspection Chart

<u>CRM Location:</u>	<u>Start:</u>	<u>Stop:</u>	<u>Interval:</u>	<u>Duration:</u>	<u>Overall Avg:</u>	<u>EPA Average:</u>
Room 186	01/14/2019 10:22 AM	01/18/2019 04:22 AM	1 hr	90 hr	1.5 pCi/l	1.5 pCi/l

<u>Measurement Units</u>	<u>Min</u>	<u>Max</u>	<u>Average</u>
Radon Concentration:	(pCi/l)	0.0	4.4	1.5

Test Result: No Mitigation Recommended

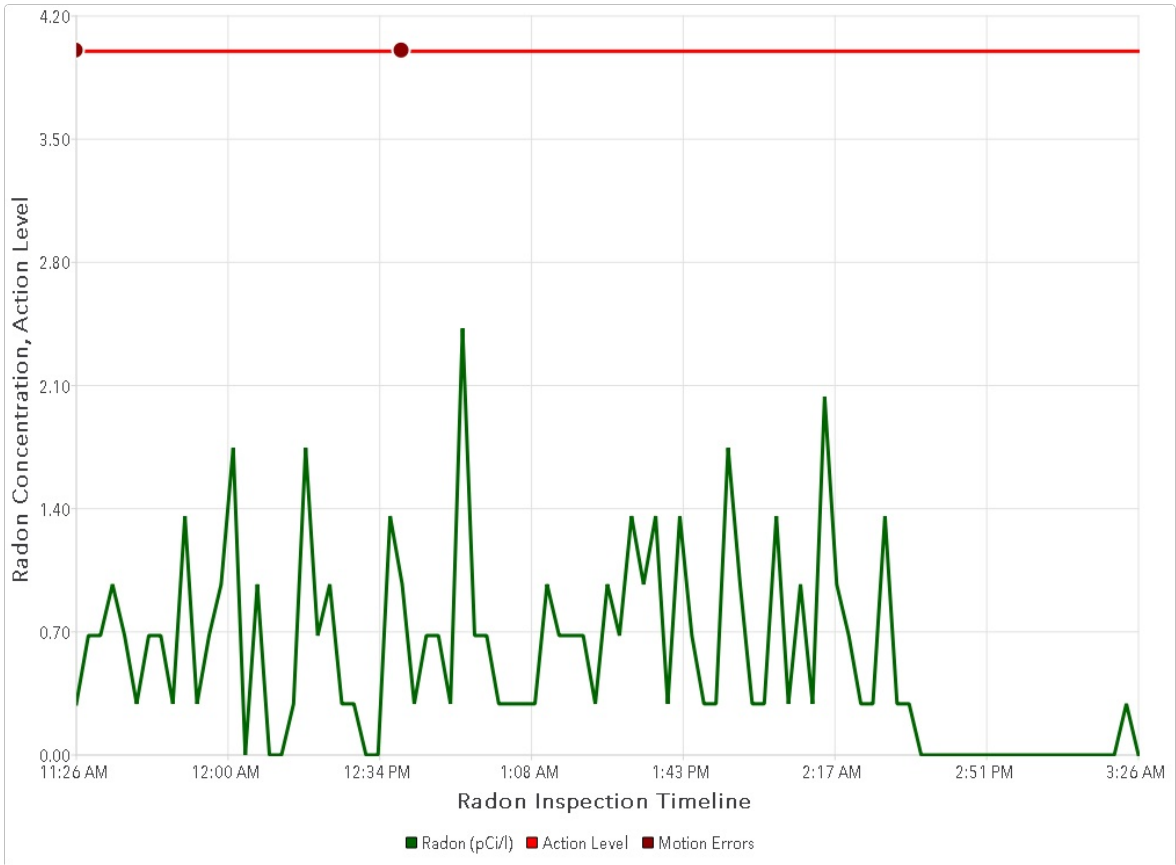
Radon Inspection Chart

<u>CRM Location:</u>	<u>Start:</u>	<u>Stop:</u>	<u>Interval:</u>	<u>Duration:</u>	<u>Overall Avg:</u>	<u>EPA Average:</u>
Room 196	01/14/2019 10:26 AM	01/18/2019 03:26 AM	1 hr	89 hr	0.6 pCi/l	0.5 pCi/l

<u>Measurement Units</u>	<u>Min</u>	<u>Max</u>	<u>Average</u>
Radon Concentration:	(pCi/l)	0.0	2.4	0.6

Test Result: No Mitigation Recommended
