January 28, 2019

Regarding: Continuous Radon Monitor Measurement Report  
Lane Middle School  
Portland, Oregon  
PBS Project No. 06500.618, Phase 0005

## Radon Inspection Report

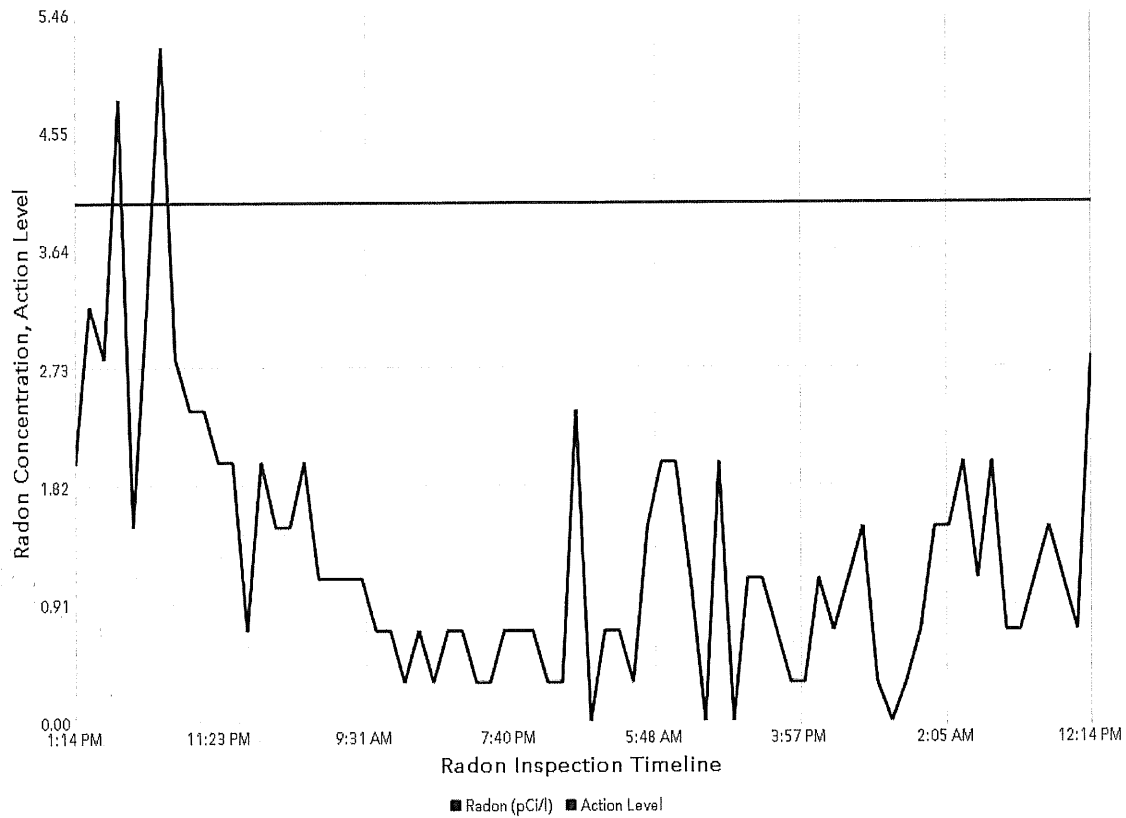
## Radon Inspection Chart

| Room 131 | 01/22/2019 12:14 PM | 01/25/2019 12:14 PM | 1 hr | 72 hr | <b>1.3 pCi/l</b> | <b>1.2 pCi/l</b> |

| Radon Concentration: | (pCi/l) | 0.0 | 5.2 | 1.3 |

**Test Result: No Mitigation Recommended**

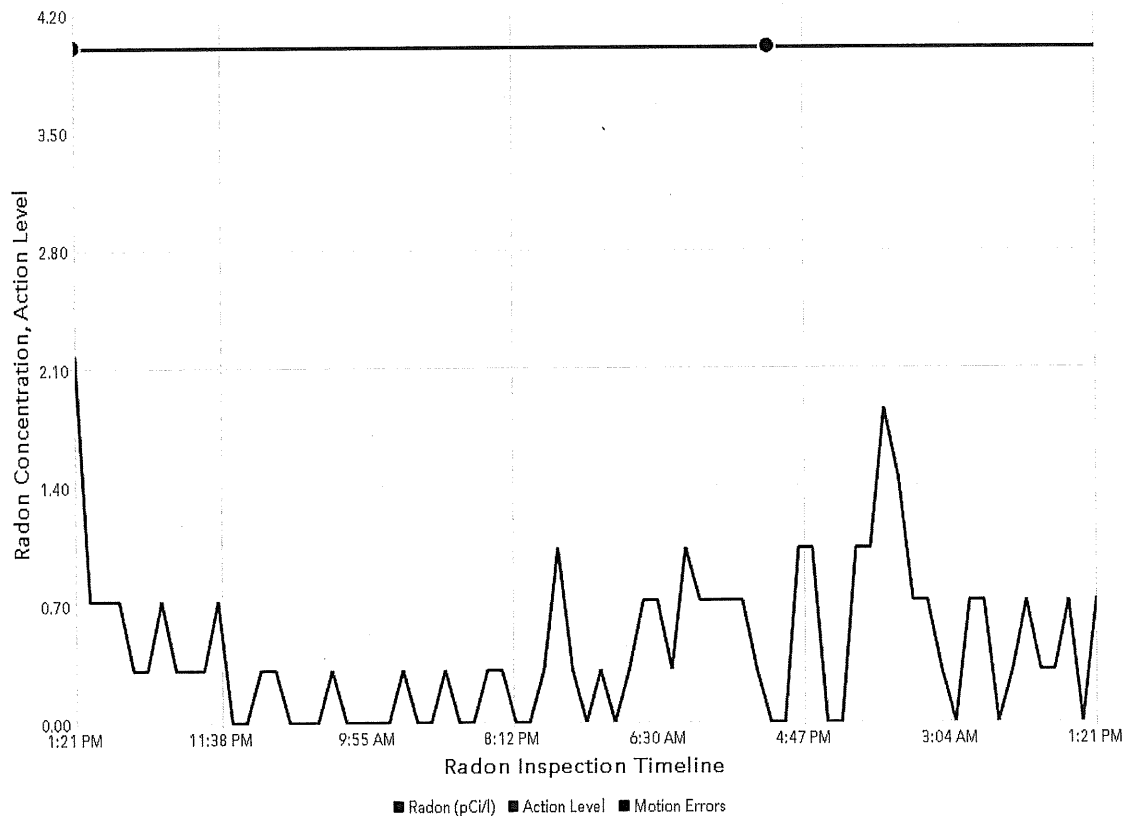
## Radon Inspection Chart

| Room 180 | 01/22/2019 12:21 PM | 01/25/2019 01:21 PM | 1 hr | 73 hr | <b>0.4 pCi/l</b> | <b>0.4 pCi/l</b> |

| Radon Concentration: | (pCi/l) | 0.0 | 2.2 | 0.4 |

**Test Result: No Mitigation Recommended**

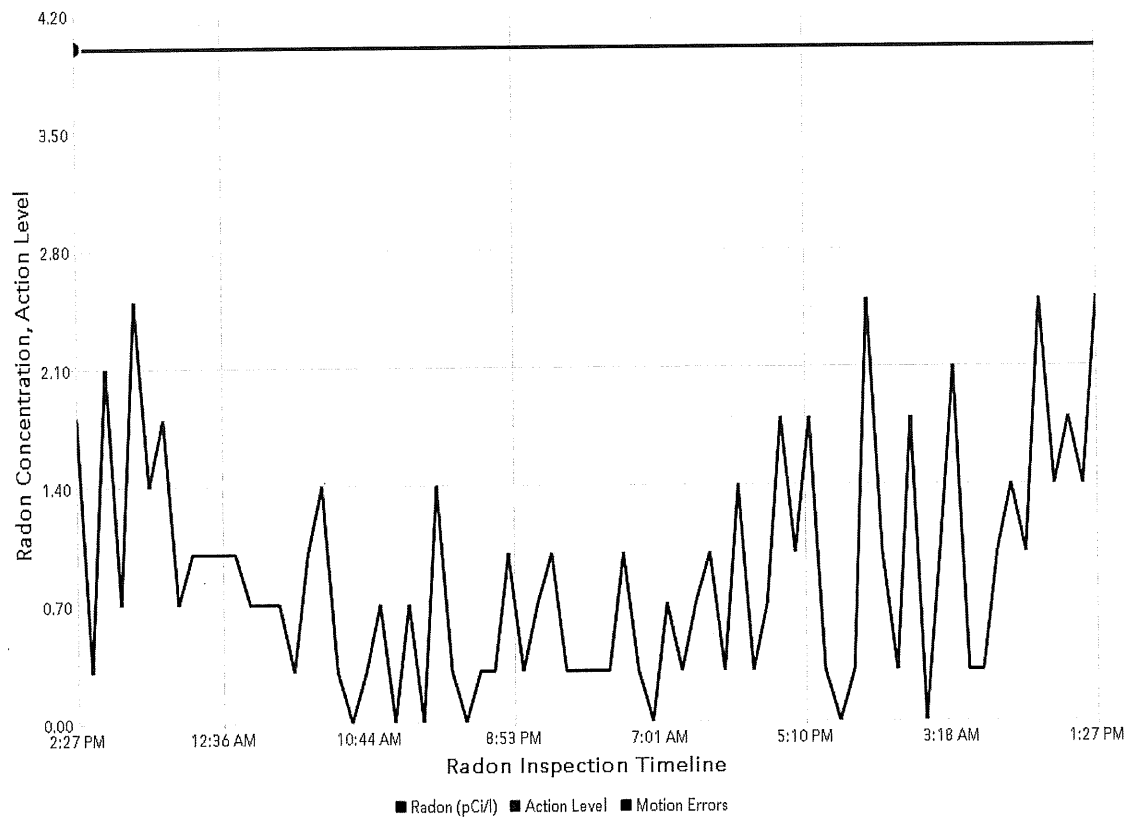
## Radon Inspection Chart

| Room 184 | 01/22/2019 01:27 PM | 01/25/2019 01:27 PM | 1 hr | 72 hr | <b>0.9 pCi/l</b> | <b>0.9 pCi/l</b> |

| | <u>Measurement Units</u> | <u>Min</u> | <u>Max</u> | <u>Average</u> |
|---|---|---|---|---|
| Radon Concentration: | (pCi/l) | 0.0 | 2.5 | 0.9 |

**Test Result: No Mitigation Recommended**

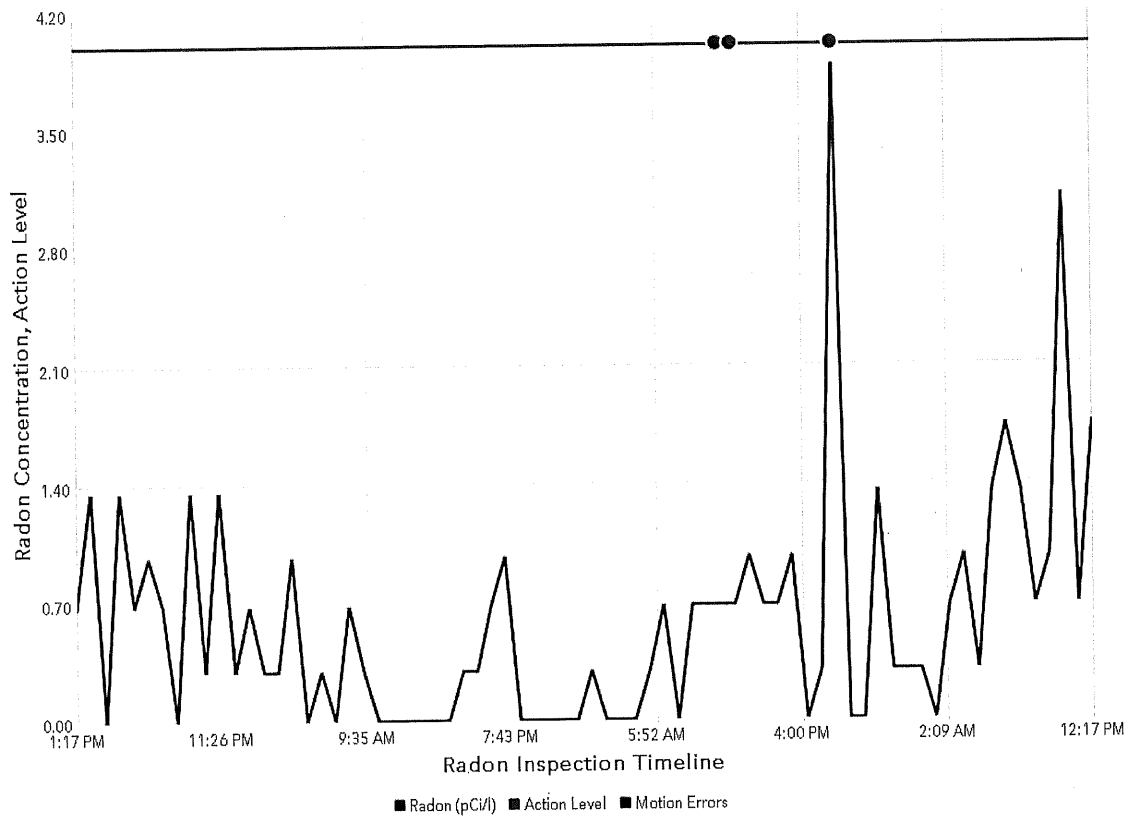
## Radon Inspection Chart

| Room 186 | 01/22/2019 12:17 PM | 01/25/2019 12:17 PM | 1 hr | 72 hr | <b>0.6 pCi/l</b> | <b>0.6 pCi/l</b> |

| Radon Concentration: | (pCi/l) | 0.0 | 3.9 | 0.6 |

**Test Result: No Mitigation Recommended**

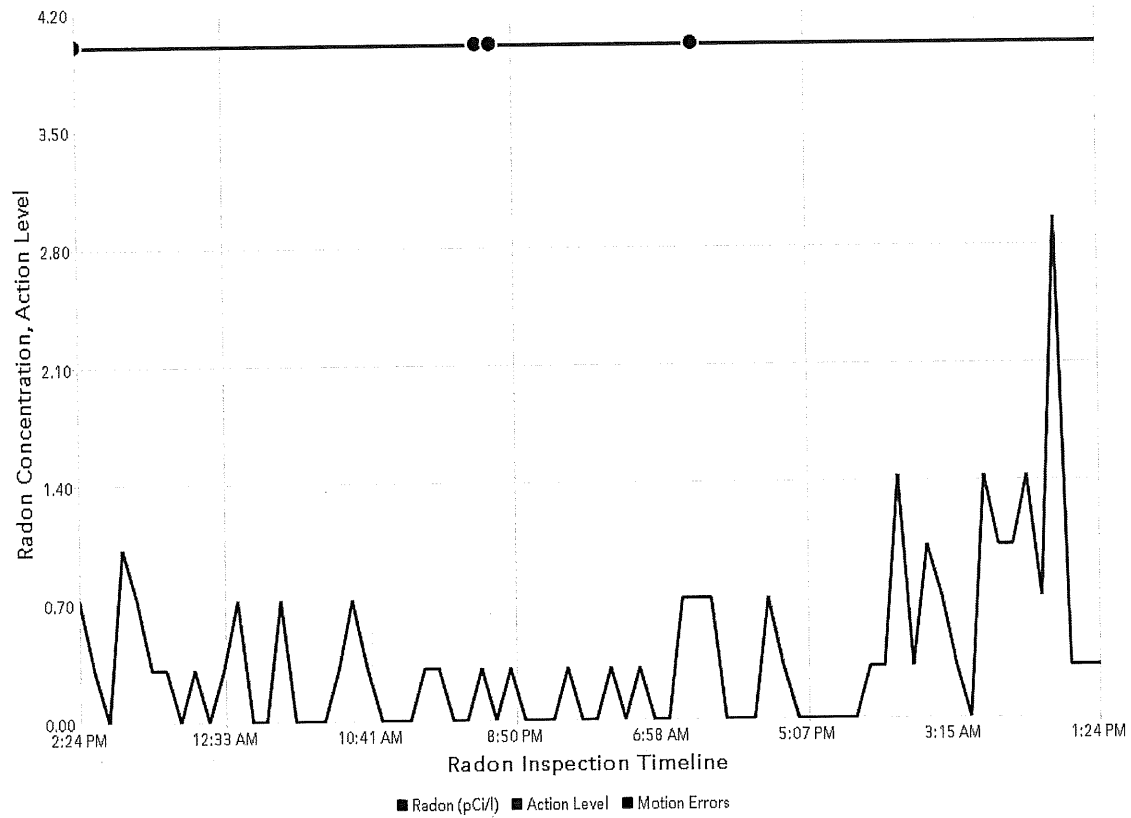
## Radon Inspection Chart

**Test Result: No Mitigation Recommended**
