PORTLAND PUBLIC SCHOOLS – FACILITY ADA ASSESSMENT

Lane 6-8
August 31, 2009

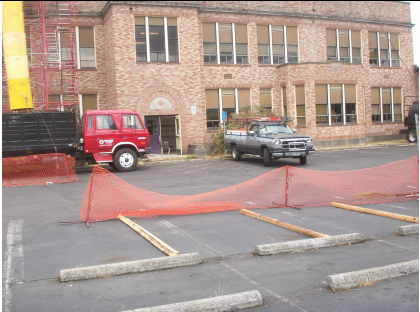
<p>Parking #1</p>	<p>Two ADA spaces exist at the north parking lot. Striping and marking is worn and the striped access aisles do not appear to be large enough. Restripe accessible stalls. Spaces are missing the stall signage, only one general marker sign in the center designates the area for parking. Secondary access aisle does not have a paved accessible path to the accessible entrance except behind the parked vehicles in the vehicular lane. Left space from access aisle to be signed Van Accessible. Verify that the stall width is 9-feet with an 8-foot striped aisle.</p>	
<p>Parking #2</p>	<p>One ADA stall at the south parking lot.</p>

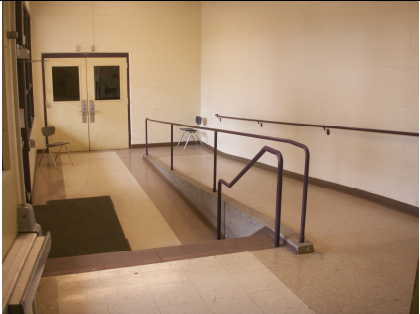
<p>Entry Accessible Path</p>	<p>Accessible path from accessible parking leads to Gymnasium entry. Add directional signage at interior for path direction to various school areas.</p>

<p>Accessible North Gym Entry is at left side in photo.</p>

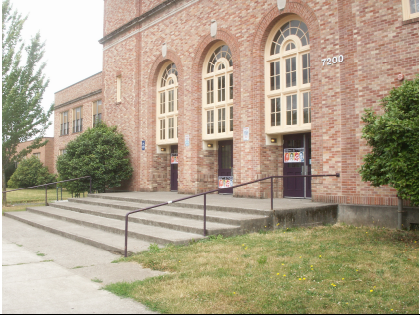
<p>Entry, Main Front</p>	<p>Provide replacement or additional accessible handrails with extensions (approximately 36 lf of rail.) Additionally, though not required, there is space for an accessible ramp. Exterior pull handles, no thumb latch. Interior panic exit bars. Adjust closers to compliant pressures.</p>

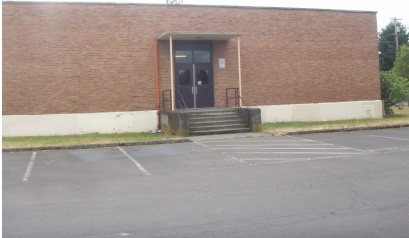
<p>North Class Wing Entry</p>

<p>Stair Handrails, Exterior</p>	<p>Existing exterior entry stairs have metal handrails at the main west entry and the north class wing entry. The main west entry has compliant height and extensions. The north entry handrails are compliant height, but does not have compliant top and bottom extensions. The south entry has one step and no handrails. See Parking note #2 above. North Gymnasium entry is a fully compliant entry except for interior signage. The Media Center / Science wing entry on the east is a compliant at-grade entry from the play area.</p>

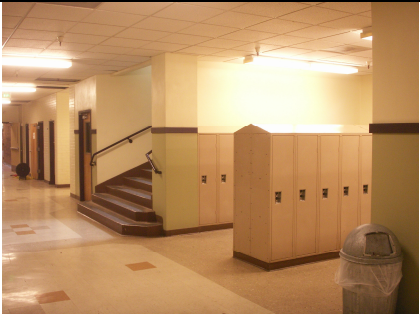
<p>Elevator</p>	<p>Provide an elevator for access to the second floor. One appropriate location for the elevator would be at the north section of the main corridor locker area across from classroom 119. Adjacent storage room 118 can be used for the machine room if required. The second floor space required would also be the north bay of the locker area across from classroom 200. This location is adjacent to the north end stairs of the second floor, and is closest to the accessible parking entry.</p>

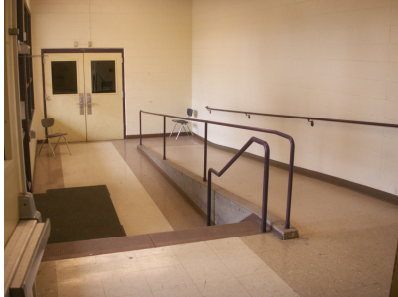
<p>Stage / Dance134</p>	<p>Stage access already provided at door 134. Compliant stairs and ramp at outside vestibule entry. Stage is 21-inches above Gymnasium floor level.</p> <p>Portable 2-step is available from Gym side, and can be readily moved.</p>

<p>Door 134 to Stage is to right of picture at top of ramp.</p>
