July 08, 2014

Re: Report of Geotechnical Engineering Services  
Vertical Settlement and Lateral Movement  
Tubman School Site for Portland Public Schools  
Portland, Oregon  
RhinoOne Project No. PPS-2013-003

Figure 1 - Current Conditions

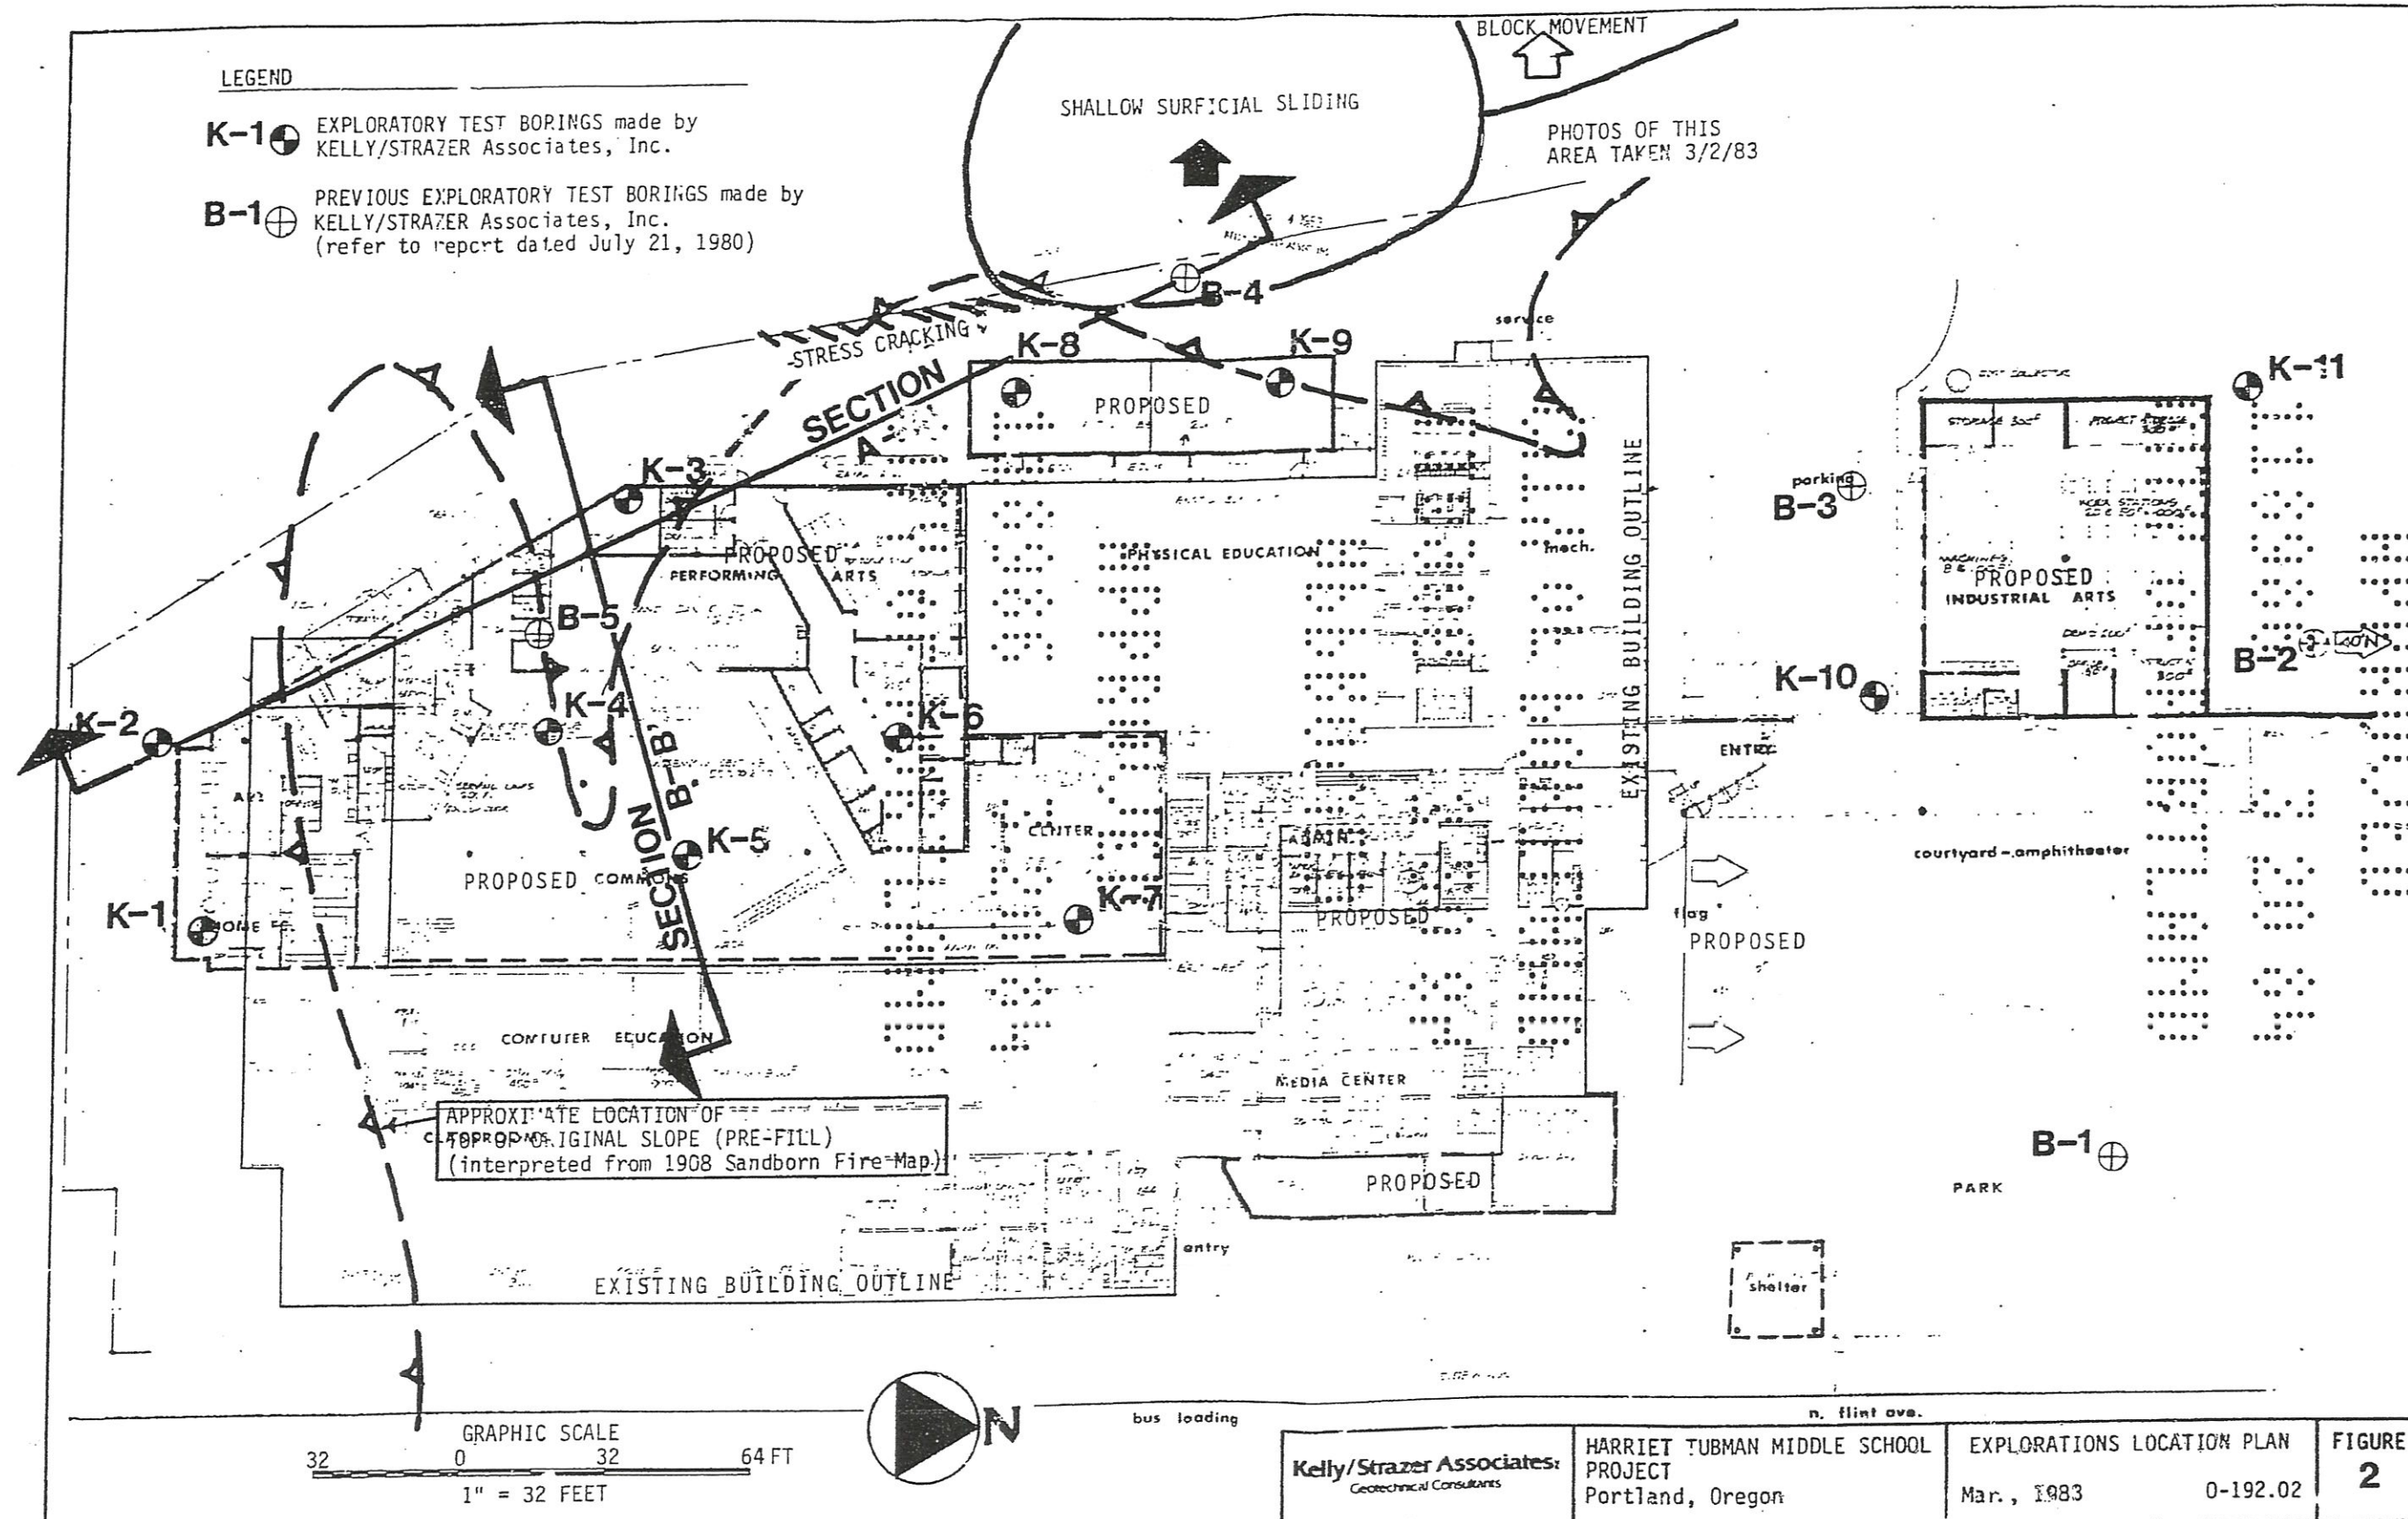
We completed a site walk with you and representatives of Oregon Department of Transportation (ODOT) on April 18, 2014. Building settlements were observed at the southwest corner and at the generator room with some additional distress observed between these two points. Distress was observed in the parking lot on the west side of the building as evidenced by various asphalt repairs over the years. Standing water was also observed in a clean-out which indicates that the water is not draining properly. A 2- to 4- inch crack running along the entire height was observed in the ODOT retaining wall downslope from the southwest corner of the building. Figure 1 shows a schematic of observed building movements. The pattern of movement appears to be lateral ground movement which subsequently causes vertical movements.

Based on our observation and discussions with you, it appears that most of the building distress is on the west wall with large settlements noted at the southwest corner. The parking area and the driveways are showing distress as indicated by un-even surface and previous asphalt patching. The generator room is also showing separation from the main building.

The effect of lateral movement is more pronounced in the parking lot area with uneven settlements, several asphalt patches and movement of the generator room. These movements have also changed the drainage patterns which may explain why standing water is observed in the cleanouts.

**Building Wall**– The west and south wall of the building in the impacted area is recommended to be underpinned using a micropile and grade beam system. The micropiles should be installed in groups of 2 at a spacing of approximately 6 feet on center. The first micropile installed inside the building should be vertical whereas the second micropile installed from outside the building should have a batter of 15 degrees. The micropiles should be a minimum of 8-inches in diameter with an outer casing for lateral loads installed to a minimum depth of 25 feet or possibly more in some areas. The total depth of micropile will be on the order of 45- to 50- feet. A continuous grade beam should be installed below the existing wall with the micropiles connected to it. For preliminary budget estimate, we have assumed a 200 feet length of wall will require remedial measures. The grade beam will most likely be 3 feet thick and 3- to 4- feet wide running along the entire length of the wall.

**Soldier Pile Wall for Slope Stabilization** – We recommend that a soldier pile wall system be constructed at the edge of the slope upslope from the ODOT retaining wall. The soldier pile wall system consists of steel beams installed in a drilled hole and backfilled with structural concrete. For this site, a soldier pile wall constructed from the top will be the most practical option. The soldier piles will be installed at spacing of 6- feet, with 30- to 36- inch diameter and to a depth of 45 to 50 feet. A steel beam like HP 14x117 will be placed entire depth. For preliminary budget purposes, assume that the length of this wall will be on the order of 200 feet.

**Parking Lot Reconstruction** – The district should decide on the potential use of the parking lot. If this lot will be used for bus traffic then remedial measures will be required. Most of the parking lot is located on un-documented fill. We recommend that five feet of this fill be removed. The exposed subgrade should then be compacted. A bi-axial geogrid with a geotextile composite should then be installed over the prepared subgrade. Four feet of 3" minus clean rock should then be installed over the geogrid and compacted in layers. The pavement structural section of asphalt concrete over crushed rock should then be installed. The actual design of the section should be done based on the intended use.
