Portland Public Schools District Assessments

2024 PPS Seismic Assessments All Schools

Version 1.0
5/15/2024

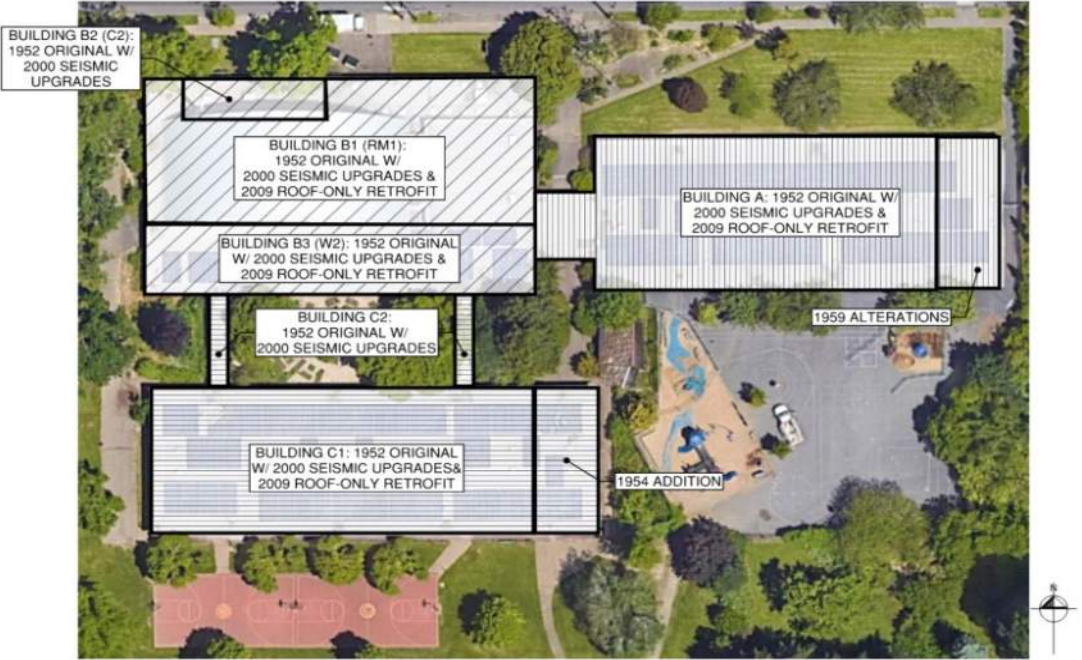
Building Year Plan:
(see below for deficiencies)

Building Part (See Diagram Above)	Year Built	URM (SF)	ROM URM Only Retrofit	ROM Total Retrofit	No. of Stories	Basement	Penthouse	Drawings Referenced	Structural Horizontal Gravity System(s)	Structural Vertical Gravity System(s)	Lateral System (ASCE Designation)	Lateral System (Description)	Likely Deficiencies	Deficiency Notes	Additional Notes
Bldg. A	1952	0	\$0	\$735,000	1	None	No	Approximately Complete Original Documents	Wood Plywood/OSB, Wood T+G Plank, Wood Joists, Wood Beams	Timber Frame	W2	Wood Frames (Commercial and Industrial Buildings)	Misc. Plan Irregularity Seismic Separation (< 1%) Inadequate In-Plane Shear	Deflection incompatibility with walkway to Building B no gap to Sector B T&G sheathing for walls typical	Alteration in 1959 to enclose covered play area on east end to make classrooms (generally matches original construction). Structural upgrades in 2000 include seismic bracing work at roof eve overhangs and new shear walls in N/S corridors w/ new collectors. Also 2009 Roof-only retrofit.

2024 Assessment Summary: Atkinson															
Building Part (See Diagram Above)	Year Built	URM (SF)	ROM URM Only Retrofit	ROM Total Retrofit	No. of Stories	Basement	Penthouse	Drawings Referenced	Structural Horizontal Gravity System(s)	Structural Vertical Gravity System(s)	Lateral System (ASCE Designation)	Lateral System (Description)	Likely Deficiencies	Deficiency Notes	Additional Notes
Bldg. B1	1952	0	\$0	\$1,440,000	1	None	No	Approximately Complete Original Documents	Wood T+G Plank, Wood Trusses, Wood Joists, Wood Beams	Reinforced Brick Walls	RM1	Reinforced Masonry Bearing Walls (Flexible Diaphragms)	Inadequate Wall Anchorage Split Levels Misc. Plan Irregularity Seismic Separation (< 1%) Heavy Cladding System Under-Reinforced Walls No Wall-Foundation Connection	Strongbacks installed at east and west wall exterior in 2000, however no other walls retrofitted Roof has split levels @ gym & cafeteria Concrete roof (Bldg. B2) is immediately adjacent to the flexible diaphragm No gap to walkway to Building A Brick veneer #5@15" o.c. in 12.5" walls = 0.0016 < 0.002 Dowels do not appear to extend fully into foundation	Structural upgrades in 2000 include strong backs @ east and west exterior walls, new shear walls at the ends of the gym roof trusses, and new roof/beam connections. The truss over the gym was strengthened in 2002. 2009 reroof included adding (N) plywood on top of (E) T&G and strengthening in-plane shear transfer between gym roof diaphragm and masonry walls.

Bldg. B2	1952	0	\$0	\$500,000	1	None	No	Approximately Complete Original Documents	Concrete 1-way Slab, Concrete Beams	Conc. CIP Walls	C2	Concrete Shear Walls (Stiff Diaphragms)	Misc. Plan Irregularity Masonry Partition Walls Heavy Cladding System No Diaphragm-Wall Connection Inadequate Wall-Foundation Connection Deflection Compatibility	Concrete roof adjacent to wood T&G roof CMU wall (likely unreinforced) @ toilet near boiler. Brick veneer Unclear from section J-J and schedules on S-4 if roof slab is adequately dowelled to walls Dowels do not appear to extend fully into foundation With adjacent timber framed portion	The 2000 structural upgrades in this area appears to focus on tying in the adjacent flexible diaphragm into the concrete walls.
Bldg. B3	1952	0	\$0	\$320,000	1	None	No	Approximately Complete Original Documents	Wood Plywood/OSB, Wood T+G Plank, Wood Joists, Wood Beams	Timber Frame	W2	Wood Frames (Commercial and Industrial Buildings)	Seismic Separation (< 1%) Heavy Cladding System Inadequate In-Plane Shear	No gap to walkways to Building A or Building C Brick veneer T&G sheathing for walls on southern side	Structural upgrades in 2000 include seismic bracing work at roof eave overhangs. Also 2009 Roof-only retrofit.

2024 Assessment Summary: Atkinson															
Building Part (See Diagram Above)	Year Built	URM (SF)	ROM URM Only Retrofit	ROM Total Retrofit	No. of Stories	Basement	Penthouse	Drawings Referenced	Structural Horizontal Gravity System(s)	Structural Vertical Gravity System(s)	Lateral System (ASCE Designation)	Lateral System (Description)	Likely Deficiencies	Deficiency Notes	Additional Notes
Bldg. C1	1952	0	\$0	\$850,000	1	None	No	Approximately Complete Original Documents	Wood Plywood/OSB, Wood T+G Plank, Wood Joists, Wood Beams	Timber Frame	W2	Wood Frames (Commercial and Industrial Buildings)	Seismic Separation (< 1%) Inadequate In-Plane Shear	no gap to walkways to Sector B T&G sheathing for walls typical	1954 addition of two classroom on east end (matches original construction). Structural upgrades in 2000 include seismic bracing work at roof eve overhangs and new shear walls in N/S corridors w/ new collectors. Also 2009 Roof-only retrofit.

Bldg. C2	1952	0	\$0	\$25,000	1	None	No	Approximately Complete Original Documents	Wood T+G Plank, Wood Beams	Timber Frame	W2, S3	Wood Frames (Commercial and Industrial Buildings), Metal Building Frames	Seismic Separation (< 1%) Inadequate In-Plane Shear Roof Chord Discontinuity Straight Sheathing (2:1, 24') Inadequate Moment-Resisting Connections (non-ductile)	No gap to buildings to north & south Relies on adjacent buildings in long direction. Unknown connection detailing	Structural upgrades in 2000 included construction of external steel moment frames.

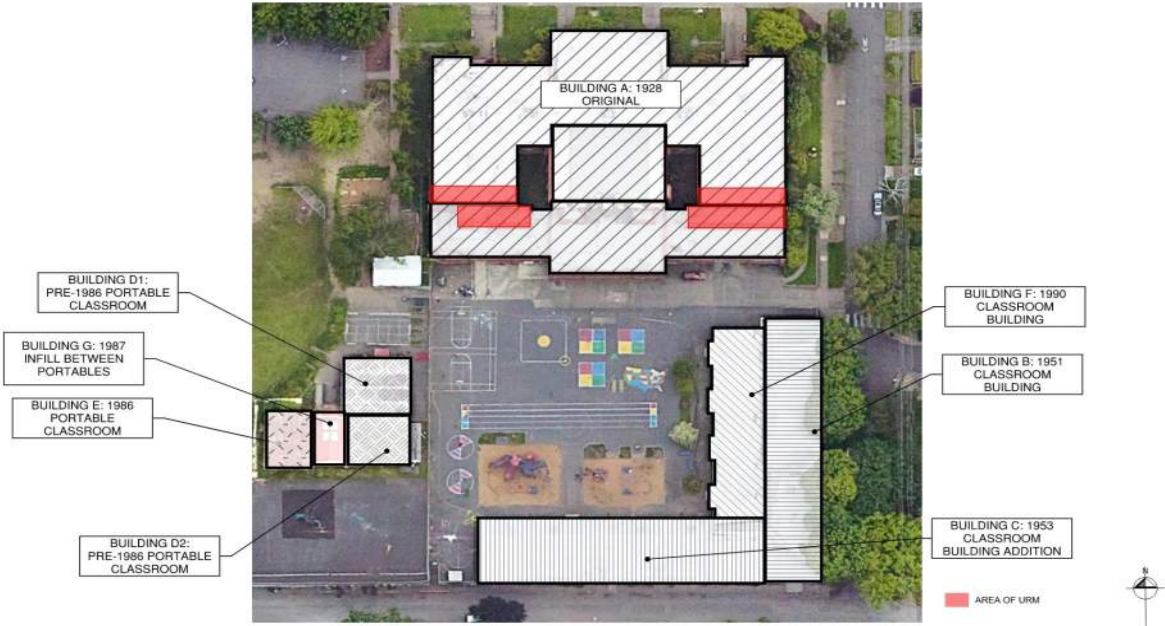
Building Year Plan:
(see below for deficiencies)

Building Part (See Diagram Above)	Year Built	URM (SF)	ROM URM Only Retrofit	ROM Total Retrofit	No. of Stories	Basement	Penthouse	Drawings Referenced	Structural Horizontal Gravity System(s)	Structural Vertical Gravity System(s)	Lateral System (ASCE Designation)	Lateral System (Description)	Likely Deficiencies	Deficiency Notes	Additional Notes
Bldg. A	1928	3000	\$1,350,000	\$12,975,000	2	Partial	No	Approximately Complete Original Documents	Concrete Pan-Joists, Wood Joists	Reinforced Concrete Walls, Unreinforced Brick Walls	C2, URM	Concrete Shear Walls (Stiff Diaphragms), Unreinforced Masonry Bearing Walls (Flexible Diaphragms)	Sloping Site (full story difference across site) Inadequate Wall Anchorage Split Levels Reentrant Corners Non-redundant (< 2 bays in < 2 lines) Inadequate In-Plane Shear Under-Reinforced Walls No Diaphragm-Wall Connection Deflection Compatibility Beams, Girders, or Trusses bear on URM wall/pilaster Walls Spaced Far Apart No Diaphragm-Wall Connection Masonry Partition Walls URM Parapets exceed 1.5:1 URM Chimneys Heavy Cladding System Other observed nonstructural falling hazard	8-13 ft (slopes parallel to Humbolt St) HCT/Brick wall stair hall 3 and 4 level 1-2 Diaphragm step at boiler room Each side of gymnasium HCT/URM walls at classroom, restroom, hall Dowels Present but likely insufficient Recommend reviewing column detailing in greater detail Likely Prior Retrofit URM Local Exterior Cladding Wall	Sht 5 Wall section X-X Section A-A Sheet 9 Sheet 4 and 5 will not provide proper lat. resistance

Building Part (See Diagram Above)	Year Built	URM (SF)	ROM URM Only Retrofit	ROM Total Retrofit	No. of Stories	Basement	Penthouse	Drawings Referenced	Structural Horizontal Gravity System(s)	Structural Vertical Gravity System(s)	Lateral System (ASCE Designation)	Lateral System (Description)	Likely Deficiencies	Deficiency Notes	Additional Notes
Bldg. B	1951	0	\$0	\$680,000	1	None	No	None, Approximately Complete Original Documents	Wood T+G Plank, Wood Joists	Wood Framed Walls	W2	Wood Frames (Commercial and Industrial Buildings)	Torsional Irregularity Non-redundant (< 2 bays in < 2 lines) Seismic Separation (< 1%) Inadequate In-Plane Shear Large Unbraced Openings Diagonal Sheathing (4:1, 40') Unblocked Diaphragms (4:1, 40')		
Bldg. C	1953	0	\$0	\$600,000	1	None	No	Approximately Complete Original Documents	Wood Joists	Wood Framed Walls	W2	Wood Frames (Commercial and Industrial Buildings)	Reentrant Corners Torsional Irregularity Non-redundant (< 2 bays in < 2 lines) Seismic Separation (< 1%) Inadequate In-Plane Shear Large Unbraced Openings Straight Sheathing (2:1, 24') Diagonal Sheathing (4:1, 40')

Bldg. D1/D2	1953	0	\$0	\$180,000	1	None, Crawlspace	No	None	CFS Joists, Wood Plywood/OSB	Unknown, Wood Framed Walls, CFS Walls	W2, CFS2	Wood Frames (Commercial and Industrial Buildings), Sheathed Shear Wall System	Misc. Load Path Issue Inadequate Foundation Ties Inadequate Wall Anchorage Seismic Separation (< 1%) Inadequate In-Plane Shear Inadequate Sill-Foundation Connections (6 ft) Diaphragm discontinuity between units

Building Part (See Diagram Above)	Year Built	URM (SF)	ROM URM Only Retrofit	ROM Total Retrofit	No. of Stories	Basement	Penthouse	Drawings Referenced	Structural Horizontal Gravity System(s)	Structural Vertical Gravity System(s)	Lateral System (ASCE Designation)	Lateral System (Description)	Likely Deficiencies	Deficiency Notes	Additional Notes
Bldg. E	1986 (Relocated)	0	\$0	\$82,500	1	None	No	Approximately Complete Original Documents	Steel Joists	Wood Framed Walls, CFS Walls, Wood Framed Walls, CFS Walls, Unknown	W2	Wood Frames (Commercial and Industrial Buildings)	Misc. Load Path Issue Inadequate Foundation Ties Inadequate Wall Anchorage Seismic Separation (< 1%) Inadequate In-Plane Shear Inadequate Sill-Foundation Connections (6 ft) Diaphragm discontinuity between units		
Bldg. F	1990	0	\$0	\$400,000	1	None	No	Approximately Complete Original Documents	Wood Joists	Wood Framed Walls	W2	Wood Frames (Commercial and Industrial Buildings)	Reentrant Corners Seismic Separation (< 1%)

Bldg. F	1990	0	\$0	\$400,000	1	None	No	Approximately Complete Original Documents	Wood Joists	Wood Framed Walls	W2	Wood Frames (Commercial and Industrial Buildings)	Reentrant Corners Seismic Separation (< 1%)		
Bldg. G	1987	0	\$0	\$60,000	1	None, Crawlspace	No	None	CFS Joists, Wood Plywood/OSB	Wood Framed Walls, CFS Walls, Wood Framed Walls, CFS Walls, Unknown	W2, CFS1	Wood Frames (Commercial and Industrial Buildings), Sheathed Shear Wall System	Misc. Load Path Issue Inadequate Foundation Ties Inadequate Wall Anchorage Seismic Separation (< 1%) Inadequate In-Plane Shear Inadequate Sill-Foundation Connections (6 ft) Diaphragm discontinuity between units		
										UNKNOWN		Wall System	Diaphragm discontinuity between units

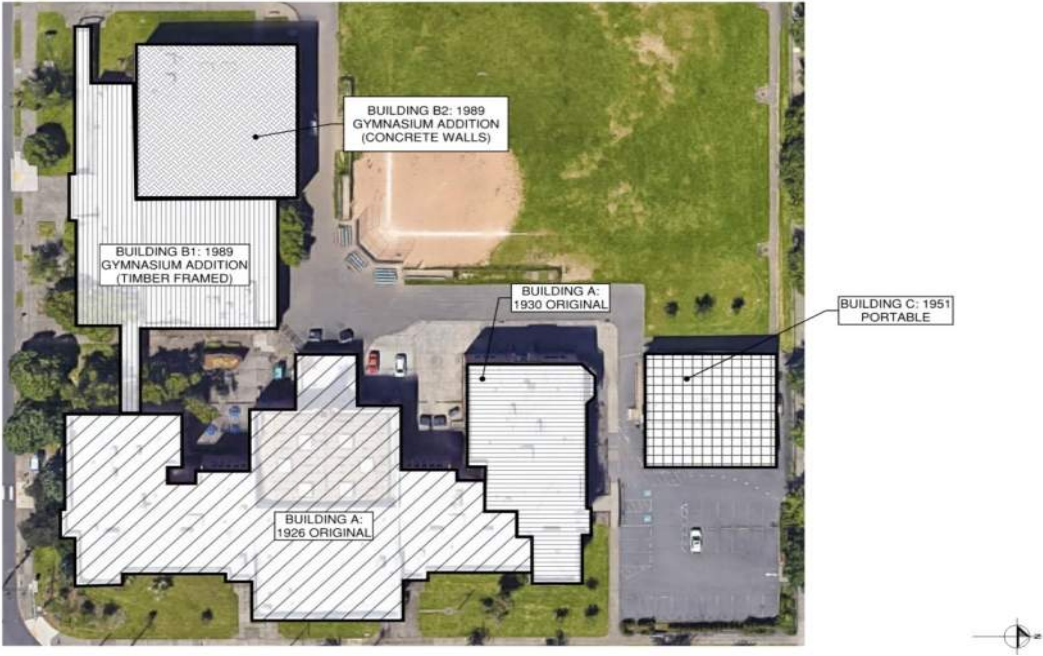
Building Year Plan:
(see below for deficiencies)

Building Part (See Diagram Above)	Year Built	URM (SF)	ROM URM Only Retrofit	ROM Total Retrofit	No. of Stories	Basement	Penthouse	Drawings Referenced	Structural Horizontal Gravity System(s)	Structural Vertical Gravity System(s)	Lateral System (ASCE Designation)	Lateral System (Description)	Likely Deficiencies	Deficiency Notes	Additional Notes
Bldg. A	1926 & 1930 (two stage construction)	0	\$0	\$16,350,000	2	Partial	No	Approximately Complete Original Documents	Concrete Beams, Concrete 1-way Slab	Conc. CIP Walls	C2	Concrete Shear Walls (Stiff Diaphragms)	Inadequate Foundation Ties Inadequate Wall Anchorage Split Levels Seismic Separation (< 1%) Masonry Partition Walls URM Chimneys Heavy Cladding System Under-Reinforced Walls Under-Reinforced Flat Slabs Inadequate Wall-Foundation Connection Deflection Compatibility Diaphragm Reinforcement at Openings	Various adjacent structures added Tall chimney Brick cladding	Original School Building

Building Part (See Diagram Above)	Year Built	URM (SF)	ROM URM Only Retrofit	ROM Total Retrofit	No. of Stories	Basement	Penthouse	Drawings Referenced	Structural Horizontal Gravity System(s)	Structural Vertical Gravity System(s)	Lateral System (ASCE Designation)	Lateral System (Description)	Likely Deficiencies	Deficiency Notes	Additional Notes
Bldg. B1	1989	0	\$0	\$1,170,000	1	None	No	Insufficient Original Documents	Steel Joists, Wood Beams	Wood Framed Walls, CFS Walls	W2	Wood Frames (Commercial and Industrial Buildings)	Misc. Load Path Issue Inadequate Wall Anchorage Split Levels Torsional Irregularity Seismic Separation (< 1%) Heavy Cladding System No Diaphragm-Wall Connection Inadequate Wall-Foundation Connection No Floor-to-Floor Connections (Shear and OT) Other Diaphragms	Connection to primary building Connection to primary building Double height at gym Mixed systems Brick cladding Connection back to primary structure Unknown condition Wood construction unknown	Cafeteria, office and covered walkways

Bldg. B2	1989	0	\$0	\$1,350,000	1	None	No	Insufficient Original Documents	Steel Joists, Wood Beams	Conc. CIP Walls	C2	Concrete Shear Walls (Stiff Diaphragms)	Misc. Load Path Issue Inadequate Wall Anchorage Split Levels Torsional Irregularity Seismic Separation (< 1%) Heavy Cladding System No Diaphragm-Wall Connection Inadequate Wall-Foundation Connection	Connection to primary building Connection to primary building Double height at gym Mixed systems Brick cladding Connection back to primary structure	High Gymnasium
Bldg. C	1951	0	\$0	\$382,500	1	None	No	None	Wood Joists	Wood Framed Walls	W2	Wood Frames (Commercial and Industrial Buildings)			Portable. Assumed Timber construction

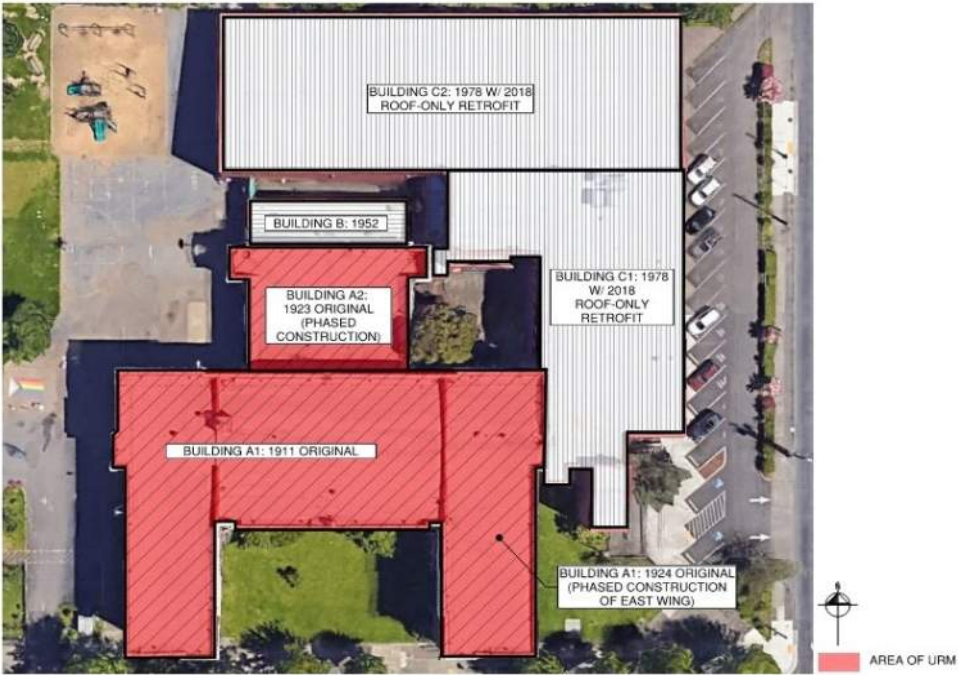
Building Year Plan:
(see below for deficiencies)

Building Part (See Diagram Above)	Year Built	URM (SF)	ROM URM Only Retrofit	ROM Total Retrofit	No. of Stories	Basement	Penthouse	Drawings Referenced	Structural Horizontal Gravity System(s)	Structural Vertical Gravity System(s)	Lateral System (ASCE Designation)	Lateral System (Description)	Likely Deficiencies	Deficiency Notes	Additional Notes
Bldg. A1	1911-1924	44000	\$13,200,000	\$13,200,000	2	Daylight	No	Approximately Complete Original Documents	Concrete Pan- Joists, Concrete Beams	Unreinforced Brick Walls, Concrete Columns	URMa	Unreinforced Masonry Bearing Walls (Stiff Diaphragms)	Misc. Load Path Issue Inadequate Wall Anchorage Reentrant Corners Overturning Seismic Separation (< 1%) Masonry Partition Walls Masonry ceiling URM Appendages over Exitway Beams, Girders, or Trusses bear on URM wall/pilaster	Tall slender URM (brick) piers no gap to A1, potentially insufficient gap to C1 HCT in basement HCT infill of pan joists

Building Part (See Diagram Above)	Year Built	URM (SF)	ROM URM Only Retrofit	ROM Total Retrofit	No. of Stories	Basement	Penthouse	Drawings Referenced	Structural Horizontal Gravity System(s)	Structural Vertical Gravity System(s)	Lateral System (ASCE Designation)	Lateral System (Description)	Likely Deficiencies	Deficiency Notes	Additional Notes
Bldg. A2	1924	4000	\$1,200,000	\$1,200,000	1	None	No	Approximately Complete Original Documents	Concrete Beams, Concrete 1-way Slab, Steel Truss	Unreinforced Brick Walls, Concrete Columns	URMa	Unreinforced Masonry Bearing Walls (Stiff Diaphragms)	Misc. Load Path Issue Inadequate Wall Anchorage Seismic Separation (< 1%) Beams, Girders, or Trusses bear on URM wall/pilaster Inadequate In-Plane Shear No Diaphragm-Wall Connection Diaphragm Reinforcement at Openings Beams, Girders, or Trusses bear on URM wall/pilaster	No Seismic Gap to A1 or B N-S direction	
Bldg. B	1924	0	\$0	\$150,000	1	None	No	Approximately Complete Original Documents	Wood Joists, Wood Plywood/OSB	Conc. CIP Walls	C2a	Concrete Shear Walls (Flexible Diaphragms)	Seismic Separation (< 1%) Masonry Partition Walls Heavy Cladding System Inadequate In-Plane Shear Under-Reinforced Walls No Diaphragm-Wall Connection Inadequate Wall-Foundation Connection Other Diaphragms Incomplete gravity frame	No Seismic Gap to A2 HCT Interior Walls Brick Veneer Reinforcement unknown Bridging only

Bldg. C1	1978	0	\$0	\$2,775,000	2	None	No	Approximately Complete Original Documents	Wood Beams, Wood Plywood/OSB, Hollow-Core Floor, Concrete Beams	Reinforced CMU Walls, Concrete Columns	RM1	Reinforced Masonry Bearing Walls (Flexible Diaphragms)	Overturning Reinforcement Provided at Wall Openings Inadequate In-Plane Shear Under-Reinforced Walls Wood Ledgers loaded across grain No Diaphragm-Wall Connection No Topping Slab-Wall Connection Deep Spandrels/Narrow Piers (50%, interfering walls)	No Seismic Gap to A2 HCT Interior Walls Brick Veneer Reinforcement unknown Bridging only

2024 Assessment Summary: Fernwood (Beverly Cleary)															
Building Part (See Diagram Above)	Year Built	URM (SF)	ROM URM Only Retrofit	ROM Total Retrofit	No. of Stories	Basement	Penthouse	Drawings Referenced	Structural Horizontal Gravity System(s)	Structural Vertical Gravity System(s)	Lateral System (ASCE Designation)	Lateral System (Description)	Likely Deficiencies	Deficiency Notes	Additional Notes
Bldg. C2	1978	0	\$0	\$1,300,000	1	None	No	Approximately Complete Original Documents	Wood Beams, Wood Plywood/OSB	Reinforced CMU Walls	RM1	Reinforced Masonry Bearing Walls (Flexible Diaphragms)	Reinforcement Provided at Wall Openings Proportions (h/t < 30) Under-Reinforced Walls Wood Ledgers loaded across grain	Double height space

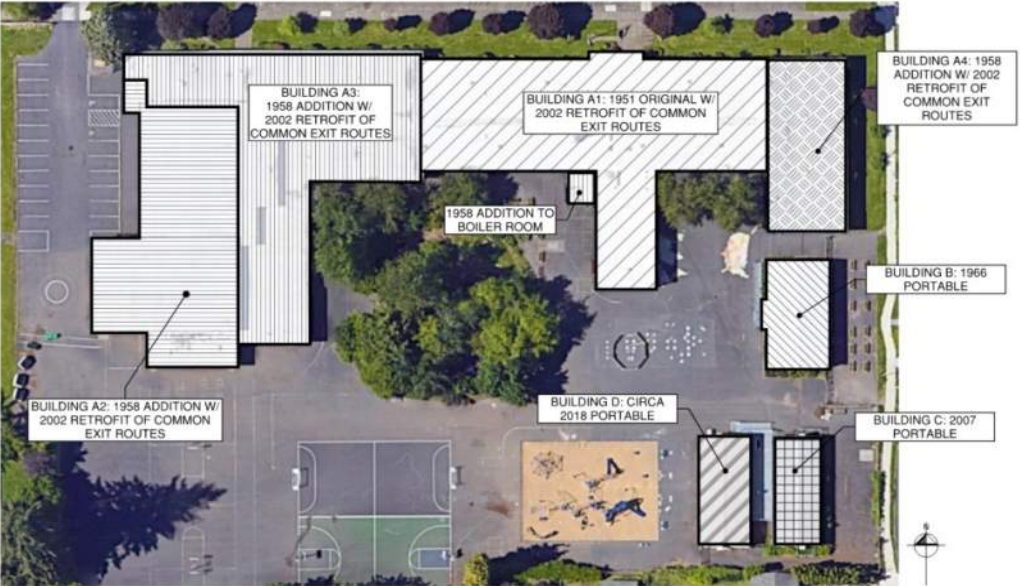
Building Year Plan:
(see below for deficiencies)

Building Part (See Diagram Above)	Year Built	URM (SF)	ROM URM Only Retrofit	ROM Total Retrofit	No. of Stories	Basement	Penthouse	Drawings Referenced	Structural Horizontal Gravity System(s)	Structural Vertical Gravity System(s)	Lateral System (ASCE Designation)	Lateral System (Description)	Likely Deficiencies	Deficiency Notes	Additional Notes
Bldg. A1	1951	0	\$0	\$1,530,000	1	None	No	Approximately Complete Original Documents	Wood Straight/Diag Sheathing, Wood Joists	Timber Frame	W2	Wood Frames (Commercial and Industrial Buildings)	Reentrant Corners Seismic Separation (< 1%) Heavy Cladding System Inadequate In-Plane Shear Straight Sheathing (2:1, 24')	to library. no gap to 1958 structures brick veneer east and west wall library	Original structure circa 1951. Addition to boiler room in 1958 w/ similar construction materials. Seismic upgrades in 2002 included (1) reducing the height of the URM chimney, (2) adding blocking & connections between the tops of stud walls and the roof diaphragm at the exterior perimeter walls, and (3) improving connections from the tops of 8 interior transverse walls to the roof diaphragm.

2024 Assessment Summary: Bridger															
Building Part (See Diagram Above)	Year Built	URM (SF)	ROM URM Only Retrofit	ROM Total Retrofit	No. of Stories	Basement	Penthouse	Drawings Referenced	Structural Horizontal Gravity System(s)	Structural Vertical Gravity System(s)	Lateral System (ASCE Designation)	Lateral System (Description)	Likely Deficiencies	Deficiency Notes	Additional Notes
Bldg. A2	1958	0	\$0	\$1,470,000	1	None	No	Approximately Complete Original Documents	Wood Straight/Diag Sheathing, Wood Joists, Wood Beams	Wood Framed Walls	C2a	Concrete Shear Walls (Flexible Diaphragms)	Inadequate Wall Anchorage Split Levels Misc. Plan Irregularity Masonry Partition Walls No Diaphragm-Wall In-Plane Connection Inadequate Wall-Foundation Connection Diagonal Sheathing (4:1, 40')	check OOP wall to diaphragm connection at lockers to exterior concrete walls At roof - May have been addressed in 2002 upgrades. Check adequacy. stiffness of concrete walls around gym and cafeteria may be incompatible with the timber walls at the classrooms concrete block and glazed tile partitions in locker rooms check wall to diaphragm connection at lockers to exterior concrete walls reinforcing dowels do not appear to extend into the foundation base Some blocking added in 2002. Original diagonal sheathing retained. Check adequacy.	Western portion of 1958 additions - Gym & multipurpose room. Seismic upgrades in 2002 included (1) improving the connection from the top of the concrete walls to the roof diaphragm at the gym and cafeteria; and (2) improving connections from the abutting lower roof diaphragms to the sides of the concrete walls at the gym and cafeteria.

Bldg. A3	1958	0	\$0	\$1,360,000	1	None	No	Approximately Complete Original Documents	Wood Straight/Diag Sheathing, Wood Beams	Wood Framed Walls	W2	Wood Frames (Commercial and Industrial Buildings)	Split Levels Misc. Plan Irregularity Seismic Separation (< 1%) Inadequate In-Plane Shear Diagonal Sheathing (4:1, 40')	At roof - May have been addressed in 2002 upgrades. Check adequacy. stiffness of concrete walls around gym and cafeteria may be incompatible with the timber walls at the classrooms no gap to original portion check east classrooms in N/S direction	Western portion of 1958 additions - classrooms. Seismic upgrades in 2002 included (1) adding blocking & connections between the tops of stud walls and the roof diaphragm at the exterior perimeter walls; and (2) improving connections from the abutting lower roof diaphragms to the sides of the concrete walls at the gym and cafeteria.
Bldg. A4	1958	0	\$0	\$420,000	1	None	No	Approximately Complete Original Documents	Wood Straight/Diag Sheathing, Wood Beams	Timber Frame	W2	Wood Frames (Commercial and Industrial Buildings)	Reentrant Corners Seismic Separation (< 1%) Heavy Cladding System Inadequate In-Plane Shear Inadequate Wood Sill-Foundation Connections (6 ft) No Girder-Column Connections Diagonal Sheathing (4:1, 40')	no gap to existing, though also wood framed brick veneer check 5/8" di bolts @ 8'-0" o.c. per section A/19 check connection between rafters and corridor wall	Seismic upgrades in 2002 included adding blocking & connections between the tops of stud walls and the roof diaphragm at the exterior perimeter walls

2024 Assessment Summary: Bridger															
Building Part (See Diagram Above)	Year Built	URM (SF)	ROM URM Only Retrofit	ROM Total Retrofit	No. of Stories	Basement	Penthouse	Drawings Referenced	Structural Horizontal Gravity System(s)	Structural Vertical Gravity System(s)	Lateral System (ASCE Designation)	Lateral System (Description)	Likely Deficiencies	Deficiency Notes	Additional Notes
Bldg. B	1966	0	\$0	\$150,000	1	Crawlspace	No	Insufficient Original Documents	Wood Plywood/OSB, Wood Beams	Timber Frame	W2	Wood Frames (Commercial and Industrial Buildings)	Inadequate In-Plane Shear Inadequate Wood Sill-Foundation Connections (6 ft) No Girder-Column Connections Roof Chord Discontinuity Straight Sheathing (2:1, 24')	Unknown connection Unknown connection Unknown connection Unknown sheathing type	Wood framed portable classroom building constructed circa 1966. Original structural drawings were not provided. Alterations (non-structural) undertaken in 1973 & 2007.

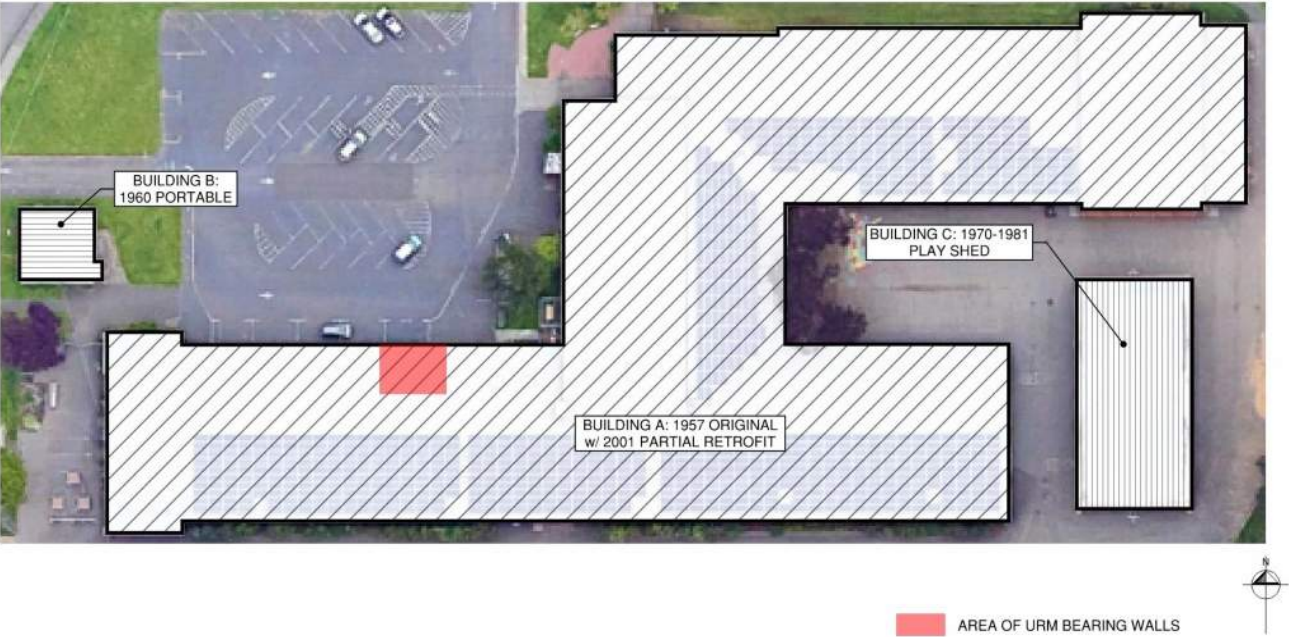
Building Year Plan:
(see below for deficiencies)

Building Part (See Diagram Above)	Year Built	URM (SF)	ROM URM Only Retrofit	ROM Total Retrofit	No. of Stories	Basement	Penthouse	Drawings Referenced	Structural Horizontal Gravity System(s)	Structural Vertical Gravity System(s)	Lateral System (ASCE Designation)	Lateral System (Description)	Likely Deficiencies	Deficiency Notes	Additional Notes
Bldg. A	1957	100	\$25,000	\$11,125,000	1	Crawlspace	No	Approximately Complete Original Documents	Wood T+G Plank, Steel Joists, Steel Beams, Wood Beams, Concrete 1-way Slab, Concrete Beams	Wood Framed Walls, Steel Columns, Reinforced Brick Walls, Unreinforced Brick Walls, Concrete Columns, Conc. CIP Walls	W2, URM, RM1, C2	Wood Frames (Commercial and Industrial Buildings), Unreinforced Masonry Bearing Walls (Flexible Diaphragms)	Sloping Site (full story difference across site) Near-fault location (250ft, DOGAMI Active Faults) Inadequate Foundation Ties Misc. Plan Irregularity Non-redundant (< 2 bays in < 2 lines) Masonry Partition Walls Heavy Cladding System Inadequate In-Plane Shear Plaster or Gypsum Shear Walls Large Unbraced Openings No Floor-to-Floor Connections (Shear and OT) Roof Chord Discontinuity Straight Sheathing (2:1, 24') Walls Spaced Far Apart Inadequate In-Plane Shear Under-Reinforced Walls Wood Ledgers loaded across grain No Diaphragm-Wall Connection Discontinuous Cross Ties Straight Sheathing (2:1, 24') Inadequate Composite Behavior Beams, Girders, or Trusses bear on URM wall/pilaster Thin Walls (9 top, 15 first, 13 other/single) Under-Reinforced Walls	incompatible systems	Fmr play area infill not documented, construction appears similar. Retrofit in 2001 of unknown scope (documents not available). Extent of unreinforced masonry bearing wall appears to be limited to the transformer vault.

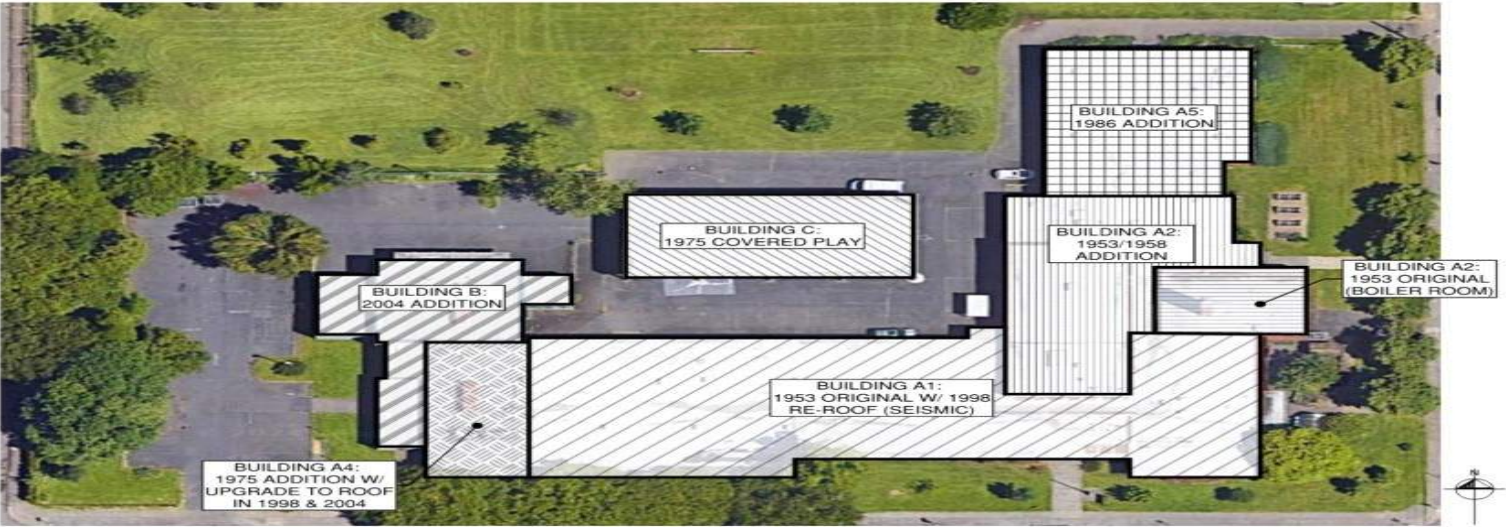
Building Year Plan:
(see below for deficiencies)

Building Part (See Diagram Above)	Year Built	URM (SF)	ROM URM Only Retrofit	ROM Total Retrofit	No. of Stories	Basement	Penthouse	Drawings Referenced	Structural Horizontal Gravity System(s)	Structural Vertical Gravity System(s)	Lateral System (ASCE Designation)	Lateral System (Description)	Likely Deficiencies	Deficiency Notes	Additional Notes
Bldg. A1	1953	0	\$0	\$1,215,000	1	None	No	Approximately Complete Original Documents	Wood T+G Plank, Wood Beams	Wood Framed Walls	W2	Wood Frames (Commercial and Industrial Buildings)	Inadequate Foundation Ties Split Levels Reentrant Corners Seismic Separation (< 1%) Heavy Cladding System Inadequate In-Plane Shear Straight Sheathing (2:1, 24')	1998 FIP identified the need for foundation underpinning for lateral forces at roof No gap to additions Masonry veneer around means of egress was secured in 1998	1953 Original structure - Classrooms are typically timber framed walls. 1998 FIP included upgrading the shear transfer mechanism between the wood-framed walls and roof diaphragm and adding continuity ties .

Bldg. A2	1953	0	\$0	\$500,000	1	None	No	Approximately Complete Original Documents	Concrete 1-way Slab	Conc. CIP Walls	C2	Concrete Shear Walls (Stiff Diaphragms)	Inadequate Foundation Ties Split Levels Masonry Partition Walls URM Chimneys Heavy Cladding System Under-Reinforced Walls No Diaphragm-Wall Connection Deflection Compatibility	1998 FIP identified the need for foundation underpinning for lateral forces Masonry veneer around means of egress was secured in 1998 1998 FIP identified that confinement reinforcement in concrete shear walls should be upgraded. doesn't appear to have dowelled bars between roof slab and walls Widely spaced ties in columns & beams. Check.	1953 Original boiler room is (CIP concrete walls with a concrete slab diaphragm).
Bldg. A3	1953/1958	0	\$0	\$1,050,000	1	None	No	Approximately Complete Original Documents	Wood T+G Plank, Wood Beams	Conc. CIP Walls, Wood Framed Walls	C2a, W2	Concrete Shear Walls (Flexible Diaphragms), Concrete Shear Walls (Stiff Diaphragms), Wood Frames (Commercial and Industrial Buildings)	Misc. Load Path Issue Inadequate Foundation Ties Inadequate Wall Anchorage Split Levels Reentrant Corners Seismic Separation (< 1%) Heavy Cladding System Under-Reinforced Walls No Diaphragm-Wall In-Plane Connection Straight Sheathing (2:1, 24')	Beams pocketed into concrete shear walls 1998 FIP identified the need for foundation underpinning for lateral forces no gap to 1986 addition Masonry veneer around means of egress was secured in 1998 1998 FIP identified that confinement reinforcement in concrete shear walls should be upgraded. Cafetorium roof	Cafetorium is conc walls w/ wood diaphragm. The original portion of cafetorium was just the stage, though the remaining portion was planned during the original design. The addition was constructed in 1958. Rooms north of the cafetorium are timber framed walls.

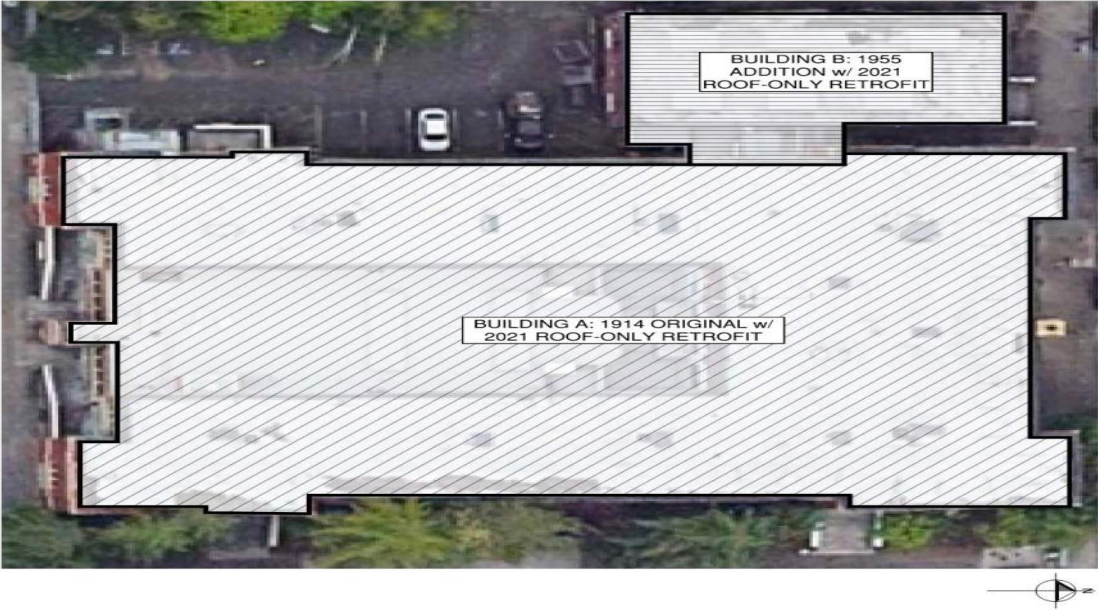
Building Year Plan:
(see below for deficiencies)

Building Part (See Diagram Above)	Year Built	URM (SF)	ROM URM Only Retrofit	ROM Total Retrofit	No. of Stories	Basement	Penthouse	Drawings Referenced	Structural Horizontal Gravity System(s)	Structural Vertical Gravity System(s)	Lateral System (ASCE Designation)	Lateral System (Description)	Likely Deficiencies	Deficiency Notes	Additional Notes
Bldg. A	1914	0	\$0	\$18,645,000	2	Daylight	No	Approximately Complete Original Documents	Concrete 1-way Slab, Concrete Pan-Joists, Concrete Beams	Concrete Columns, Conc. CIP Walls, Unreinforced Brick Walls	C2, C3	Concrete Shear Walls (Stiff Diaphragms), Concrete Frames with Infill Masonry Shear Walls (Stiff Diaphragms)	Split Levels Misc. Moderate Vertical Irregularity Reentrant Corners Large Diaphragm Openings (50%) Masonry Partition Walls Heavy Cladding System Inadequate In-Plane Shear Under-Reinforced Walls Under-Reinforced Flat Slabs No Diaphragm-Wall Connection (Conc.) Inadequate Wall-Foundation Connection Deflection Compatibility Diaphragm Reinforcement at Openings Thin Walls (>1:9) Inadequate In-Plane Shear No diaphragm-wall connection (URM)	Diaphragm steps at auditorium Conc. Walls over infilled frames large skylights Brick façade thin slabs HCT	1999 CMU elevator shaft 2021 roof-only seismic upgrade

Bldg. B	1955	0	\$0	\$360,000	1	None	No	Approximately Complete Original Documents	Concrete 1-way Slab, Concrete Beams, Steel Beams	Conc. CIP Walls	C2	Concrete Shear Walls (Stiff Diaphragms)	Split Levels Seismic Separation (< 1%) Heavy Cladding System Inadequate In-Plane Shear Under-Reinforced Walls Under-Reinforced Flat Slabs No Diaphragm-Wall Connection (Conc.) Inadequate Wall-Foundation Connection Diaphragm Reinforcement at Openings	entryway steps attached lobby between part A	2021 roof-only seismic upgrade

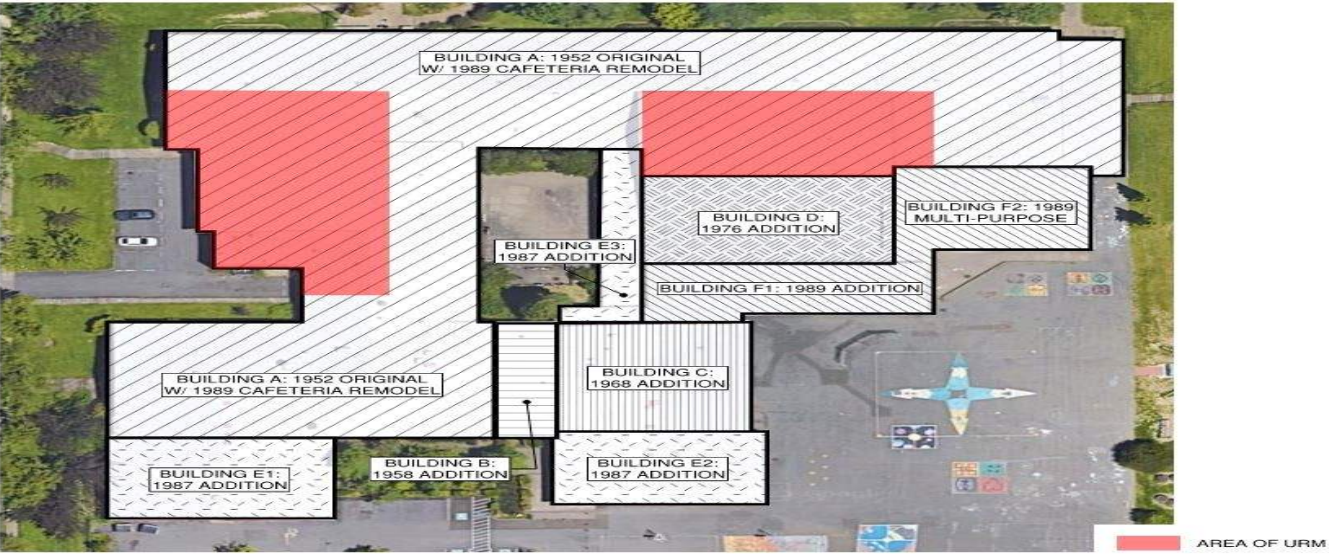
Building Year Plan:
(see below for deficiencies)

Building Part (See Diagram Above)	Year Built	URM (SF)	ROM URM Only Retrofit	ROM Total Retrofit	No. of Stories	Basement	Penthouse	Drawings Referenced	Structural Horizontal Gravity System(s)	Structural Vertical Gravity System(s)	Lateral System (ASCE Designation)	Lateral System (Description)	Likely Deficiencies	Deficiency Notes	Additional Notes
Bldg. A	1952	14000	\$4,900,000	\$8,500,000	1	None	No	Approximately Complete Original Documents	Wood Joists, Wood Trusses	Unreinforced Brick Walls, Wood Framed Walls	W2	Wood Frames (Commercial and Industrial Buildings)	Inadequate Foundation Ties Vertical LRFS elements are offset Reentrant Corners Deep Spandrels/Narrow Piers (50%, interfering walls) In-Plane Stress Gypsum Wall board or Plaster Shear walls Inadequate Diaphragm-Wall Connection Other Diaphragms Beams, Girders, or Trusses bear on URM wall/pilaster Inadequate In-Plane Shear Thin Walls (9 top, 15 first, 13 other/single) Cavity Wall Construction Heavy Cladding System	URM walls not adequately tied to foundation Narrow piers Unknown from drawings and unable to determine on site Tectum at Gymnasium Narrow piers at gym URM walls Applicable to URM walls Brick veneer, glass block	URM double height bordering walls of gymnasium and cafeteria.

Bldg. B	1958	0	\$0	\$220,000	1	None	No	Approximately Complete Original Documents	Wood Joists, Wood Trusses	Wood Framed Walls	W2	Wood Frames (Commercial and Industrial Buildings)	Seismic Separation (< 1%) In-Plane Stress Gypsum Wall board or Plaster Shear walls Inadequate Diaphragm-Wall Connection Diagonally Sheathed/Unblocked Diaphragms > 40' or 1:4 Heavy Cladding System	Buildings interconnected Inadequate connection to tie to adjacent structures for lateral Diagonal sheathing Brick veneer
Bldg. C	1968	0	\$0	\$510,000	1	None	No	Approximately Complete Original Documents	Wood Trusses, Steel Column	Wood Framed Walls	W2	Wood Frames (Commercial and Industrial Buildings)	In-Plane Stress Gypsum Wall board or Plaster Shear walls Heavy Cladding System	Brick veneer
Bldg. D	1976	0	\$0	\$490,000	1	None	No	Approximately Complete Original Documents	Wood Trusses, Steel Column	Wood Framed Walls	W2	Wood Frames (Commercial and Industrial Buildings)	Seismic Separation (< 1%) Inadequate Sill-Foundation Connection Heavy Cladding System	Buildings interconnected Brick veneer

Bldg. E1 + E2 + E3	1987	0	\$0	\$1,010,000	1	None	No	Approximately Complete Original Documents	Wood Trusses, Wood Beams	Wood Framed Walls	W2	Wood Frames (Commercial and Industrial Buildings)	Seismic Separation (< 1%) Heavy Cladding System	Buildings interconnected Brick Veneer	
Bldg. F1	1989	0	\$0	\$490,000	1	None	No	Approximately Complete Original Documents	Wood Trusses, Wood Beams	Wood Framed Walls	W2	Wood Frames (Commercial and Industrial Buildings)	Seismic Separation (< 1%) Inadequate Sill-Foundation Connection Heavy Cladding System	Brick Veneer	
Bldg. F2	1989	0	\$0	\$487,500	1	None	No	Approximately Complete Original Documents	Wood Beams	Reinforced CMU Walls	RM1	Reinforced Masonry Bearing Walls (Flexible Diaphragms)	Seismic Separation (< 1%) Under-Reinforced Walls No Topping Slab-Wall Connection	Slab not tied into wall footing

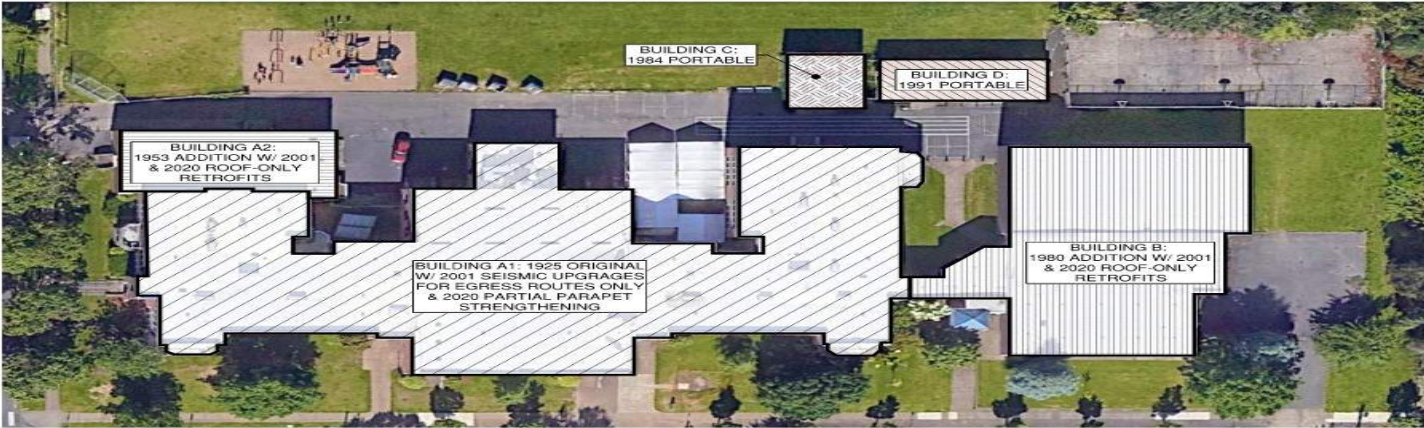
Building Year Plan:
(see below for deficiencies)

Building Part (See Diagram Above)	Year Built	URM (SF)	ROM URM Only Retrofit	ROM Total Retrofit	No. of Stories	Basement	Penthouse	Drawings Referenced	Structural Horizontal Gravity System(s)	Structural Vertical Gravity System(s)	Lateral System (ASCE Designation)	Lateral System (Description)	Likely Deficiencies	Deficiency Notes	Additional Notes
Bldg. A1	1925	0	\$0	\$8,000,000	1	Partial, Crawlspace	No	Approximately Complete Original Documents	Concrete Pan- Joists, Concrete Beams, Steel Joists, Steel Truss	Conc. CIP Walls, Concrete Columns	C2	Concrete Shear Walls (Stiff Diaphragms)	Inadequate Wall Anchorage Moderate Vertical Element Size Discontinuity (50-75%) Split Levels Reentrant Corners Masonry Diaphragm Seismic Separation (< 1%) Masonry Partition Walls Masonry ceiling URM Parapets exceed 1.5:1 Heavy Cladding System Other observed nonstructural falling hazard Inadequate In-Plane Shear Under-Reinforced Walls Under-Reinforced Flat Slabs No Diaphragm-Wall Connection Inadequate Wall-Foundation Connection Deflection Compatibility	Check anchorage of steel trusses and "I"-joists East wall of classroom 205 and 217 do not continue to foundation Section D-D and E-E on pg 16 indicate tile used in ceiling No gap Section D-D and E-E on pg 16 indicate tile used in ceiling Parapet bracing over stairs #2 & #3 exits only (circa 2001) & bracing around boiler room added in 2020 Brick veneer E.g., cast stone parapets & Plaster ceilings hung from trusses Few continuous walls around classrooms Walls appear to be typically unreinforced Check adequacy of connections to slabs & steel members Walls appear to be typically unreinforced	1925 Original Structure - Jones School. Two-story structure with classrooms, auditorium and gyms (boys & girls). Roof and floors typically pan joist system with topping slab. Auditorium and gyms have 2" conc. slab supported by steel I-joists and steel trusses. Some seismic upgrades in 2001 - mostly along egress routes, included installation of strong backs along stairways and parapet bracing over stairs #2 & #3 exits. Also, strong backs installed at masonry wall adjacent to 1953 addition and chimney height was reduced. Further parapet and chimney bracing added in 2020

Bldg. A2	1953	0	\$0	\$277,500	1	None	No	Approximately Complete Original Documents	Wood Plywood/OSB, Wood T+G Plank, Steel Truss, Wood Joists	Conc. CIP Walls	C2a	Concrete Shear Walls (Flexible Diaphragms)	Masonry Partition Walls Heavy Cladding System Inadequate In-Plane Shear	In kitchen. Also hollow tile @ east wall Brick veneer Check North/South direction	1953 Addition. Concrete walls, typ. T&G diaphragm supported by steel joists over cafeteria timber joists over kitchen. Roof-only retrofit in 2001. New ties @ south wall, central wall and east wall. Another roof-only retrofit in 2020 including a plywood overlay and new diaphragm-wall connections & anchorage
Bldg. B	1980	0	\$0	\$1,340,000	1	None	No	Approximately Complete Original Documents	Wood Plywood/OSB, Wood Truss-Joists	Reinforced CMU Walls	RM1	Reinforced Masonry Bearing Walls (Flexible Diaphragms)	Split Levels Seismic Separation (< 1%) Under-Reinforced Walls	at roof no gap to original building Typical reinforcing is deficient per structural notes on page BS2	1980 Addition of industrial arts, gym & lockers. Roof-only retrofit in 2001

Bldg. C	1984	0	\$0	\$67,500	1	Crawlspace	No	Insufficient Original Documents	Unknown	Wood Framed Walls	W2	Wood Frames (Commercial and Industrial Buildings)	Inadequate In-Plane Shear No Girder-Column Connections Roof Chord Discontinuity	analysis required analysis required analysis required	1984 Portable. Moved from West Sylvan, so age of superstructure is unknown. Only foundation drawings available. Assumed to be wood framed with no significant seismic upgrades

Bldg. D	1991	0	\$0	\$135,000	1	Crawlspace	No	Insufficient Original Documents	Unknown	Wood Framed Walls	W2	Wood Frames (Commercial and Industrial Buildings)	Inadequate In-Plane Shear No Girder-Column Connections Roof Chord Discontinuity	analysis required analysis required analysis required	1991 Portable. Only site information available - nothing architectural or structural. Assumed to be wood framed with no significant seismic upgrades. Benchmark building.

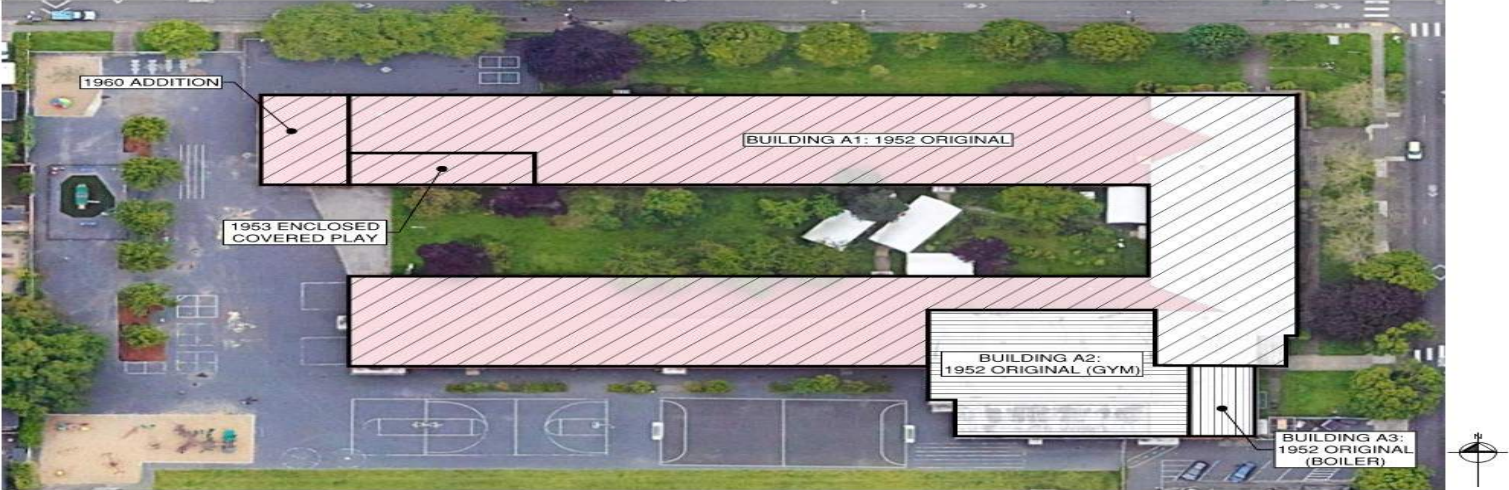
Building Year Plan:
(see below for deficiencies)

Building Part (See Diagram Above)	Year Built	URM (SF)	ROM URM Only Retrofit	ROM Total Retrofit	No. of Stories	Basement	Penthouse	Drawings Referenced	Structural Horizontal Gravity System(s)	Structural Vertical Gravity System(s)	Lateral System (ASCE Designation)	Lateral System (Description)	Likely Deficiencies	Deficiency Notes	Additional Notes
Bldg. A1	1952, 1960	0	\$0	\$5,250,000	1	None	No	Approximately Complete Original Documents	Wood Straight/Diag Sheathing, Wood Beams, Wood Joists	Wood Framed Walls	W2, C2	Wood Frames (Commercial and Industrial Buildings), Concrete Shear Walls (Stiff Diaphragms)	Split Levels Reentrant Corners Misc. Plan Irregularity Seismic Separation (< 1%) Heavy Cladding System Inadequate In-Plane Shear Inadequate Wood Sill-Foundation Connections (6 ft) Roof Chord Discontinuity Straight Sheathing (2:1, 24')	At gym & boiler room U-shaped building Deformation incompatibility between concrete walls of boiler room and adjacent structure. no gap between building portions brick veneer Check walls between classrooms (See detail 46)	Original Structure - U-shaped building. Classrooms are timber framed with trussed rafter roof. Cafeteria is timber framed with glum-lam beam roof. Alterations to the west end of the north wing include enclosing the covered play to make 3 new classrooms in 1953 and adding toilets and two new classrooms in 1960. Construction materials and detailing matches original construction.

Bldg. A2	1952	0	\$0	\$950,000	1	None	No	Approximately Complete Original Documents	Wood Straight/Diag Sheathing, Wood Trusses, Wood Joists	Wood Framed Walls	W2	Wood Frames (Commercial and Industrial Buildings)	Misc. Load Path Issue Split Levels Misc. Plan Irregularity Seismic Separation (< 1%) Masonry Partition Walls Heavy Cladding System Inadequate In-Plane Shear No Girder-Column Connections Roof Chord Discontinuity Straight Sheathing (2:1, 24')	Check gym truss detailing - not in drawings Deformation incompatibility between concrete walls of boiler room and adjacent structure. no gap between building portions glazed tile walls around locker room showers brick veneer Typically non-quantifiable connections between roof trusses and walls	Original Structure - Gym is timber framed with ring-connected bow string trusses. Project folder shows gym truss drawings dated 2016, however these drawings weren't received.

Bldg. A3	1952	0	\$0	\$320,000	1	None	No	Approximately Complete Original Documents	Concrete 1-way Slab, Concrete Beams	Conc. CIP Walls	C2	Concrete Shear Walls (Stiff Diaphragms)	Inadequate Wall Anchorage Split Levels Misc. Plan Irregularity Seismic Separation (< 1%) Masonry Partition Walls URM Chimneys Heavy Cladding System No Diaphragm-Wall Connection Inadequate Wall-Foundation Connection	There are no hooked dowels connecting the concrete walls to the topping slab. Deformation incompatibility between concrete walls of boiler room and adjacent structure. no gap between building portions unreinforced CMU around janitors office height has bee reduced, but still above roof line. brick veneer There are no hooked dowels connecting the concrete walls to the topping slab. Dowels appear to be straight to foundation (i.e., not hooked)	Original Structure - Boiler room area has CIP concrete walls with concrete slab roof.

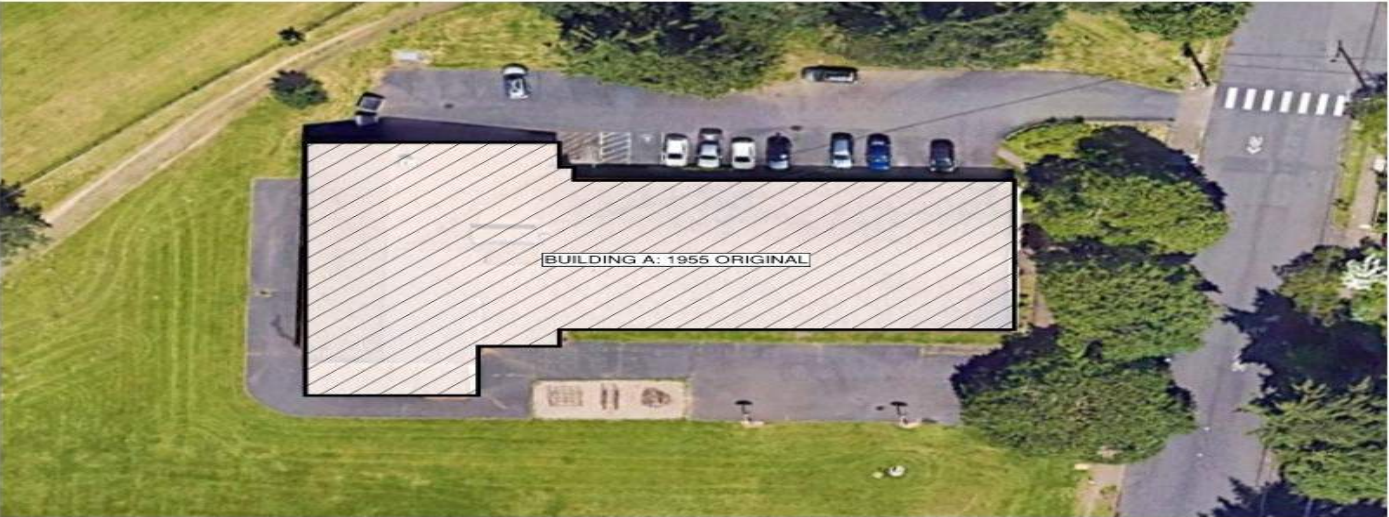
Building Year Plan:
(see below for deficiencies)

Building Part (See Diagram Above)	Year Built	URM (SF)	ROM URM Only Retrofit	ROM Total Retrofit	No. of Stories	Basement	Penthouse	Drawings Referenced	Structural Horizontal Gravity System(s)	Structural Vertical Gravity System(s)	Lateral System (ASCE Designation)	Lateral System (Description)	Likely Deficiencies	Deficiency Notes	Additional Notes
Bldg. A	1955	0	\$0	\$1,645,000	1	None	No	Approximately Complete Original Documents	Wood Plywood/OSB, Wood Trusses	Timber Frame	W2	Wood Frames (Commercial and Industrial Buildings)	Inadequate Foundation Ties URM Chimneys Inadequate In-Plane Shear Roof Chord Discontinuity Unblocked Wood Panel Diaphragms (4:1, 40')	Doesn't appear to be a positive connection between foundation base and stem Lots of openings @ exterior. Assumed gyp @ interior walls.	Simple, timber-framed structure. Appears to have had limited interventions

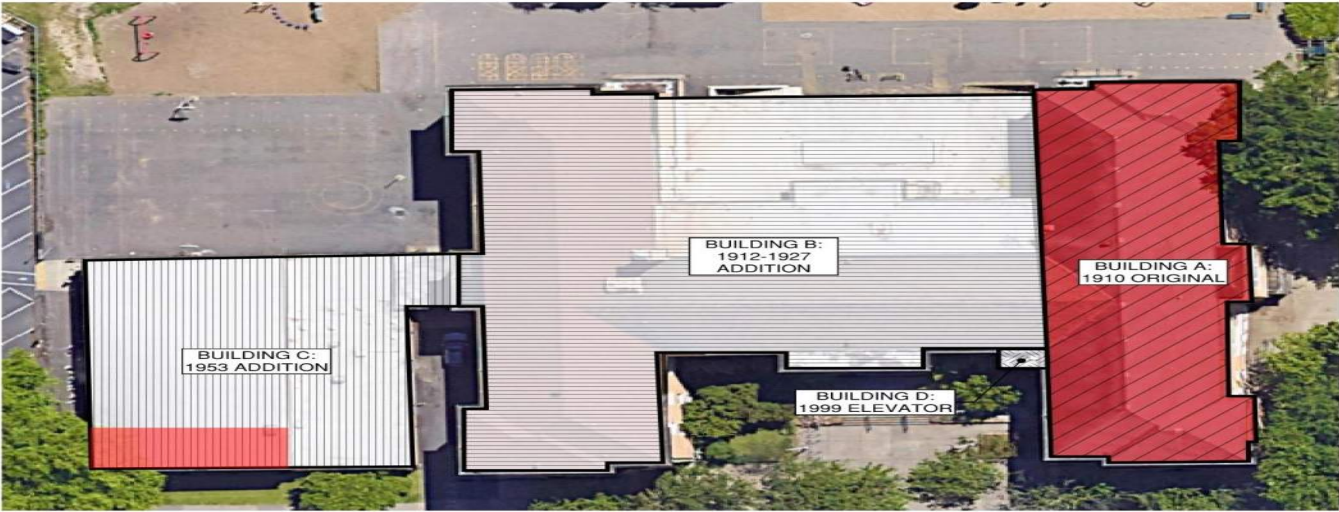
Building Year Plan:
(see below for deficiencies)

Building Part (See Diagram Above)	Year Built	URM (SF)	ROM URM Only Retrofit	ROM Total Retrofit	No. of Stories	Basement	Penthouse	Drawings Referenced	Structural Horizontal Gravity System(s)	Structural Vertical Gravity System(s)	Lateral System (ASCE Designation)	Lateral System (Description)	Likely Deficiencies	Deficiency Notes	Additional Notes
Bldg. A	1910	8000	\$1,600,000	\$4,000,000	2	Daylight	No	None	Wood Plywood/OSB, Plaster & Lathe, Wood Joists, Steel Truss, Steel Beams	Wood Framed Walls, Conc. CIP Walls, Concrete Columns, Unreinforced Brick Walls	URM, W2	Unreinforced Masonry Bearing Walls (Flexible Diaphragms), Wood Frames (Commercial and Industrial Buildings)	Reentrant Corners Beams, Girders, or Trusses bear on URM wall/pilaster Walls Spaced Far Apart Inadequate In-Plane Shear (URM) Thin Walls (9 top, 15 first, 13 other/single) Wood Ledgers loaded across grain No Diaphragm-Wall Connection No Girder-Column Connections Discontinuous Cross Ties Straight Sheathing (2:1, 24') Inadequate In-Plane Shear (Wood) Plaster or Gypsum Shear Walls Large Unbraced Openings No Floor-to-Floor Connections (Shear and OT) Inadequate Wood Sill-Foundation Connections (6 ft) Roof Chord Discontinuity Masonry Partition Walls		Basement appears to be URM Brick, Wood walls above Original construction: Center wing in 1912, North wing in 1914, gym in 1914 or 1927 1999 - Partial seismic upgrade at URM portion 2023 - roof-only retrofit (assumed seismic retrofit, documentation not available)

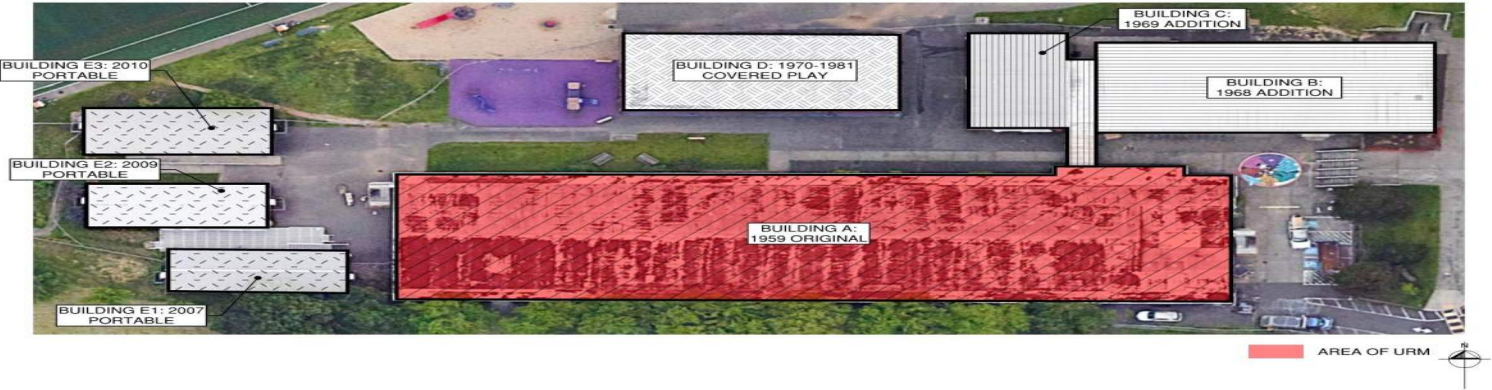
Building Year Plan:
(see below for deficiencies)

Building Part (See Diagram Above)	Year Built	URM (SF)	ROM URM Only Retrofit	ROM Total Retrofit	No. of Stories	Basement	Penthouse	Drawings Referenced	Structural Horizontal Gravity System(s)	Structural Vertical Gravity System(s)	Lateral System (ASCE Designation)	Lateral System (Description)	Likely Deficiencies	Deficiency Notes	Additional Notes
Bldg. A	1959	20800	\$4,160,000	\$4,160,000	1	Crawlspace	No	Approximately Complete Original Documents	Tectum, Steel Truss, Wood Plywood/OSB	Steel Columns, Unreinforced CMU Walls	URM	Unreinforced Masonry Bearing Walls (Flexible Diaphragms)	High Landslide Susceptibility (DOGAMI State Overview) Inadequate Foundation Ties Split Levels Non-redundant (< 2 bays in < 2 lines) Beams, Girders, or Trusses bear on URM wall/pilaster Inadequate In-Plane Shear Thin Walls (9 top, 15 first, 13 other/single) Unbraced Gable Walls No Diaphragm-Wall Connection Discontinuous Cross Ties URM Chimneys Heavy Cladding System	Roof Diaphragm split at East end Exterior Windows No longitudinal ties shown	Recommend investigating crawlspace for potential joist deterioration (gravity concern) 2000 - partial seismic upgrade 2023 - roof-only seismic upgrade
