Portland Public Schools District Assessments

2024 PPS Seismic Assessments All Schools

Version 1.0
5/15/2024

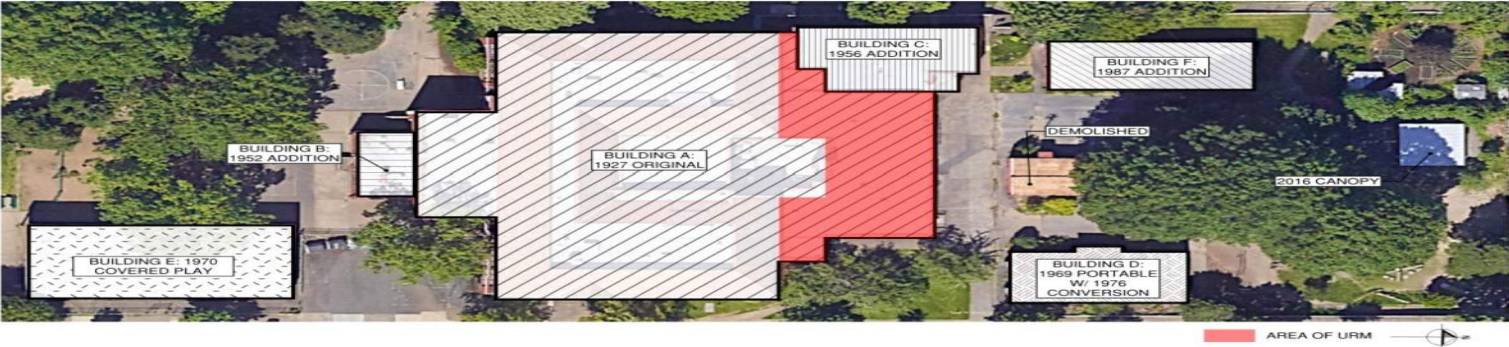
Building Year Plan:
(see below for deficiencies)

Building Part (See Diagram Above)	Year Built	URM (SF)	ROM URM Only Retrofit	ROM Total Retrofit	No. of Stories	Basement	Penthouse	Drawings Referenced	Structural Horizontal Gravity System(s)	Structural Vertical Gravity System(s)	Lateral System (ASCE Designation)	Lateral System (Description)	Likely Deficiencies	Deficiency Notes	Additional Notes
Bldg. A	1927	6500	\$2,600,000	\$17,500,000	2	Daylight, Partial	No	Approximately Complete Original Documents	Concrete Pan- Joists, Steel Truss, Steel Beams	Reinforced Concrete Walls, Unreinforced Brick Walls	C2	Concrete Shear Walls (Stiff Diaphragms)	Inadequate Foundation Ties Mass Discontinuity Deep Spandrels/Narrow Piers (50%, interfering walls) Under-Reinforced Walls Under-Reinforced Flat Slabs Inadequate Wall-Foundation Connection Masonry Partition Walls Concrete Parapets exceed 2.5:1 Heavy Cladding System URM Appendages over Exit way	U-shaped level 2 Hollow clay tile walls throughout Brick veneer	URM at gym and north exterior walls at entries. Slender steel gravity columns in URM at gym, but likely deficient for gravity loads alone.
