Regarding: Lead Paint Condition Assessment
Marshall High School
3905 SE 91st Avenue
Portland, Oregon 97266
PBS Project: 6500.721 Phase 0074

Marshall High School
Assessment of Paint/Varnish in Deteriorated Condition

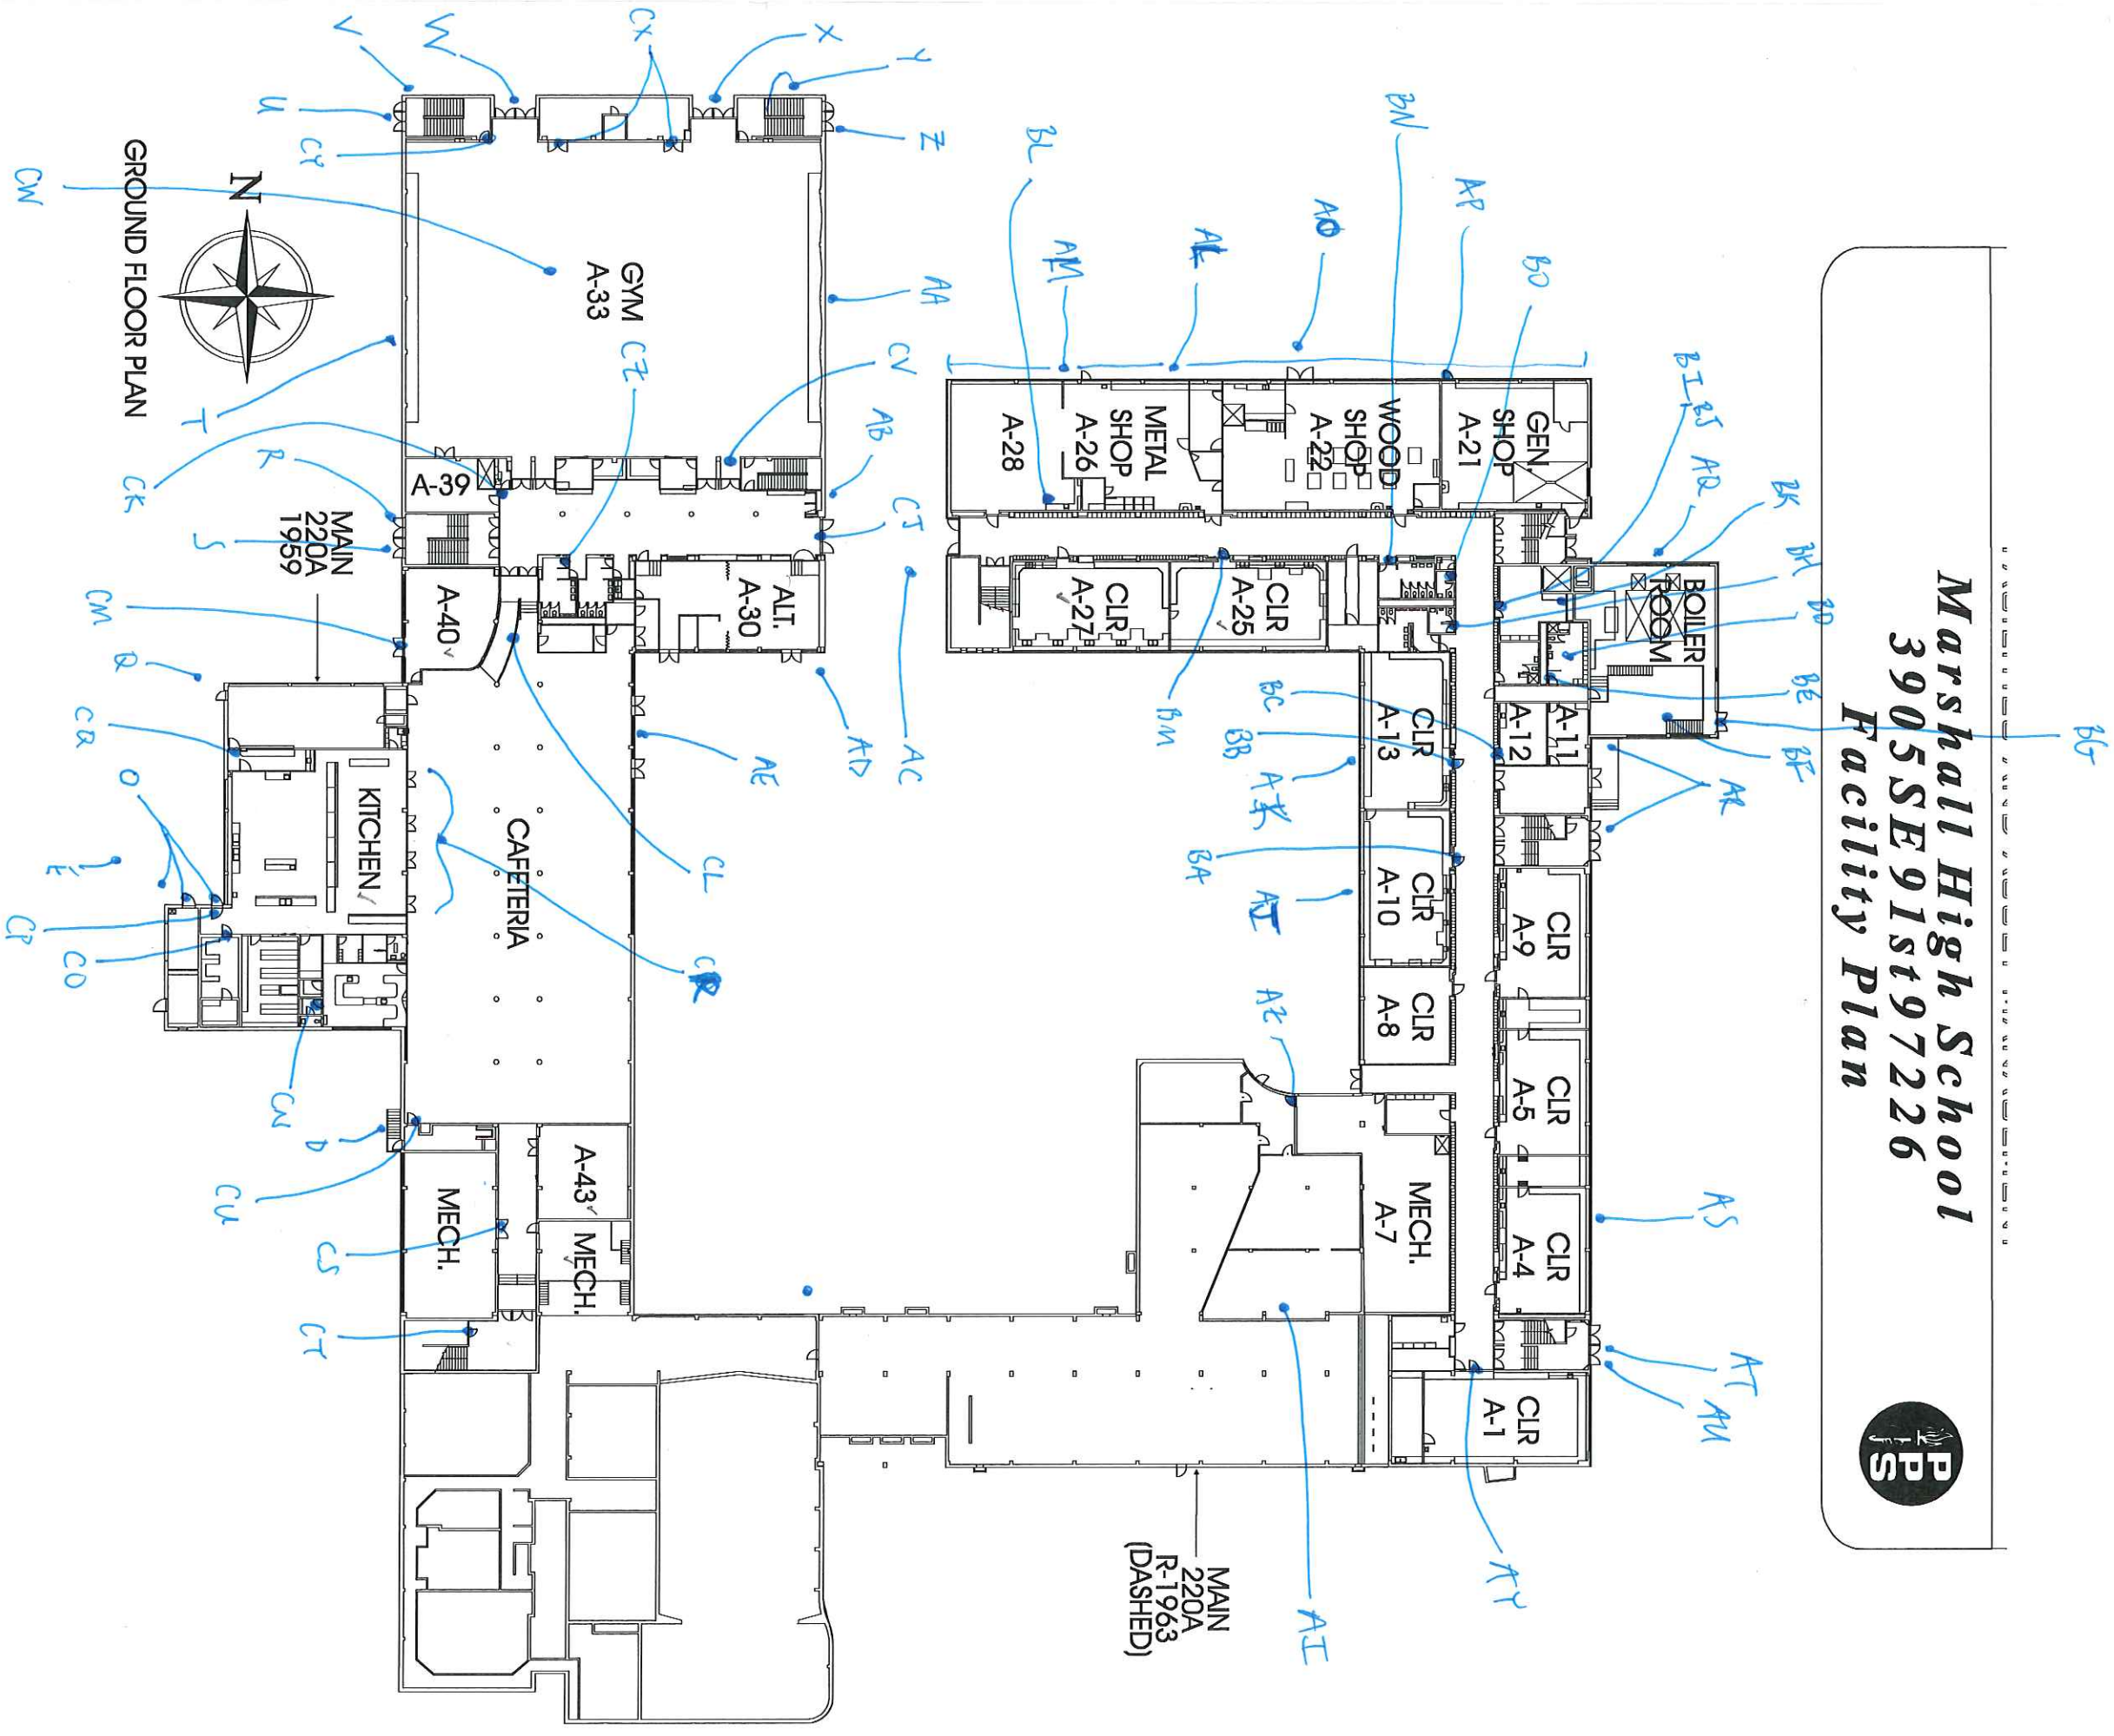
SECOND FLOOR PLAN

No paint chips were observed in the school's garden spaces; however, paint chips were observed on concrete at the southwest and northwest gym doors and on asphalt by the west shop wing walls.

PBS recommends that all painted or varnished surfaces in deteriorated condition noted on the attached table be stabilized. All paint chips noted in this report should be removed.
