Executive Summary

Project Overview

Project Intent

Existing Conditions Summary

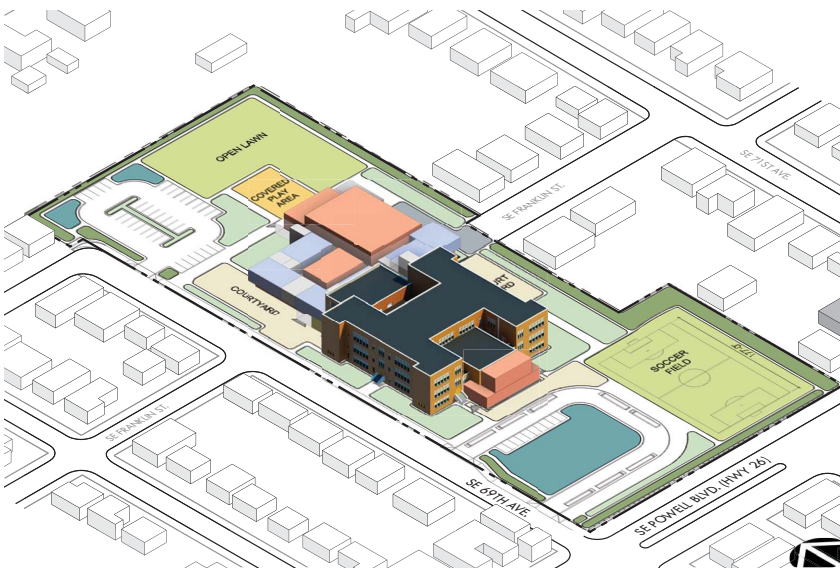
The Renovation and Addition option includes 61% renovation and 39% new construction to facilitate the District's health, safety and design standards while incorporating the programmatic and educational goals for new middle schools in the District. The existing 1917 school will be rehabilitated to a minimum LEED (Leadership in Energy and Environmental Design) Silver level of certification, receive seismic strengthening to meet current building code, and meet the programmatic and education goals of the District. The existing 1987 addition and 1952 annex will be demolished. A new addition will be designed to a minimum LEED Silver level of certification and mitigate building programming deficiencies.

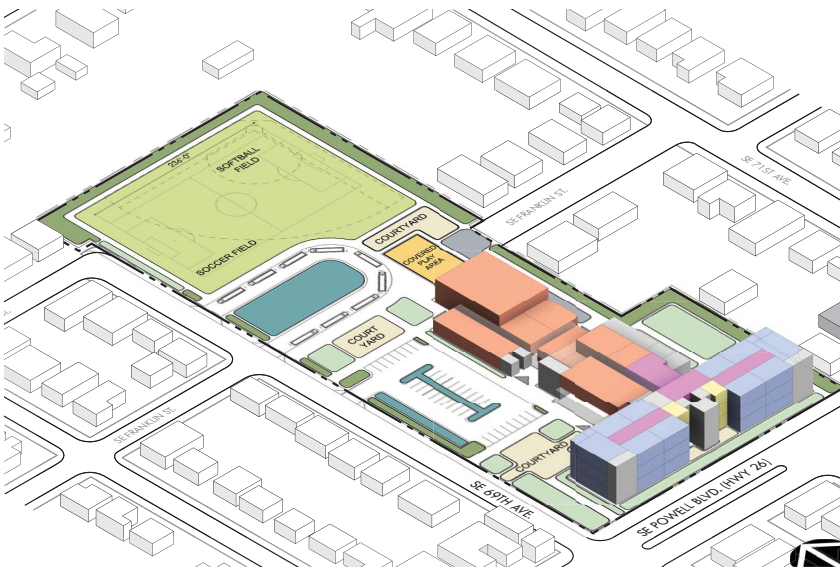
The Full Replacement option (100% new construction) includes the removal of all the existing buildings and construction of a new school facility. This middle school will be designed to minimum LEED Gold level of certification, the programmatic and educational goals of the District, and current building code and seismic requirements.

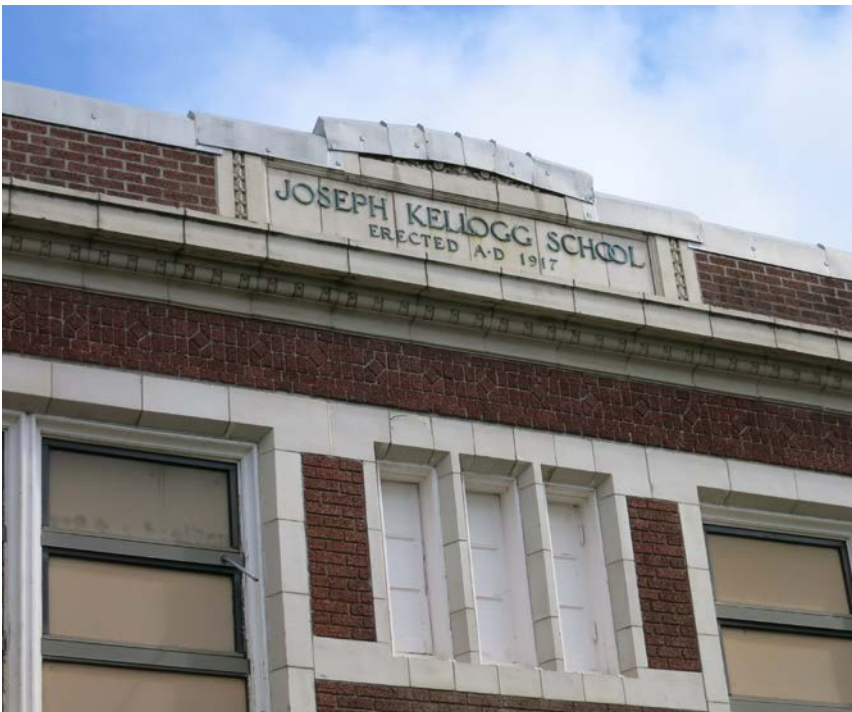
Existing Main Building Parapet Coping and Windows

- Extensive seismic strengthening required for existing main building deficiencies: unreinforced masonry walls, hollow clay tile walls, roof-wall diaphragm connections, and unbraced parapets

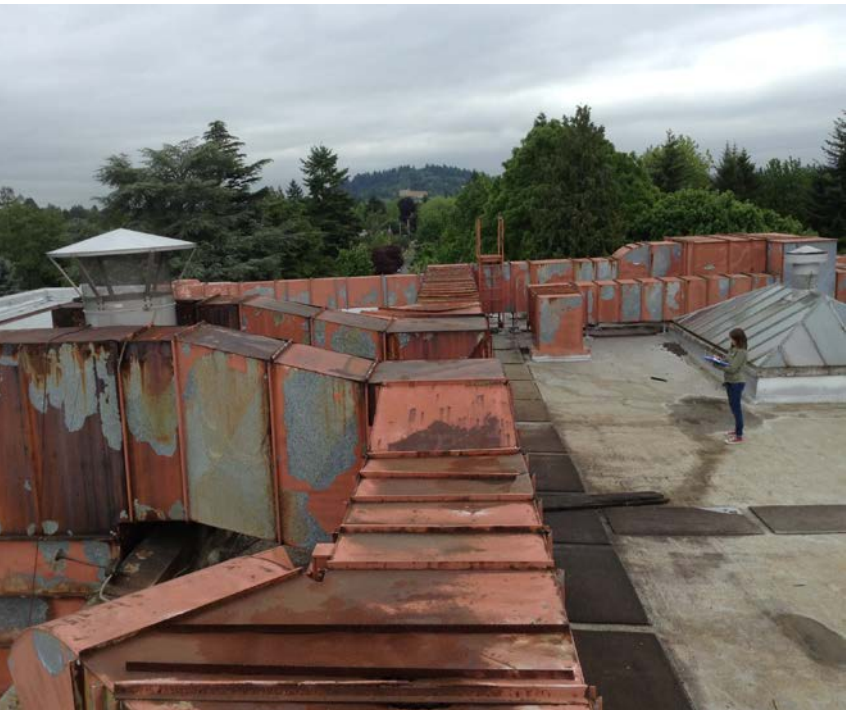
Existing Roof and Rooftop Mechanical System

All existing mechanical ventilation systems must be replaced for the Renovation and Addition and the Full Replacement option. Various mechanical systems have been investigated for use in both building schemes. Descriptions and diagrams for each of these may be found in Chapter 6 [Appendix], but for the purpose of pricing and further development during the pre-design phase this document will focus on Displacement Ventilation with Perimeter Finned Tube as the basis of design.

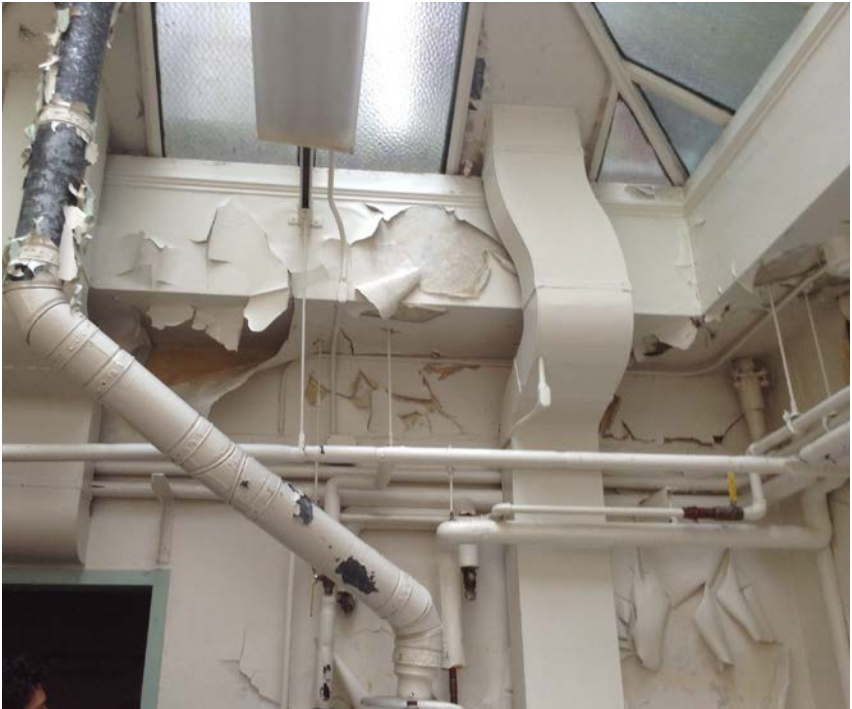
Existing Skylight and Building Systems

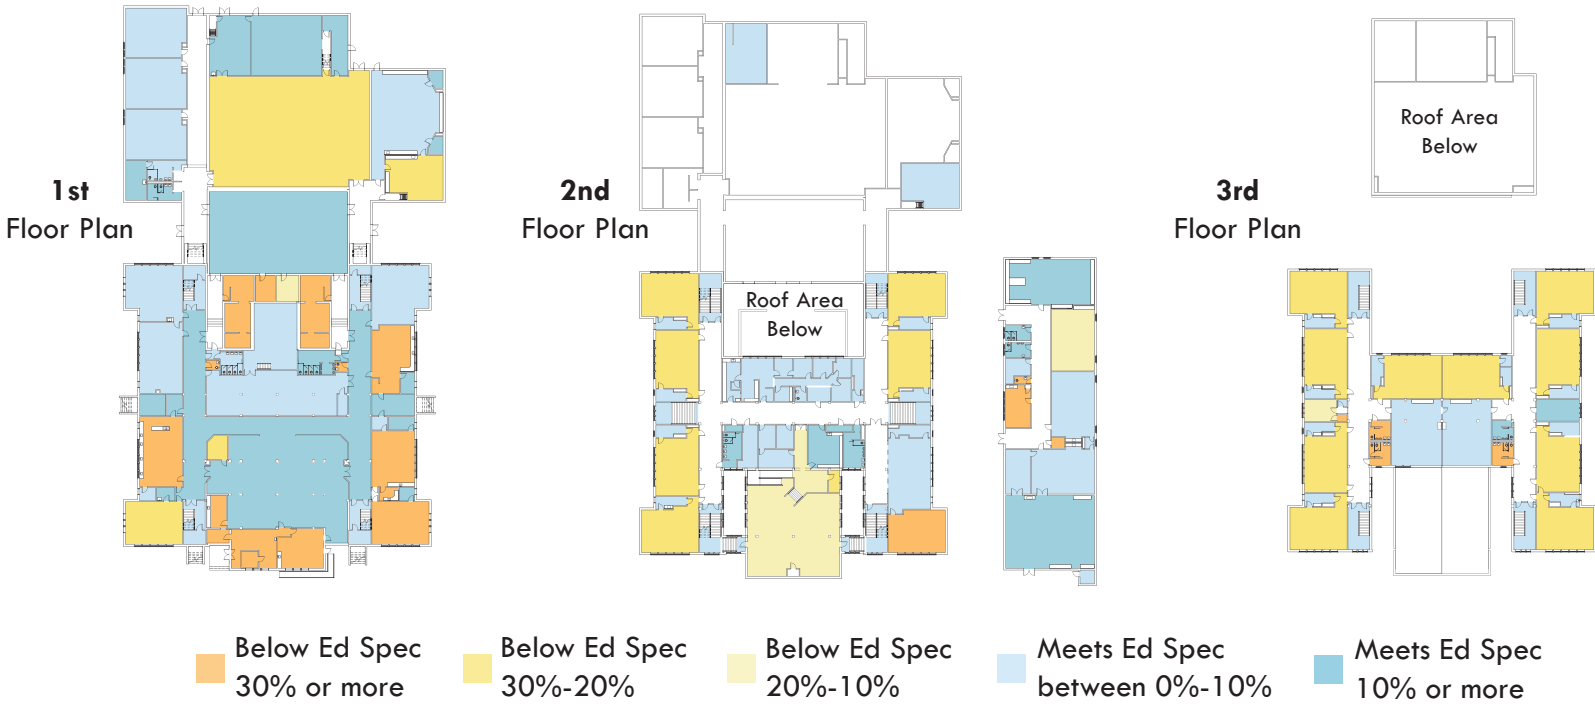
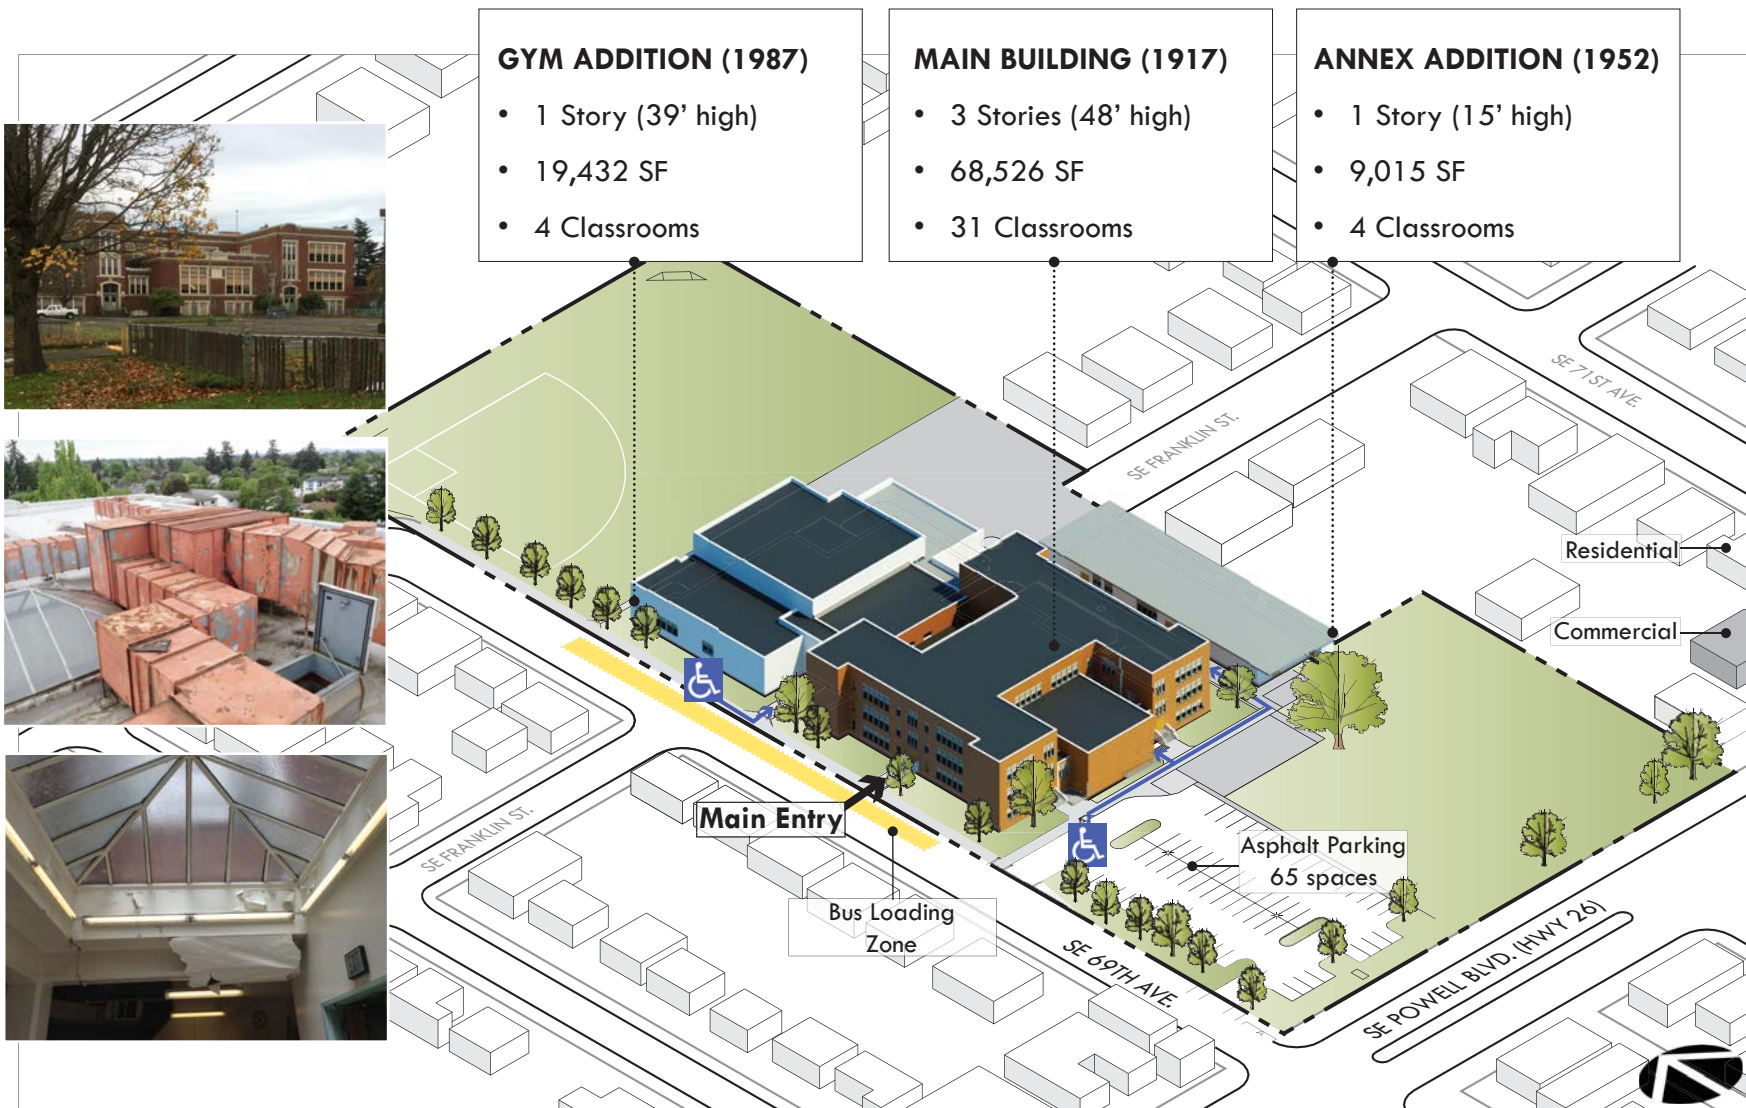
EXISTING Kellogg Middle School SF = 96,973 SF
REQUIRED SF per 2015 PPS Middle School ED SPEC = 105,112 SF*
*105,112 includes educational specifications preferred programming increases but does not include educational specifications required 4,000 SF of site covered play

- 2nd and 3rd Floors are not ADA Accessible
 - Existing Health and Safety Issues [Asbestos, Lead Based Paint, Mold & Moisture, PCB's and Mercury Light Tubes]
 - Requires Extensive Roof and HVAC & Plumbing Systems Replacement and Seismic Strengthening
- 26 of 39 Classrooms Do Not Meet Current PPS Ed Spec
 - Gymnasium and Cafeteria Do Not Meet Current PPS Ed Spec
 - See 2015 Assessment Report for Further Information

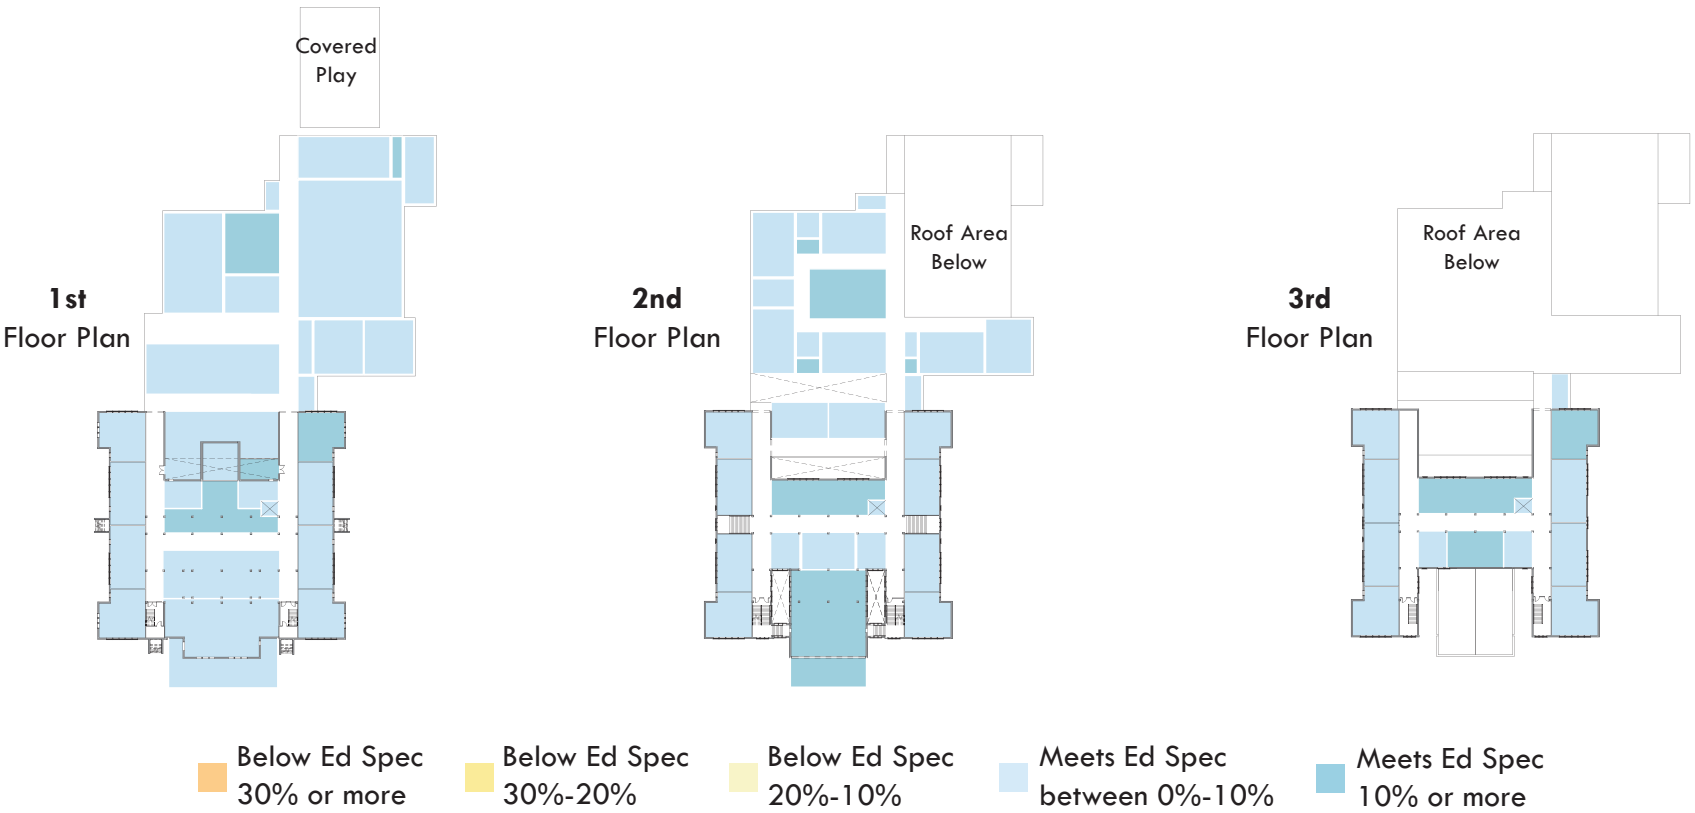
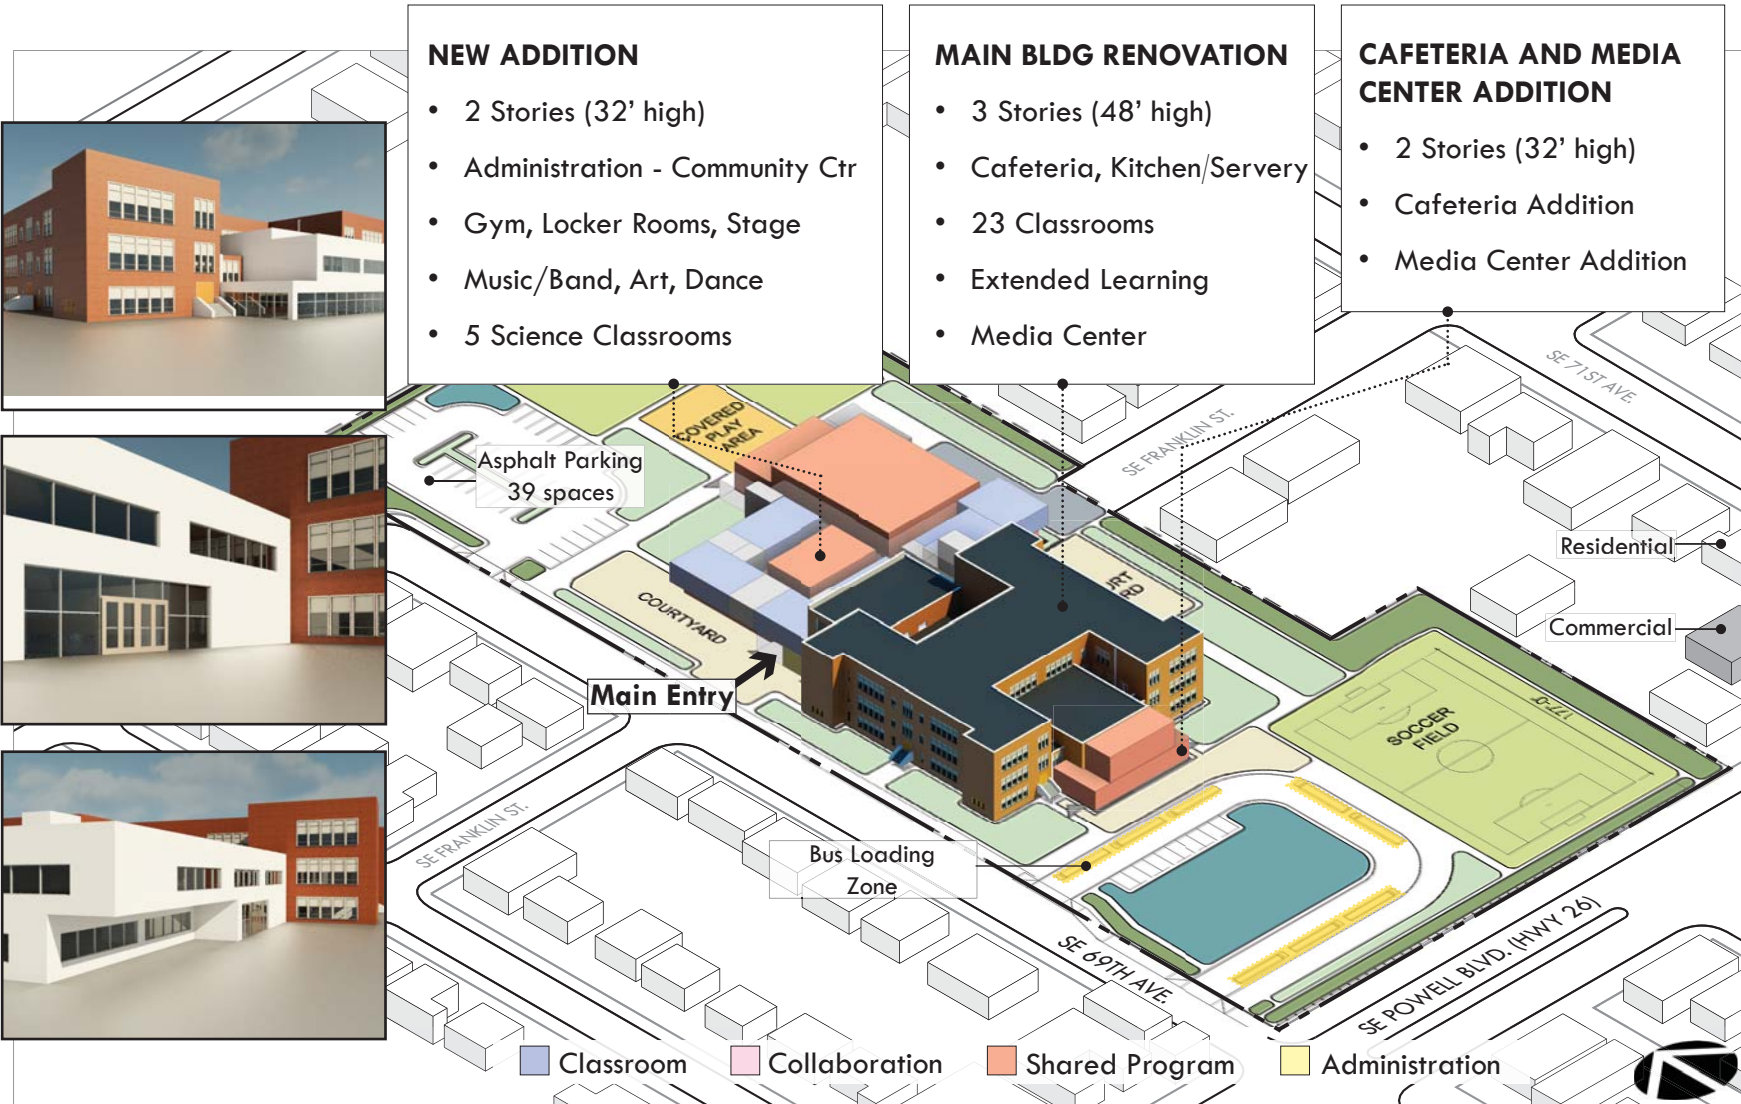
Renovation and Addition Summary

RENOVATION and ADDITION Middle School SF = 105,112 SF*
REQUIRED SF per 2015 PPS Middle School ED SPEC = 105,112 SF*

- **61% Renovation**
- **39% New Construction (Addition)**
- **Building Design Remediate PPS Health and Safety Issues**
- **All Floors ADA Accessible**
- **New Roof, HVAC & Plumbing Systems, Seismic Strengthening**
- **All Program Meets Current PPS Ed Spec**
- **Secure Access to All Zones**
- **Separation of Bus Drop-off and Parking**

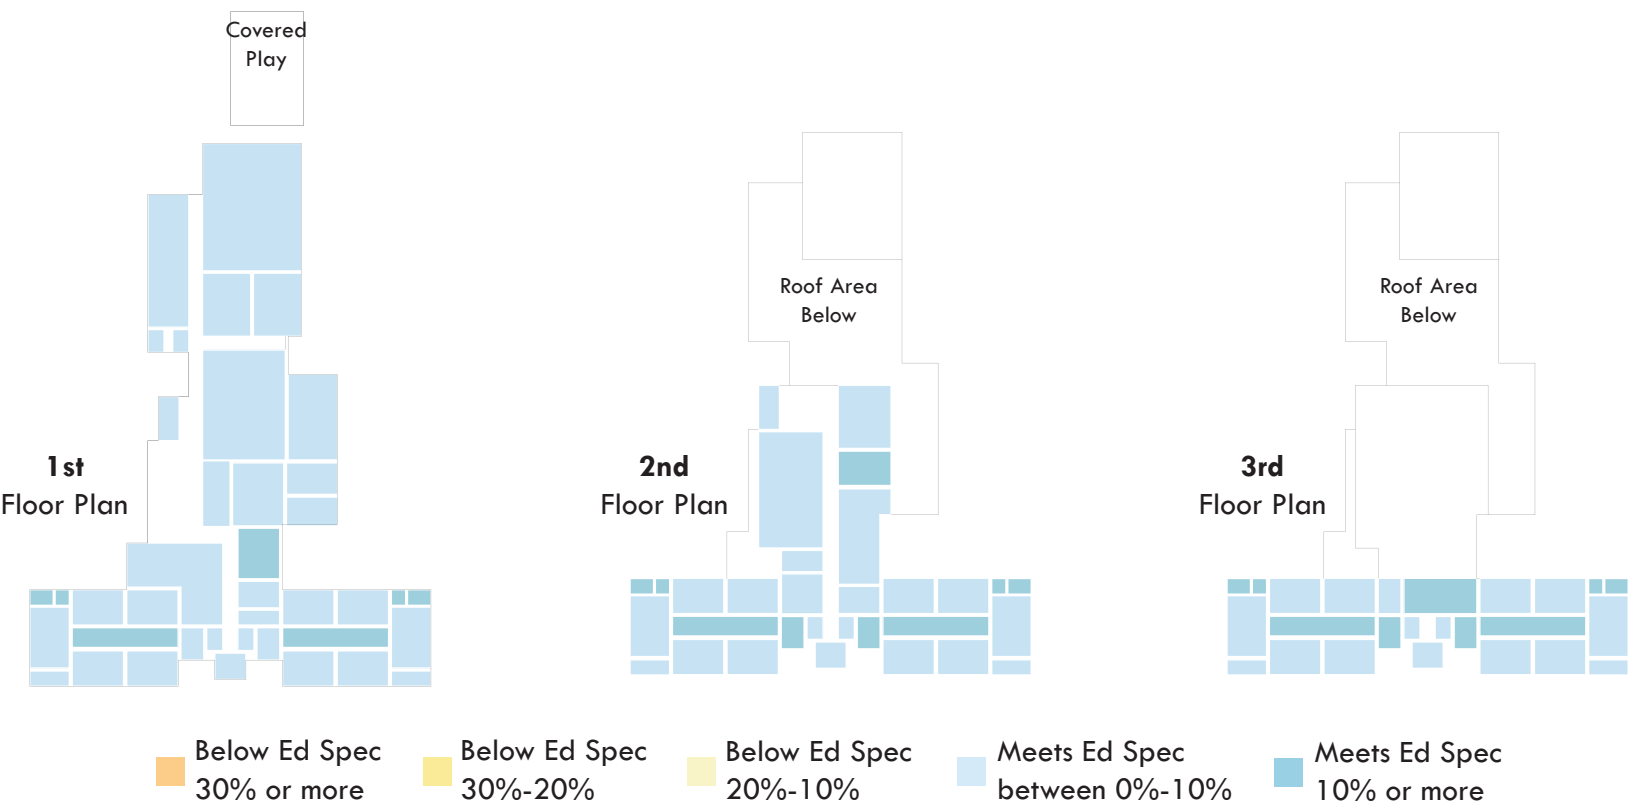
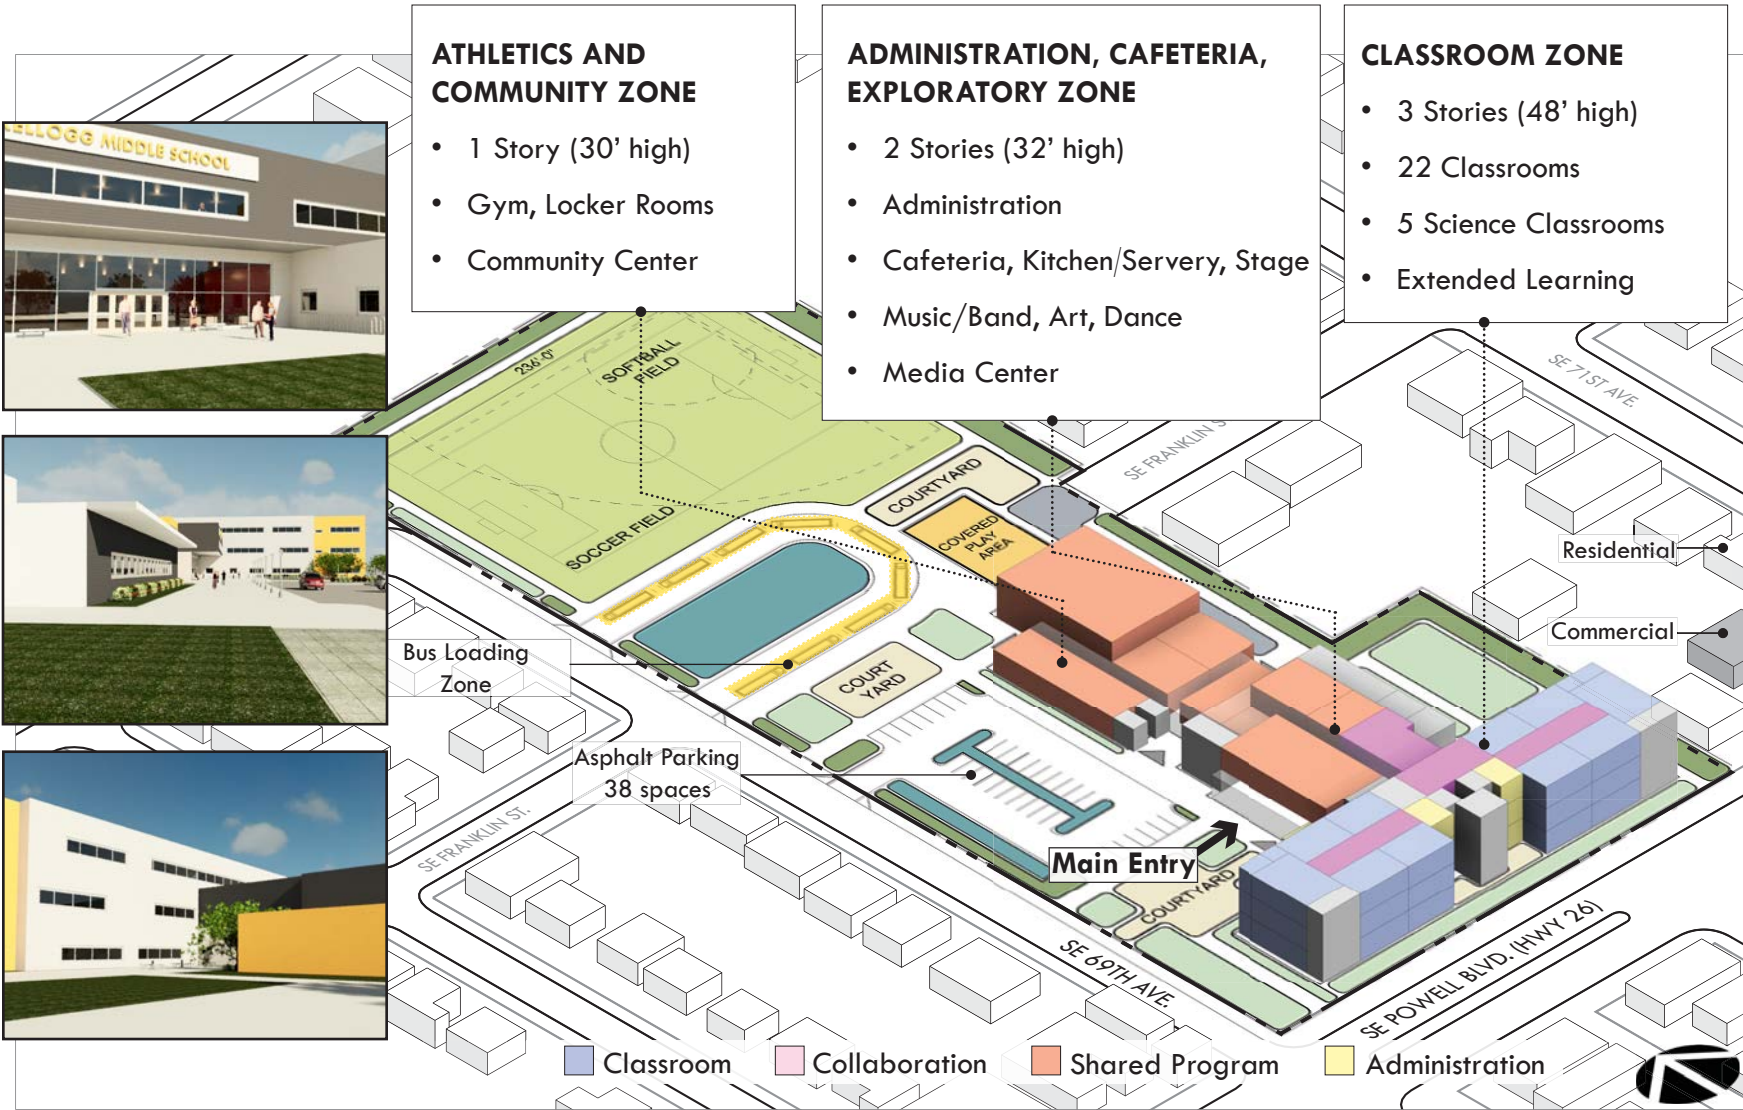
Full Replacement Summary

FULL REPLACEMENT Middle School SF = 105,112 SF*
REQUIRED SF per 2015 PPS Middle School ED SPEC = 105,112 SF*
**105,112 includes educational specifications preferred programming increases but does not include educational specifications required 4,000 SF of site covered play*

- 100% New Construction
 - Building and Systems are Designed to Meet PPS Health and Safety Priorities
 - All Floors and Entries ADA Accessible
 - All Program Meets Current PPS Ed Spec
- Program Zones per PPS Ed Spec
 - Secure Access to All Zones
 - 25 ft Building Setback Required from SE Powell Blvd.
 - Separation of Bus Drop-off and Parking
