PORTLAND PUBLIC SCHOOLS – FACILITY ADA ASSESSMENT

Franklin High School
August 31, 2009

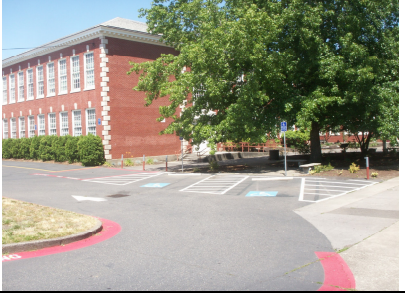
<p>Parking, South Front Entry (#1)</p>	<p>Two ADA spaces exist at the entry turnaround off SE Woodward at the front of the school. Signage and striping are new and distinct. Left space is signed as Van Accessible. Overhanging tree branches partially obscure signs, trim. Verify that the stall width is 9-feet with an 8-foot wide striped access aisle.</p>

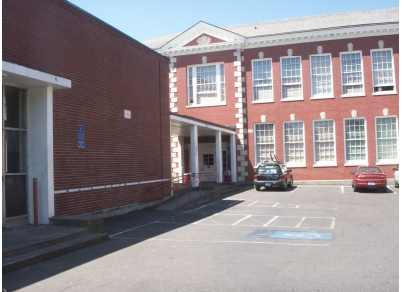
<p>Parking, East (#2)</p>	<p>One ADA stall space at the east parking lot between the Gym and Auditorium. Striping needs to be redone and access aisle needs to be 8-foot wide to conform the “van accessible” stall sign mounted on Gym. Ramp and handrails up to Gym entrance are compliant.</p>

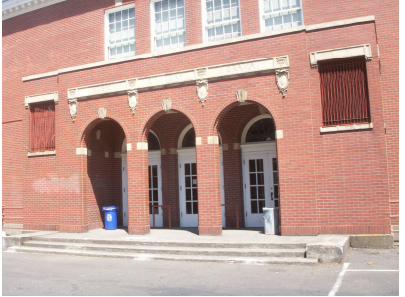
<p>Entry Accessible Path</p>	<p>Accessible path from accessible parking #1 has compliant ramp and stairs that leads into the west wing of the main building entry. Accessible path from accessible parking #2 has compliant ramp and handrails to accessible Gym entry. Raised covered path also leads to accessible entry doors at east wing of the main building. Main Auditorium formal entry is not fully accessible with 3 steps and no handrails. Auditorium accessible entry is from Main building corridor. Add directional signage near accessible stall for directions to all common use spaces. Accessible path from accessible parking</p>

<p>#3 to the athletic fields and stadium seating is a moderate paved sloping path leading to the top tier accessible wheelchair stadium spaces. Outside edge of stadium stairs needs a handrail adjacent to the landscape edge.</p>	
Entry, Main Front	<p>Main entrance from street requires a ramp. Main building triple doors has 3 steps and no handrails. Accessible entry's are at each end of east and west wings. There are no directional signs on interior to direct you to main building function areas (i.e. office, auditorium, gym, library, etc)</p>	
Stair Handrails, Exterior	<p>Existing exterior entry stairs have metal handrails at a few of the exit doors already retrofitted for accessibility. All other exits with exterior steps do not have handrails. Add compliant handrails.</p>

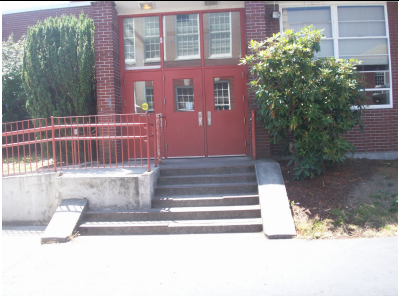
Southwest Entry ramp	<p>This door is the closest ramp from the front accessible parking stalls, but only leads into the Media Center. Add directional signage for main accessible entry to building corridors and common spaces. This would currently be the main building southeast entry by the Gym. Stairs need handrails. Repair stair tread nosings due to tripping hazard.</p>

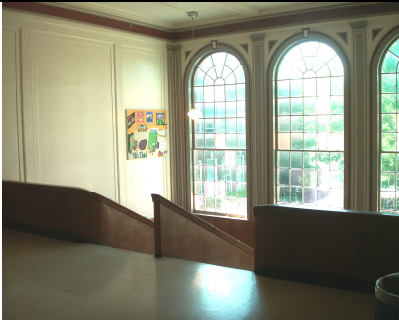
<p>Stair Handrails, Interior</p>	<p>Some existing interior stairs have been retro-fitted with compliant metal handrails on each side, with compliant top and bottom extensions. Most stairwells still have wood handrails at non-compliant heights. Main building central stairs: guardrails at +32.5", with wood handrails at outer wall side and no handrails at the inner side of the stairs. Add compliant metal railing wall extensions at floors and landings to reach +42". Add compliant metal handrails on both sides of the stairs with compliant top and bottom</p>

extensions. Inner handrail to be a continuous railing.

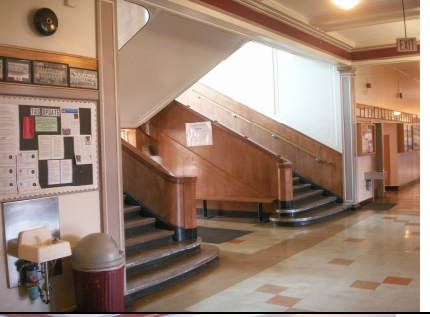
Auditorium 151	Main auditorium lobby has 4 mid-room steps. Add edge and mid handrails and stair edge visual markers.

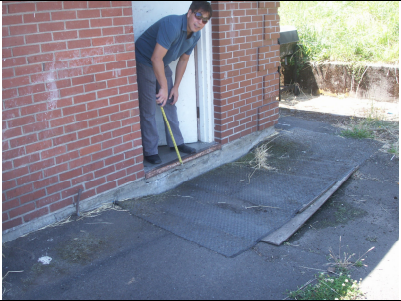
<p>within reach ranges. Widen and reconfigure entry and privacy partition to provide 36" clearances.</p>	
Field House, Boys	<p>Upgrade and provide accessible toilet stall, clearances, lavatory and accessories within reach ranges. Repair and add landing and ramp at entry door. Existing 6" threshold step has increased to 12" due to paving subsidence on the exterior.</p>

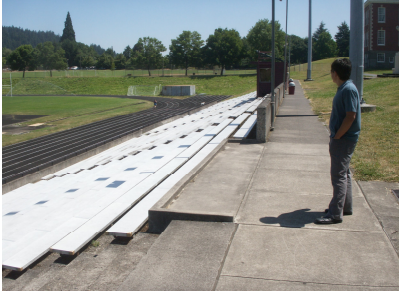
Auditorium 151	Verify that wheelchair and companion seating spaces are provided.	
Office 146 / 146B	Replace 36" section of tall counter/divider wall with one at + 34" above finish floor.	
Stadium Seating	<p>The exterior stadium seating for the track and football field has long series of stairs leading from the accessible parking level at the top, down to the various levels of bench seats. Accessible seating platform areas have been provided at the accessible top level for wheelchairs. There is no available companion seating except at bench rows below the wheelchair spaces. Add adjacent companion seating, either moveable or foldable, to provide the greatest flexibility.</p> <p>Add handrails along the outer edges of the outer stair runs adjacent to the landscape edges.</p>
