PORTLAND PUBLIC SCHOOLS – FACILITY ADA ASSESSMENT

Irvington School K-8
 August 31, 2009

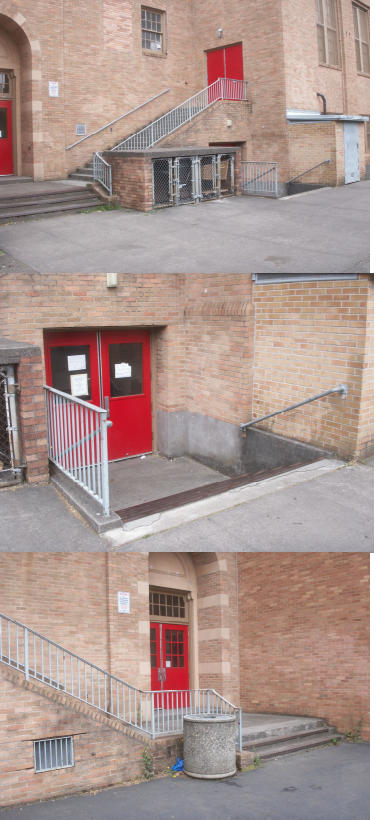
<p>Parking</p>	<p>If possible, arrange with City to provide 1 accessible parking space at curbside on NE Brazee located near accessible main entrance. Locate immediately west of the current No Parking, drop-off zone directly in front of the school entrance.</p>	
<p>Exterior Stair Handrails</p>	<p>Exterior stairs, especially at the south leading to the playground, have non-compliant or missing handrails. Replace handrails at southwest exit stairs with compliant double handrails with top and bottom extensions (approximately 76lf of rail.) It would also improve accessibility to replace handrails at south cafeteria exit and southeast exit stairs with compliant double handrails with top and bottom extensions.</p>

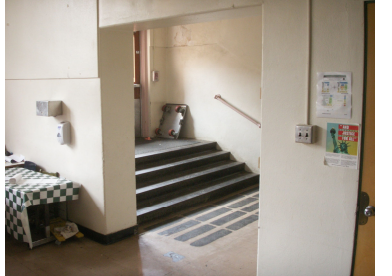
doors to the cafeteria. Provide lever hardware on the pair of doors to the serving line.	
Gym	Provide lever hardware on the two pairs of doors.	
Computer Lab 206	Provide lever door hardware.	
Science Room 214	Provide lever door hardware.	
Music Room 213	Provide lever door hardware.	
Classroom doors	Provide all classrooms with lever handle hardware.	
Stair Handrails, Interior	Replace existing wood handrails at (1) major staircase from basement to second floor with accessible double handrails with top & bottom extensions (approximately 224lf of rail.) Recommend southwest interior staircases next to the Gym, closest to the play area route and potential elevator location.	
Cafeteria Interior Stairs	Interior cafeteria exit stairs out to playground have non-compliant handrails. Replace with compliant double handrails with top and bottom extensions (approximately 20lf of rail.)

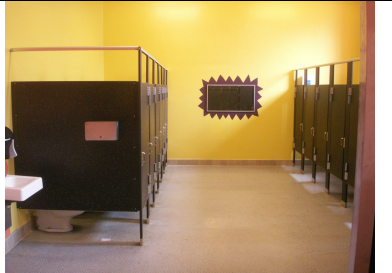
Basement, Boys 87	Provide accessible toilet stall, clearances, lavatory and accessories within reach ranges. Revise restroom door to provide 32" clear entry.	
Basement, Girls 89	Provide accessible toilet stall, clearances, lavatory and accessories within reach ranges. Revise restroom door to provide 32" clear entry.	
2 nd Floor Restroom, Boys 216	Provide accessible toilet stall, clearances, lavatory and accessories within reach ranges. Revise restroom doors and interior privacy partitions by removing wall and doors to match 1 st floor.	
2 nd Floor Restroom, Girls 215	Provide accessible toilet stall, clearances, lavatory and accessories within reach ranges. Revise restroom doors and interior privacy partitions by removing wall and doors to match 1 st floor.

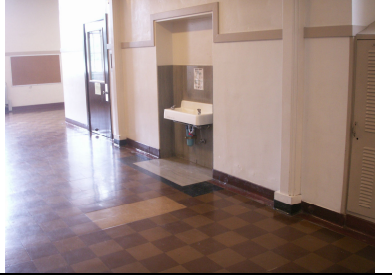
Drinking Fountains	Verify that at least one corridor DF on each floor complies with clearances. Existing DF's on 1 st and 2 nd floors are all at 32" AFF spout heights. Wall recesses comply with access requirements.
