PORTLAND PUBLIC SCHOOLS – FACILITY ADA ASSESSMENT

Youngson SPED K-8
August 31, 2009

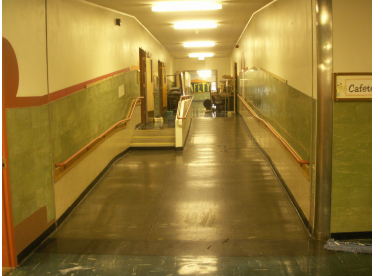
Southwest Parking	Locate and stripe a permanent pedestrian path from the parking access aisle to the closest accessible building entry.	
Southwest Entry	Entry closest to parking area is the accessible entry.	
Interior Ramps	Existing ramps in main corridor outside Rooms 7-8-18 are compliant for slope and double handrails. Intermediate side stairs before Room 7 door has compliant rise and run and has compliant double handrails.

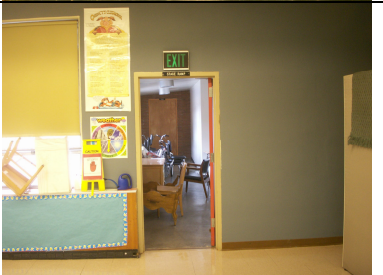
Stage 22A	Ramped access has been provided to the raised stage, and is accessible from door in Class 18.

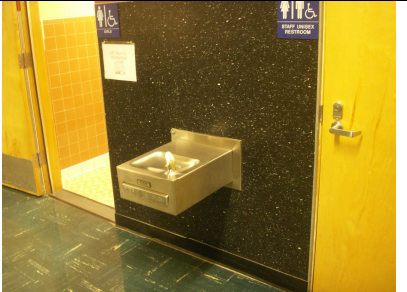
Drinking Fountains	Verify that drinking fountain outside Girls 27 complies with accessibility standards. Drinking fountains in this building's program are subject to daily abuse, and existing fountain was observed to have damage. Mounting is loose on wall. Need a high vandal-resistant model.

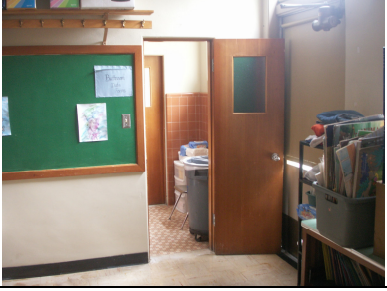
Bathroom	Modify the existing bathroom shared between classrooms 1 and 2 to provide one K-5 range accessible toilet, no partitions, and add a lavatory to the room. This bathroom is being used within the enclosed classroom to support the program. Replace existing 2-0x6-4 doors into each classroom with wider and taller doors.

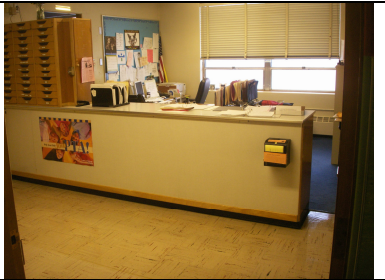
Office 28	Provide a 36" wide minimum section of lowered counter at + 34" high above finish floor.
